Clunking/Rattle Noise from Rear Axle Area

Topic number	LI32.25-N-069847
Version	1
Function group	32.25 Shock absorbers, damper struts, spring struts
Date	05-28-2019
Validity	Sprinter Model 907.xxx with SA codes CB8 and/or XB3, XL4, IT5
Reason for change	
Reason for block

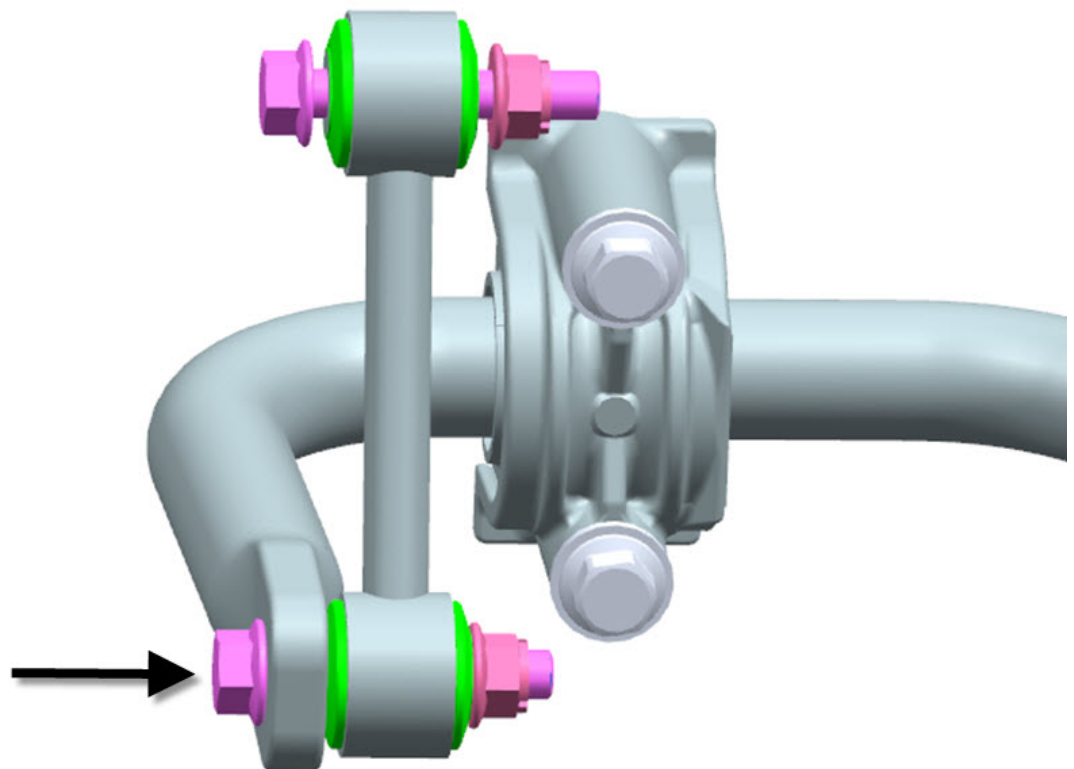
bolt installation.jpg:

Bolted connection at rear sway bar to sway bar link loose

Attachments	
File	Description
bolt installation.jpg	Bolted connection orientation

1. Replace the left and right bolt & locking nut at the sway bar to sway bar link connections

NOTE: Ensure proper orientation of the bolted connection (see bolt installation.jpg)

2. With the vehicle suspension loaded torque the bolted connection to 50Nm + 90° torque angle

NOTE: Apply torque and torque angle to the nut while counter holding the bolt
