WJ90 - Checking Hinge For Convertible-Top Compartment Lid (Workshop Campaign)

Vehicle type: **911 Targa 4 (991)/911 Targa 4S (991)/911 Targa 4 GTS (991)**

Model Year: **As of 2014 up to 2019**

Subject: **Hinge for convertible-top compartment lid**

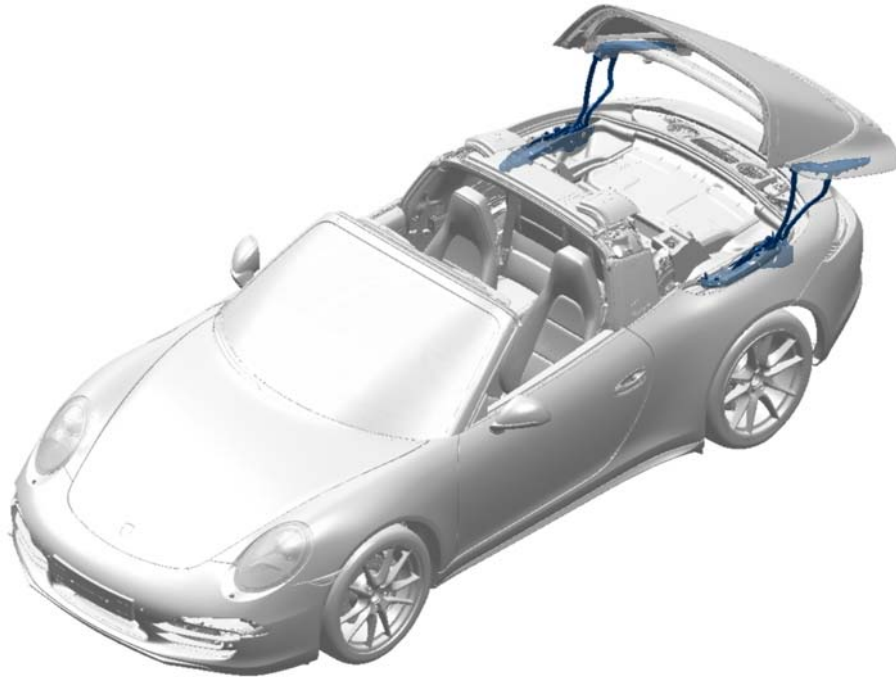
Installation position of hinge

Information: **There is a possibility that the end position in the actuating mechanism for the convertible-top compartment lid on the affected vehicles may not be reached due to unfavorable tolerances. This could result in the convertible top being partially released.**

- Checking hinge for convertible-top compartment lid and reworking it if necessary
- Re-coding convertible top control unit (depending on the date of manufacture of the vehicle)

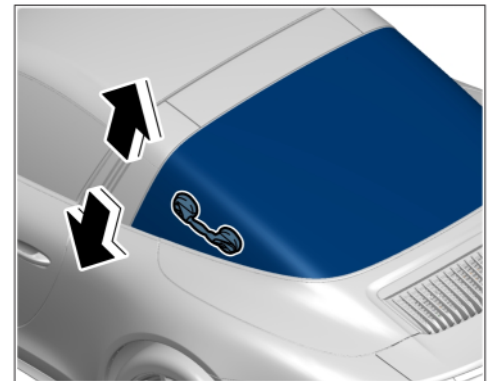
Checking by pulling at the front

- The **convertible-top compartment lid cannot be lifted**: The convertible-top compartment lid is locked **correctly**.
- The **convertible-top compartment lid lifts up**: The hinge is **not locking correctly**.

- (0) - **Convertible-top compartment lid is not OK** and **coding is not required**: Continue with ⇒ *Workshop Manual '61901510 Adjusting convertible-top compartment lid'*. Warranty processing: **Scope 3**.

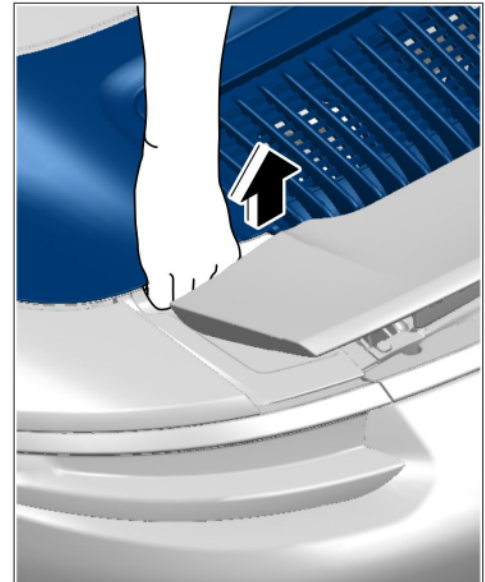
4.2 Pull convertible-top compartment lid at the left and right in the rear spoiler area **up forcefully at least 3 times** and shake it slightly.

Checking by pulling at the rear

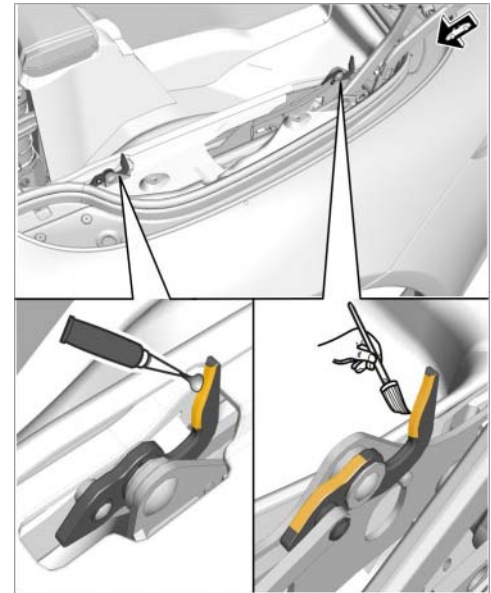
Lubricating hooks

- 5 Clean the front and rear hook on the left and right hinge and then lubricate them with Krytox as shown.
