## LATEST VEHICLE CONCERN FIXES

### Turbo Seized & P02CD stored in PCM

### 17-19MY F-PACE AJ20D

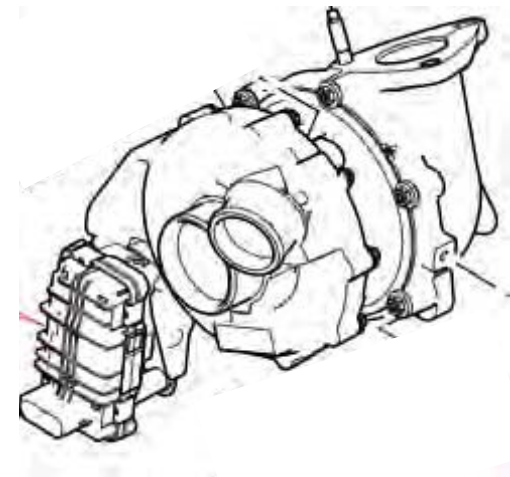
- Turbo may be ingesting oil from impeller bearing failure or the impeller nut becoming dislodged. If all parts are not found, this can result in a second turbo replacement.

- Under Investigation
- Replace the turbo as required & find all missing pieces.
- Once turbo replacement is complete & test drive successful, run a new session file. Check for any stored DTCs. Prior to release of vehicle, check compression on all cylinders, ideally using PicoScope. If low compression is found with DTC P02CD stored, please raise a TA and follow LTS guidance. Otherwise, raise an EPQR with a picture of the part label on the replaced turbo. Hold onto the replaced parts.
