Service Bulletin

July 4, 2019

2016-17 HR-V: *Bluetooth*[®] HandsFreeLink[®] Will Freeze After Calls and Voice Tags are Missing at Startup

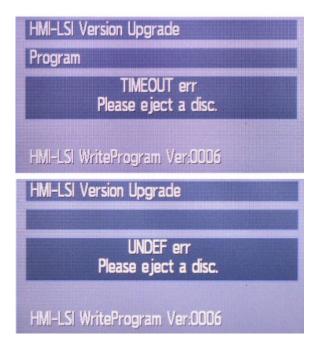
If at any time during the update process a **TIMEOUT err** or **UNDEFINE err** message appears, check the USB flash drive for damage, or use a different one.

5. Turn the ignition to ON.

6. With the audio unit turned off, press the buttons in order as shown.

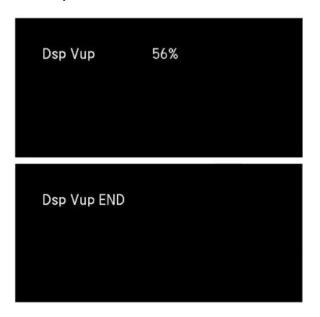
DSP Vup

You will see the following screens as the update runs:
