UPDATE FROM WARRANTY OPERATIONS

V08/V11/V16 3.0L Diesel Emission Campaigns

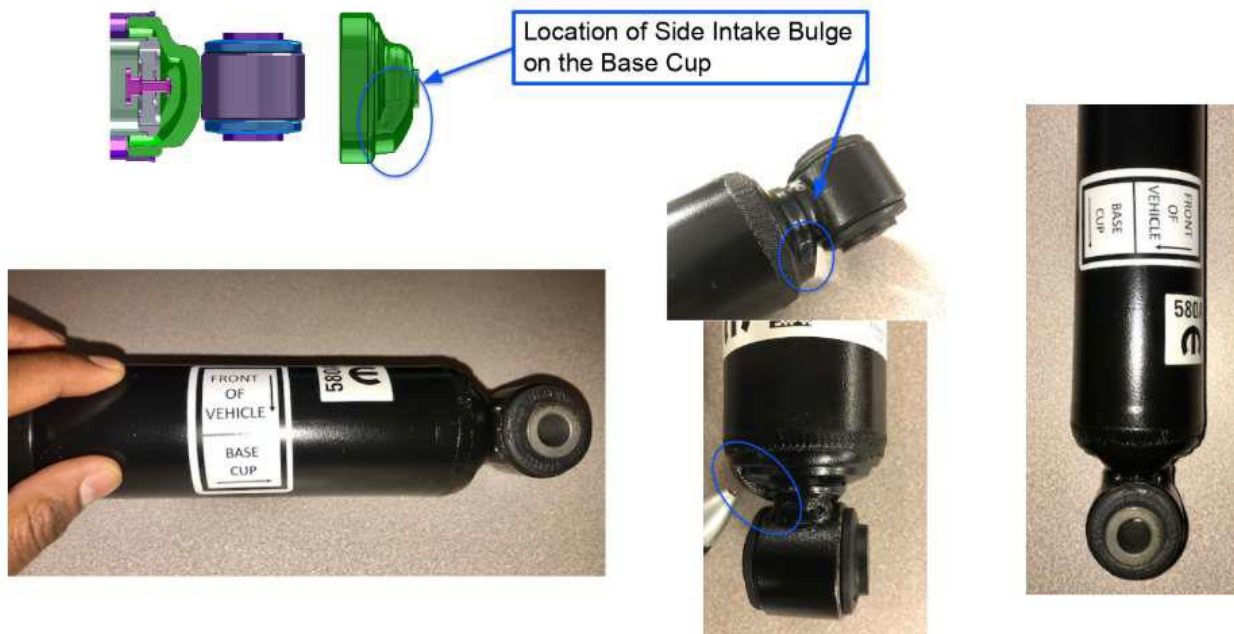
On New Wranglers or Gladiators that experience a shimmy in the steering wheel after hitting an irregularity in the road surface such as an expansion joint, pothole, bump, etc., the steering damper must be replaced with an AE level part or newer. Also the damper must be installed in a certain orientation.

AE level dampers have an orientation direction. (See the images below for orientation.) Also, please reference the *JL Steering Damper Installation TIPS Video* located in the Service Library in DealerCONNECT.

The damper must be installed with the “Bulge” on the bottom and the arrow pointing to the front of

the vehicle. The damper will only operate correctly in this orientation.

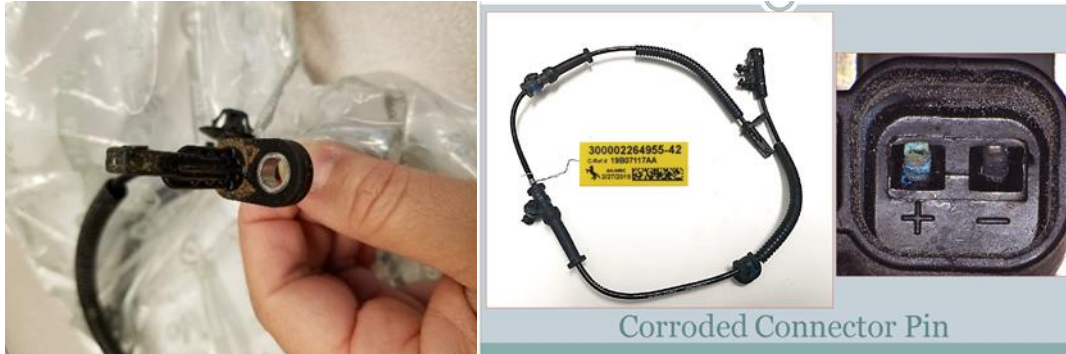
If the ABS light is on and diagnosis leads to the wheel speed sensor, be sure to check the electrical connections. There have been reports of wheel speed connectors not fully latching, allowing water to enter the connector and corrode the pins on the wheel speed connector.

In addition, check the tone wheel as well before replacing the wheel speed sensors. The wheel speed sensors returned are covered in rust (see pictures). This can cause the sensor to not read the tone wheel. If there is rust on the tone wheel,

If that is the case, the wire harness should be replaced and NOT the sensor. A new sensor with the old harness will cause a shop comeback for the same issue. Wheel speed sensors that are returned and found to be in good working order will be charged back as an over repair.

simply clean it off and reinstall the sensor after cleaning and test the system again for a good reading. In all cases this will correct the issue in the first visit.

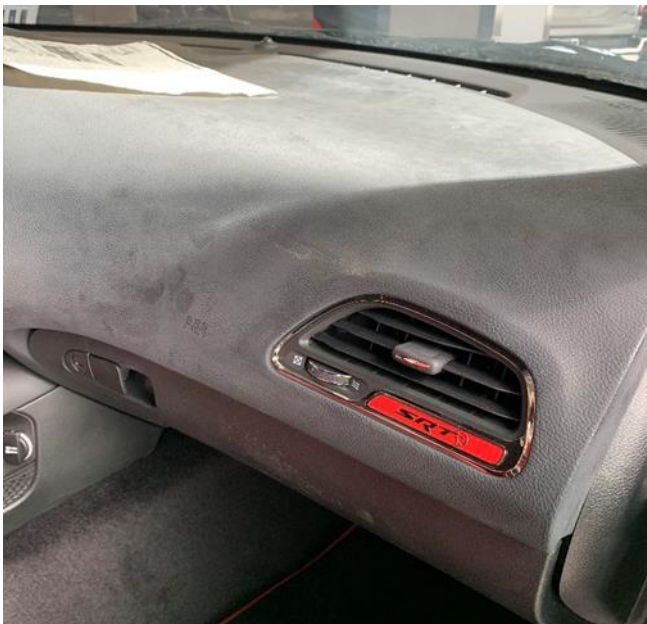
Over time on new vehicles the vinyl on door trim panels and the Instrument panel will exhibit a condition called Vinyl Gassing which can cause a “dusty” appearance to the surface (see below). This is a normal part of the vinyl curing process

and can be cleaned with MOPAR Total Clean PN 04897840AD, or MOPAR Interior Cleaner PN 05003240AC, during the New Vehicle Prep process in the last step of the process “Clean Vehicle Interior”. Replacement of parts is not required, only a good cleaning.

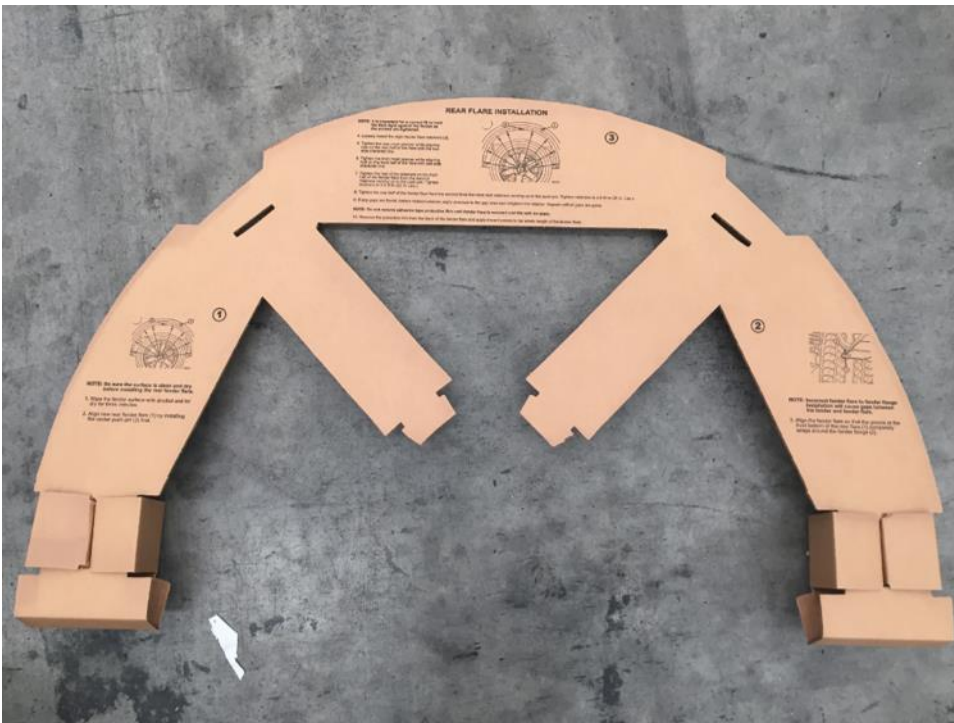
Poor installation of Dual Rear Wheel RAM Wheel Flares

We have seen a number of warranty claims for reinstallation of Rear Wheel Flares on RAM 3500 Dual Rear Wheel vehicles. These vehicles are shipped to your dealership with the wheel flares inside the vehicle, and require dealer installation at PREP. Any issues with gaps between the body panel and the wheel flare indicates poor

workmanship during dealer installation and cannot be considered a warrantable condition. The instructions on the box, the wheel flares are shipped in, MUST be followed very closely, and in order, to assure a proper bond to the body. Failure to follow those instructions will cause adhesion gaps to appear between the flare and the pick-up box side. Below are those instructions. Wheel Flare warranty claims filed for reinstallation or replacement due to loss of adhesion between the flare and the body will be charged back.

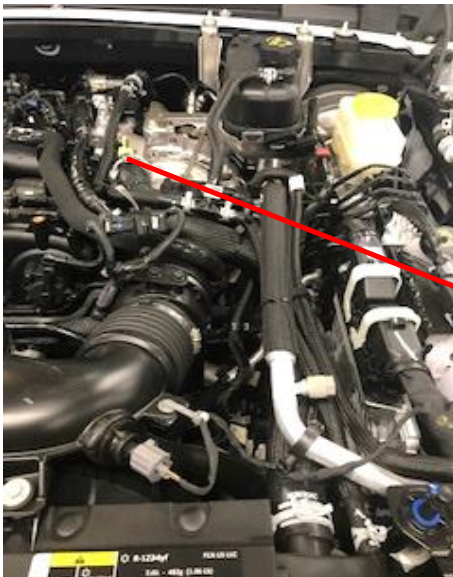
Under-hood View of Upper Radiator Hose Clamp Grenade Pin Still Attached.

Clamp in question is on the upper radiator hose next to the turbo charger.

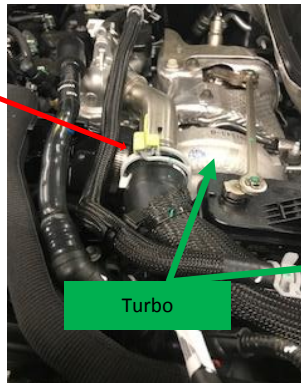
View from front of vehicle.

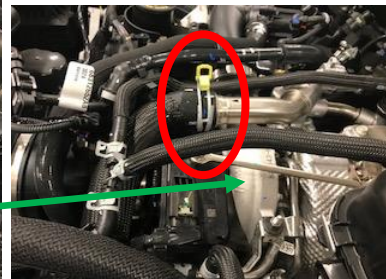
Clamp viewed from left fender.

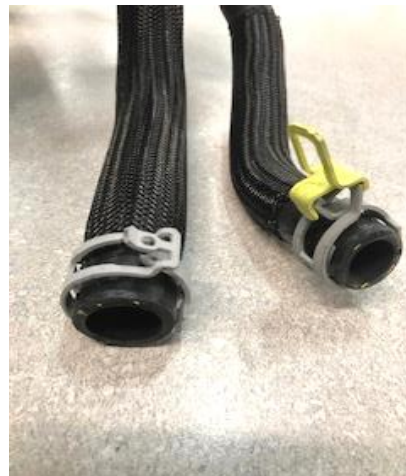
“Clipless” Mubea clamp on left / “Grenade Pin” Mubea clamp on right. Both clamps are un-sprung. Specifying where on the hose (i.e., at the turbo charger), and what type of clamp, helps us understand where and what the issue is.

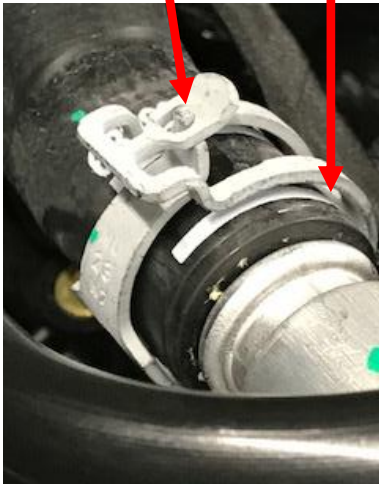
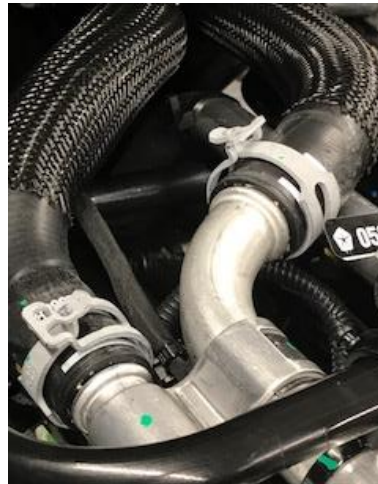
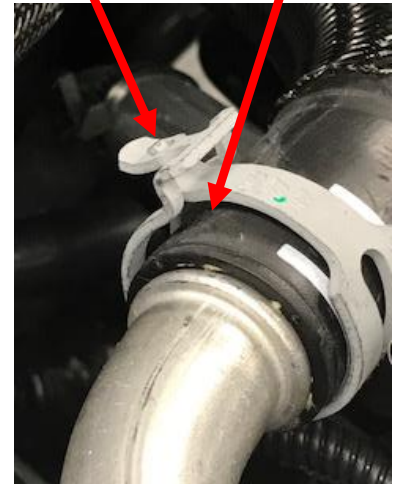
Clamp Pin Engaged / Clamp Gapped To Hose

**CUSTOMER CLAIMS
VEHICLE LEAKS COOLANT
DUE TO CLAMPS NOT SPRUNG**

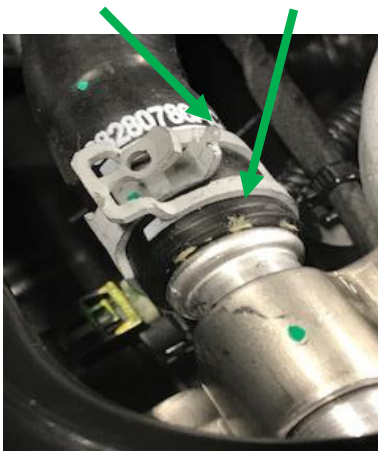
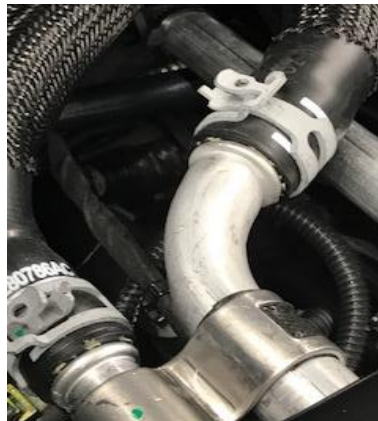
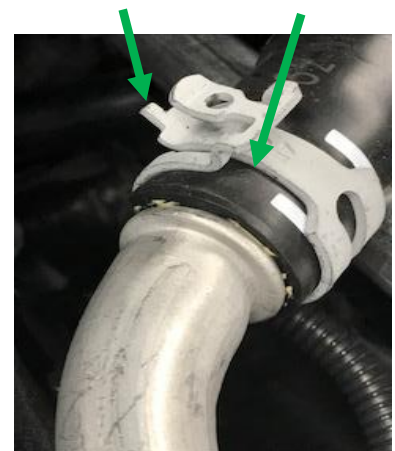
Clamp Pin Visible / No Gap To Hose

**VEHICLE HAS NO COOLANT LEAKS
DUE TO CLAMPS BEING SPRUNG**
