MBUX multimedia system: Navigation and/ or Satellite Radio not selectable/not available

Topic number LI82.85-N-069752

Validity Model 907 with code E1A (MBCONNECT - 5)/ E1C (AU-

DIO 25)/ EJ9 (COMAND ONLINE)

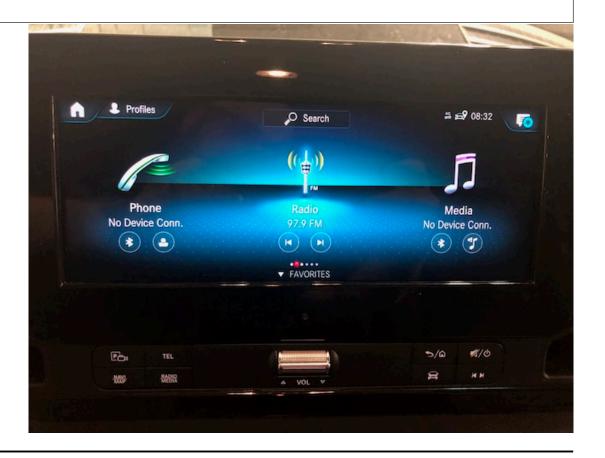
MBUX menu.jpg:

Navigation not available in source menu and Traffic Sign Assist inoperative

Head unit software (component A26/17)

- 1. Perform manual commissioning of head unit
- 2. Perform teach-in process of head unit -> Adaptations / Teach-in processes / Special function
