## Liftgate deformed below the star

Topic number	LI72.20-N-062702
Version	2
Function group	72.20 Tailgate, rear door
Date	06-20-2019
Validity	Model 447.### ## up to 198809 with code W65 (Liftgate)
Reason for change	Validity restricted.
Reason for block

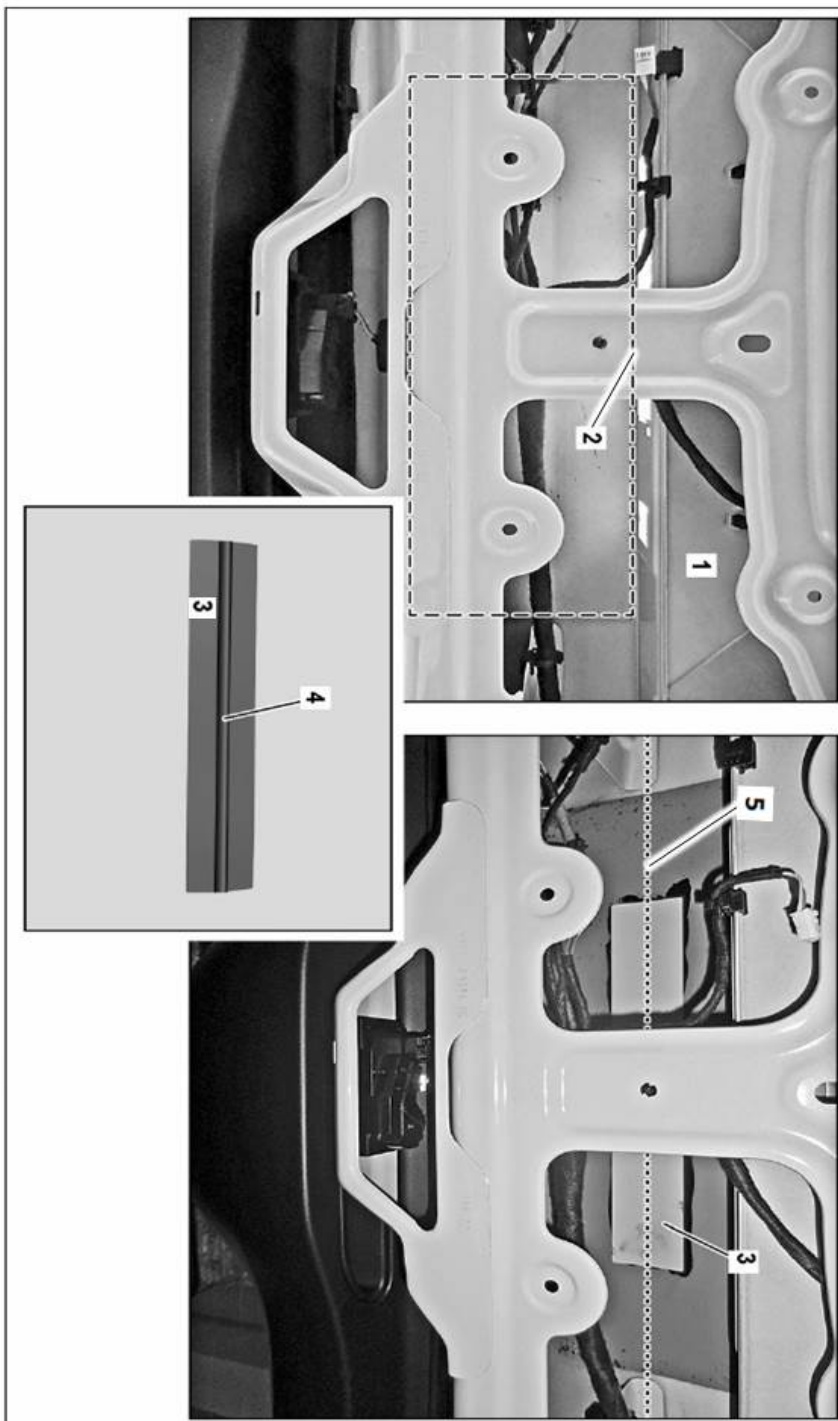
03.jpg:

Attachments	
File	Description
03.jpg	Installation of reinforcement (3) on liftgate.

10. Apply adhesive bead (4) to center of reinforcement (3).

The reinforcement (3) is shaped to fit the base of the beading (5) on the liftgate (1). The depth of the adhesive (repair kit A 221 670 81 01) must be at least 5 mm. Otherwise the necessary adhesion cannot be guaranteed.

11. Glue reinforcement (3) with adhesive bead (4) fitting in base of beading (5).

Note: Pay attention to the position and installation location of the reinforcement (3) in the base of the beading (5) in the liftgate (1). Otherwise the desired support cannot be guaranteed.

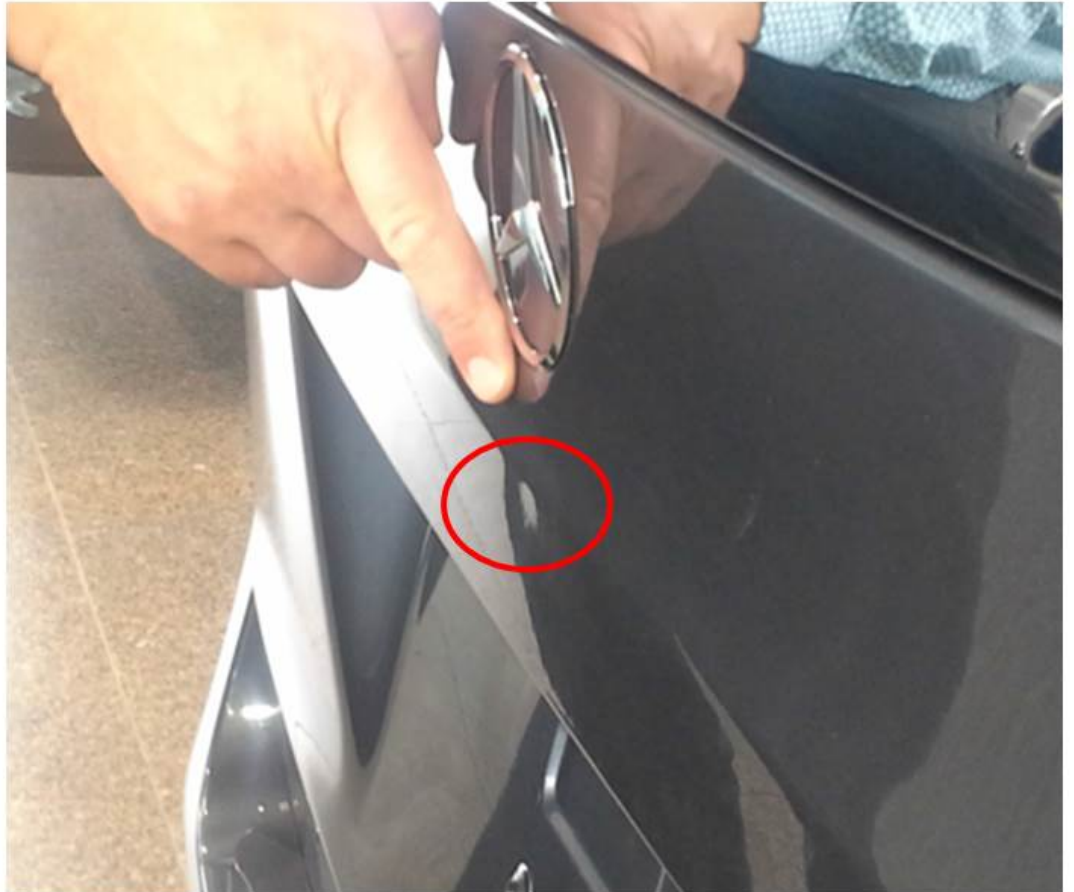
01.jpg:

When the liftgate is closed manually, a dent (deformation) occurs below the star.

Attachments	
File	Description
01.jpg	Dent in liftgate below star.
02.jpg	Dent in liftgate below star.

Internal reinforcement of liftgate not sufficient.

1. Reform dent in liftgate (see Figure 1 and Figure 2).  
-----
2. Clean reinforcement (3) with assembly cleaner and degrease.  
-----
3. Prime reinforcement (3) with primer filler.  
Note: Observe AS98.00-Z-0002-01A.  
-----
4. Remove both license plate lamps (see AR82.10-S-5161E).  
-----
5. Remove handle of liftgate (1) (see AR72.20-S-7320E).  
-----
6. Remove insulation mat (2).  
Note: To do this, heat the insulation mat (2) and pull it off (heat gun, 000 588 00 84 00).  
-----
7. Clean inside of liftgate (1) in working area using assembly cleaner.  
-----
8. Apply primer from repair kit (A 221 670 81 01) to reinforcement (3).
