Title Engine Brake - Diagnostic Trouble Code (DTC) P1021-11 Volvo Compression Brake (VCB) Control Circuit Short To Ground - **US17+OBD16 Through US17+OBD19 Emissions, Model Years 2018 To 2020**

Engine family 13L Engine , MP8

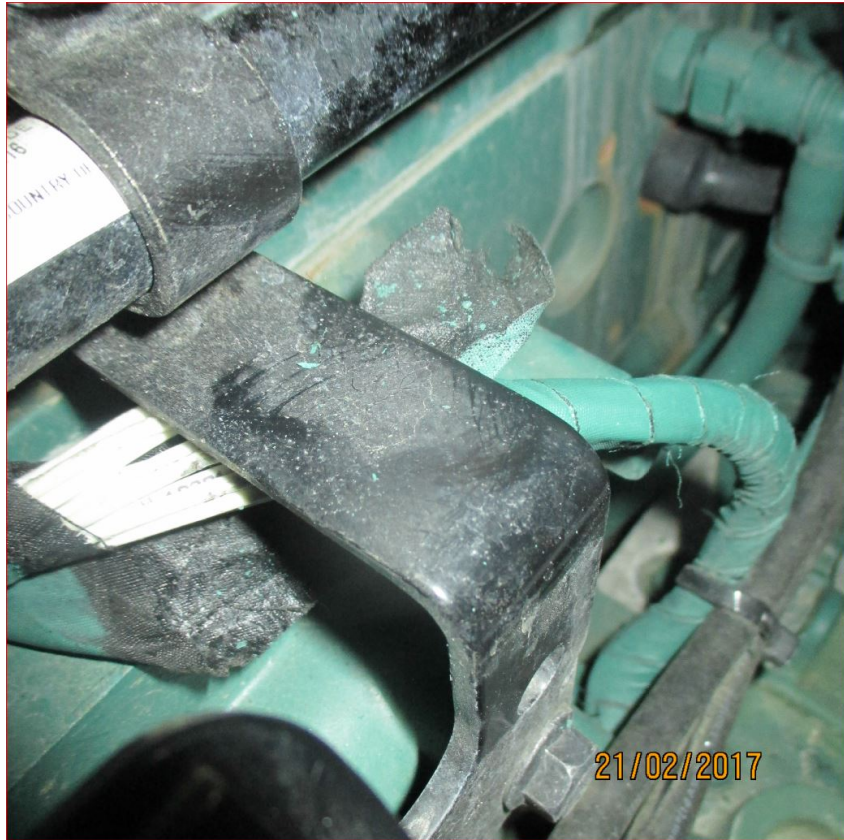
Charge Air Cooler Pipe Bracket

Cause The VCB circuit wires may rub on the air compressor supply pipe bracket, resulting in a short to ground circuit issue.

Solution **Once the circuit issue has been confirmed repair the damaged wires and move the harness away from the bracket so no further rubbing occurs. Refer to the pictures below -**

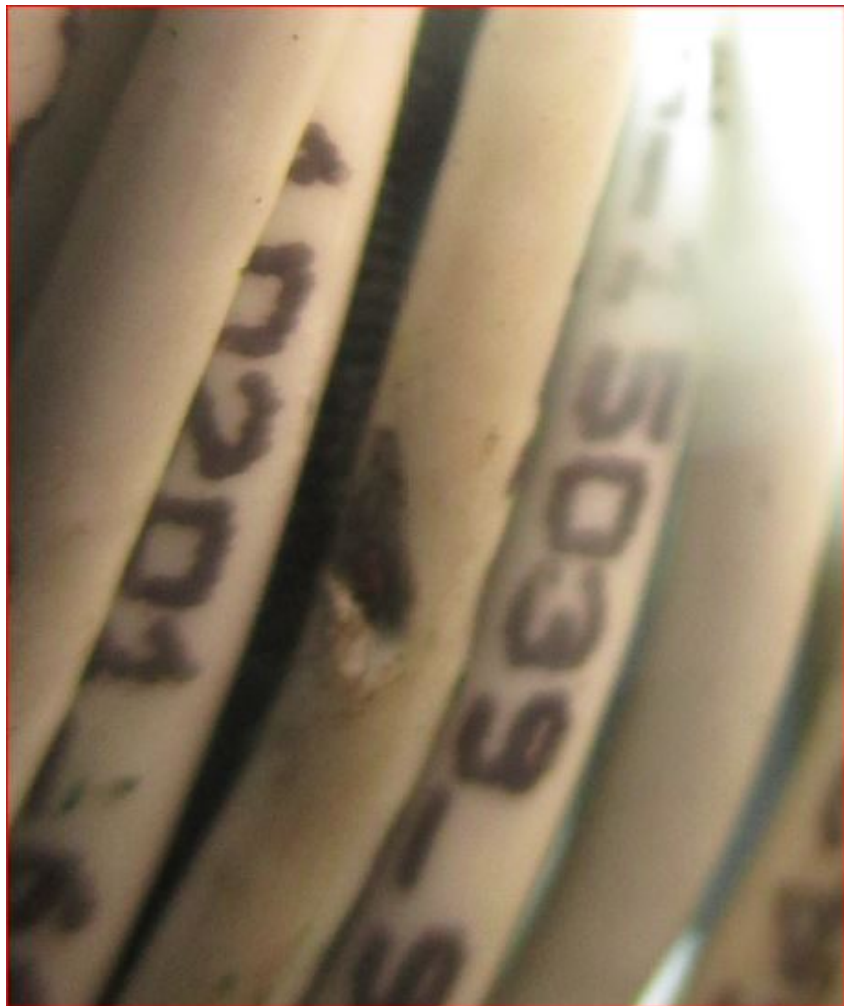
VCB circuit wire with rub fatigue
