Technical Service Bulletin:
TSB190042

Released Date: 24-Jun-2019

New Vented Coolant Drain Line Kit to Reduce Variable Geometry Turbocharger Actuator Overheating: FC2636 and FC1894

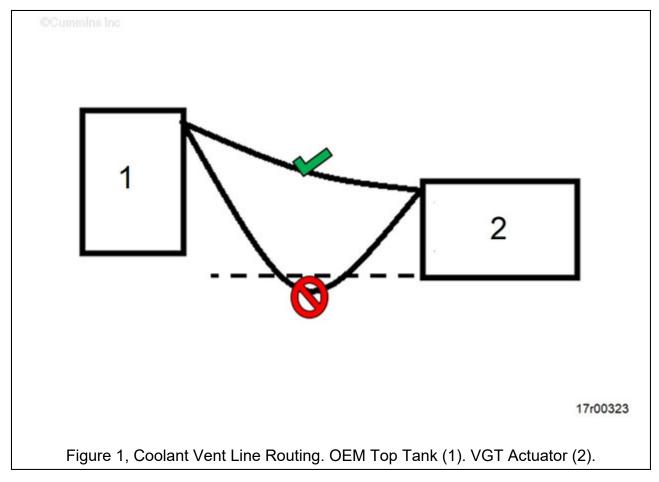
- New turbocharger actuator vented coolant drain line kits are available with a horizontal or vertical outlet.
- Turbocharger actuator vented coolant drain line orientation must be determined in order to determine correct service kit to be ordered. See Figures 1, 2, 3, and 4 for existing product and service kit layouts.
- See Figure 5 for new production routing.
- See Table 1 for kit part numbers.
- For new turbocharger actuator coolant drain line kit installation, see corresponding Service Manual. Reference Procedure 008-017 in Section 08.
- Dips or sags of the coolant vent line below the bottom surface of the actuator should be avoided. If the coolant vent line to the OEM top tank, dips or sags below the bottom surface of the turbocharger actuator, the coolant vent line **must** be shortened and raised to be above the top surface of the turbocharger actuator. See Figure 1 below.

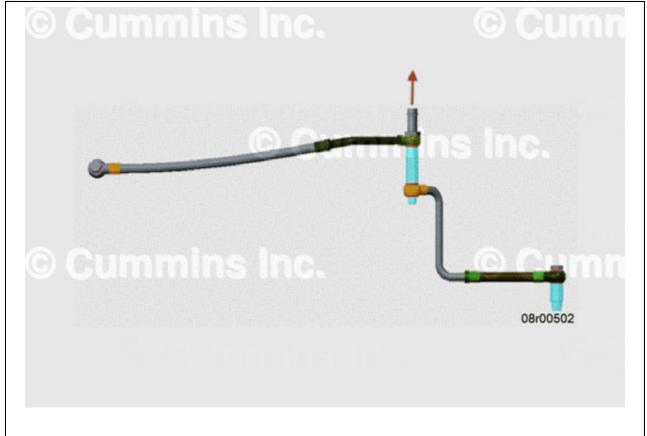
Figure 2, Existing Production Turbocharger Actuator Coolant Lines, Part Number 4352363.

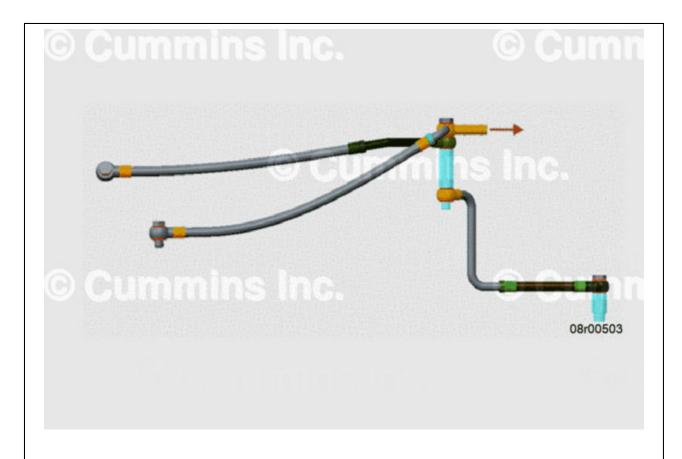
Figure 3, New Turbocharger Actuator Coolant Lines Kit with Horizontal Outlet, Part Number 5473157.

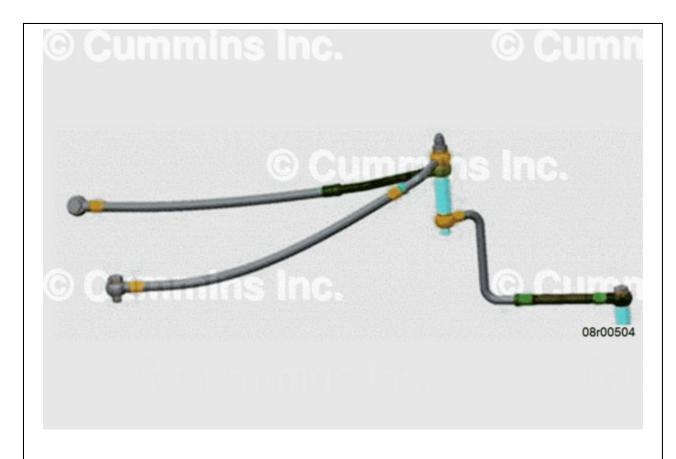
Figure 4, New Turbocharger Actuator Coolant Lines Kit with Vertical Outlet, Part Number 5473158.

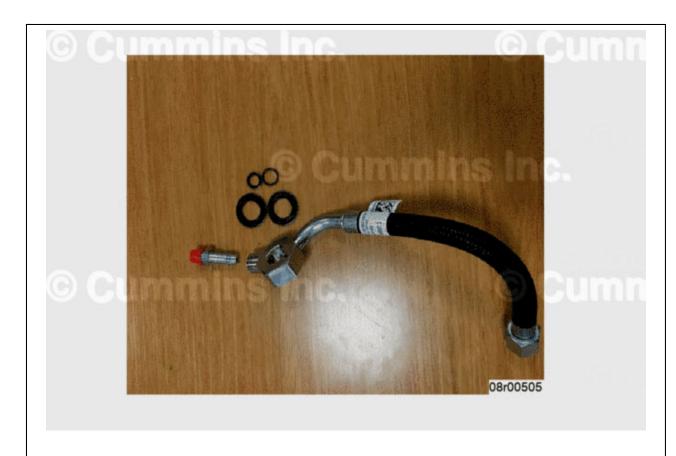
Figure 4, New Self-Assembled Turbocharger Actuator Coolant Lines Kit, Part Number 5473159.

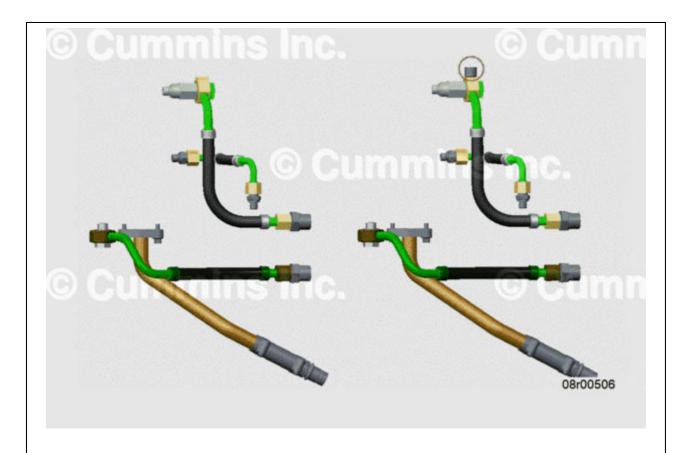
Figure 6, Existing Production Turbocharger Actuator Coolant Drain Tube With Vent Accommodation (Left), Part Number 5302803. New Production Turbocharger Actuator Coolant Drain Tube with Vent Accommodation (Right), Part Number 5446929.
