ITB19-014 June 13, 2019

2013 JX35 AND 2014-2020 QX60; REMOVAL OF HEADLIGHT ASSEMBLY LOCATING BRACKET

APPLIED VEHICLES: 2013 JX35 (L50)

2014-2020 QX60 (L50)

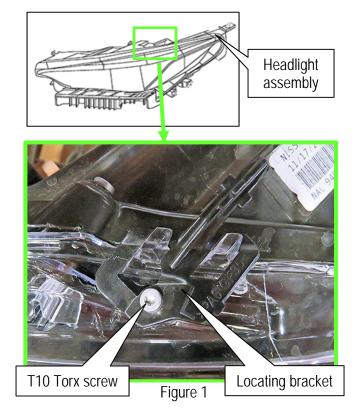
If replacement of a Front Combination Headlamp assembly (headlight assembly) is necessary, for the applied vehicles, the locating bracket (if present) on the new replacement headlight assembly must first be removed before installation.

Inspect the new replacement headlight assembly and confirm if a locating bracket is attached, with a Torx

screw, on top in the center (see Figure 1).

- 1. Using a T10 Torx screwdriver, remove the locating bracket attached to the topcenter of the replacement headlight assembly (see Figure 1).
- 2. Discard the locating bracket and Torx screw.
- 3. Continue the installation of the replacement headlight assembly.
