Technical Journal

Drive shaft bellows, noise

REF NO: TJ 32760.3.1	ISSUING DEPARTMENT: Technical Service	CAR MARKET: United States and Canada	
PARTNER: 3 US 7510 Volvo Car USA		ISSUE DATE: 2019-06-24	STATUS DATE: 2019-06-26
FUNC GROUP: 4620	FUNC DESC: Front axle casing	Page 1 of 5

TJ Instruction VCC-512748-1

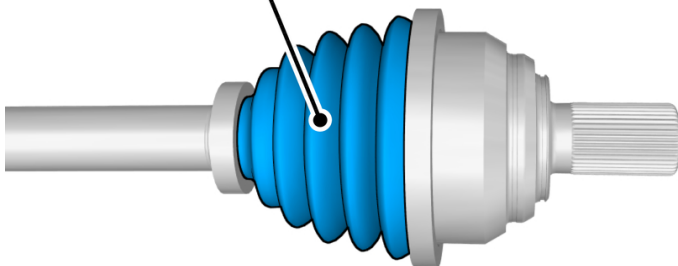
During driving a noise may occur from the front drive shafts. The noise is most obvious during slow driving and turning (e.g., parking maneuvers).

The noise comes from the rubber material which has a certain friction that may create a noise in cold conditions. This noise will go away after some driving.

Wipe off
