## SERVICE BULLETIN

**APPLICABILITY:** 2017-18MY Impreza  
 2018MY Crosstrek  
 2018MY Legacy and Outback  
 2018MY BRZ\*

**NUMBER:** 15-211-17R

**SUBJECT:** Reprogramming File Availability for Additional Optimization of Harman Gen 3 Audio and Navigation Head Units

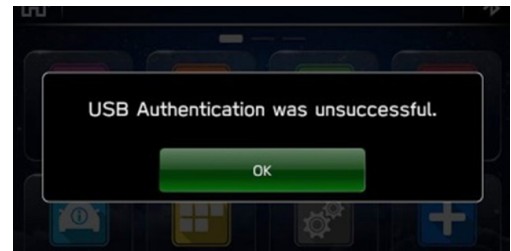
**CAUTION:** NEVER attempt to install this software on any 2019 MY vehicles as they are equipped with Gen 3.1 Audio/Navigation systems. This update is ONLY for models equipped with Gen 3.0 Audio/Navigation systems. Should an attempt be made to install any of these files into a Gen 3.1 head unit, the authentication error screen to the right will be displayed.

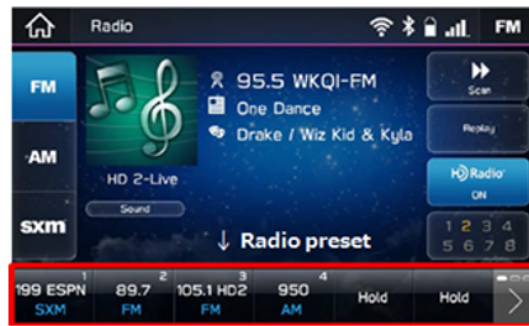
- Update to address some or all AM/FM station presets becoming lost and replaced by “Hold”

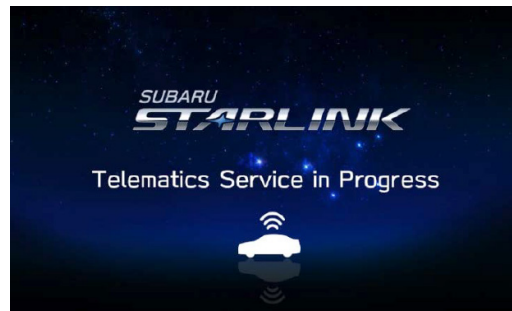
2- STARLINK “Telematics Service in Progress” screen freezes.

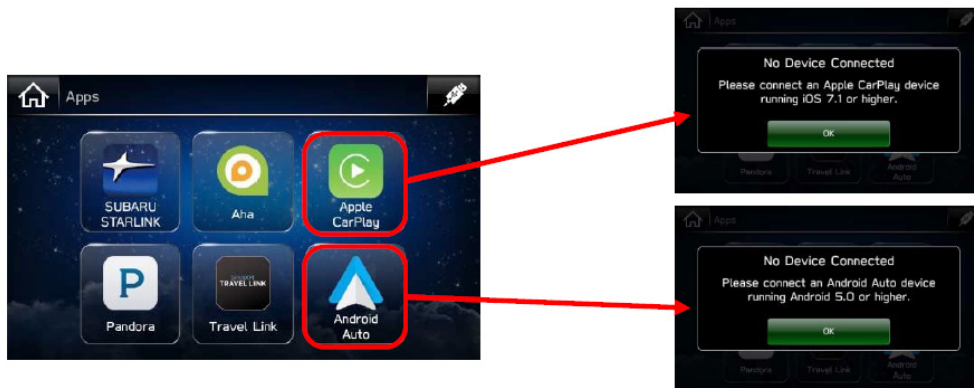
3- Apple Car Play / Android Auto function does not operate (“No Device Connected”).

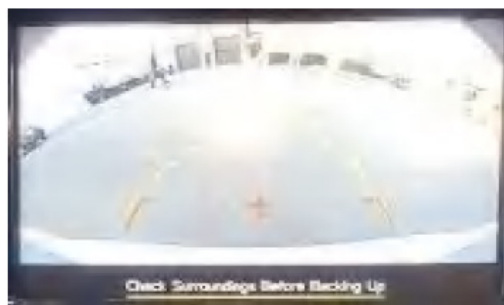
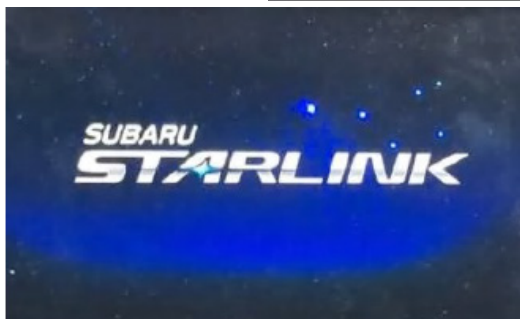
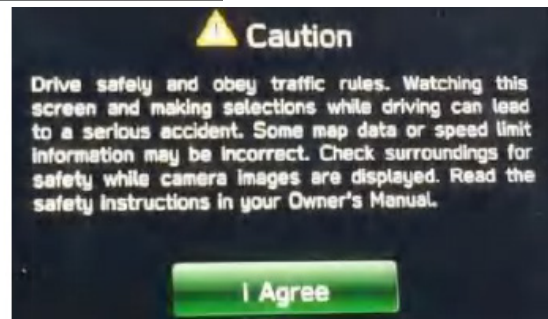
For reference, the previously released WTN-74R symptoms are also provided below. The main purpose of WTN-74R was to address display screen freeze-up during Back-Up Camera display (when the shifter is in “R”). In addition, the screen may also freeze when either the Subaru STARLINK or Disclaimer Caution / I Agree screen is displayed.

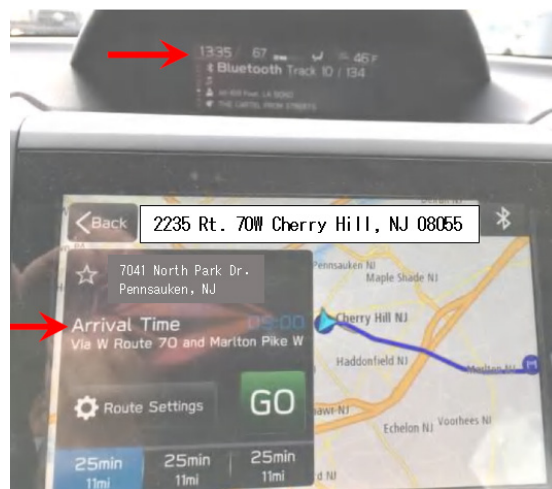
- 2) Time of day displayed in the MFD is incorrect and the arrival time displayed in Navigation unit is also incorrect.

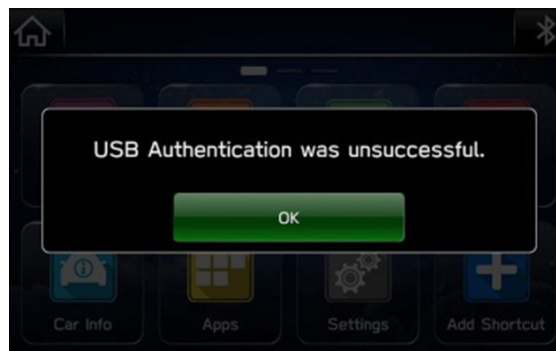
**NOTE:** If an attempt is made to install the wrong “grade” file into the wrong grade head unit (EXAMPLE: “Base” update file into a “Mid” or “High” head unit), the USB Authentication error screen below will be displayed:
