SI B01 21 18  
Warranties

## **UPDATE!** N63 ENGINE: OIL CONSUMPTION CLASS ACTION SETTLEMENT DIAGNOSIS AND REPAIR PROCEDURES (VERSION 10.0)

This Service Information bulletin supersedes SI B01 21 18 **dated March 2019**

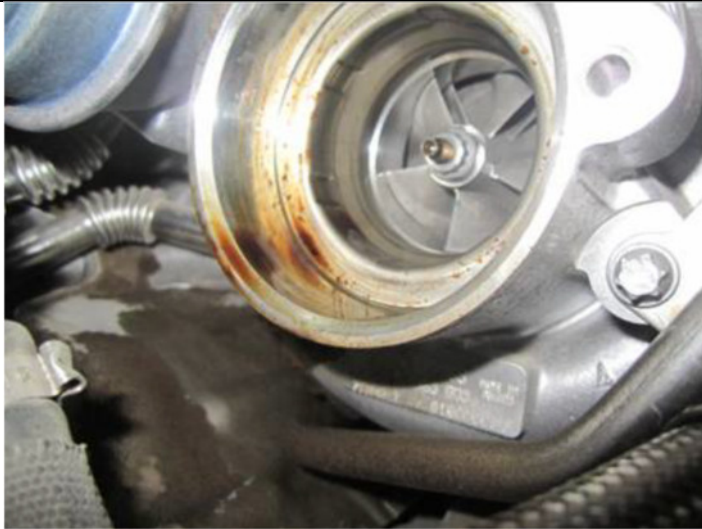
The turbocharger is OK.  
No engine oil can be seen around the turbocharger impeller.

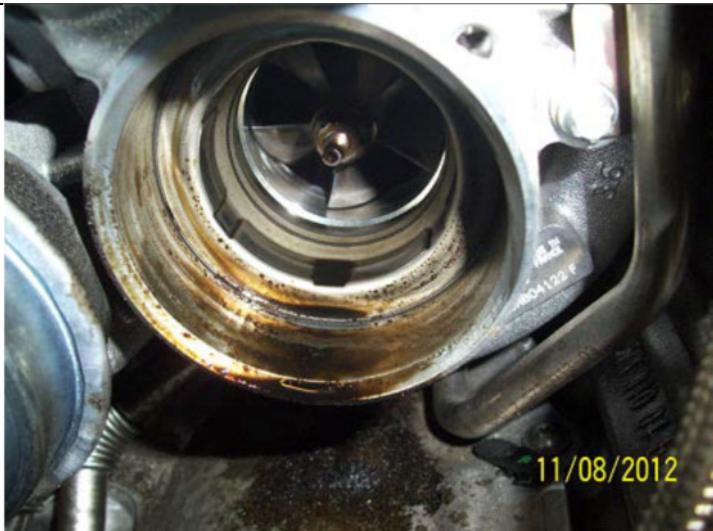
The turbocharger is OK.  
No engine oil can be seen around the turbocharger impeller.

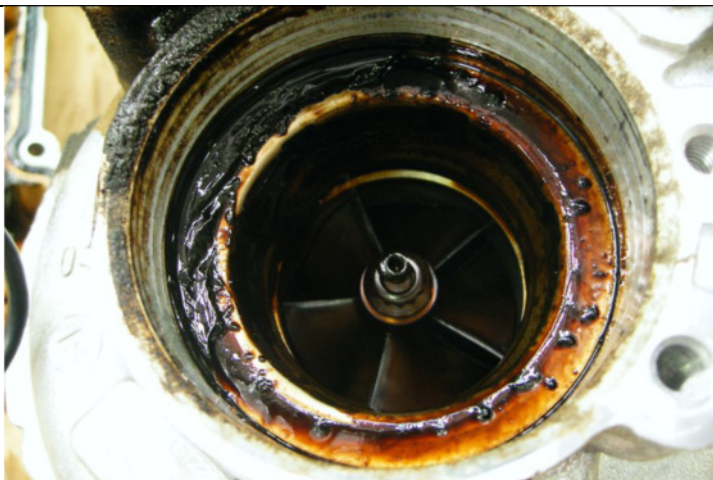
The turbocharger is not OK.  
The turbocharger impeller seals are leaking engine oil.

If the turbocharger inspection is "NOT OK", then replace the turbochargers in conjunction with the recommendations in step 10. Go to step 10.

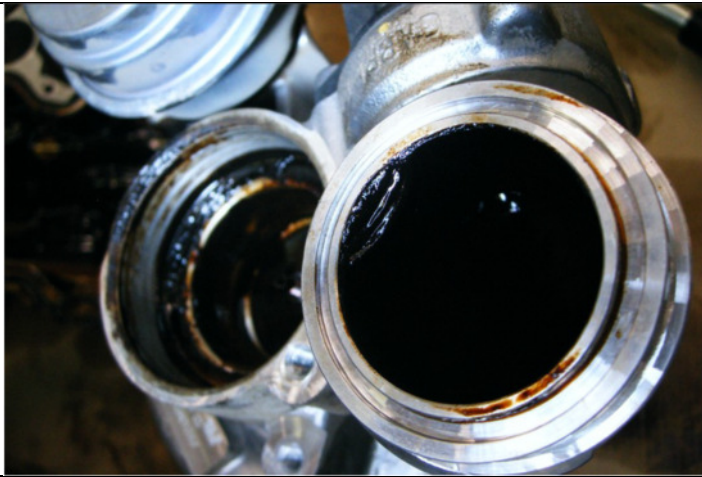
The turbocharger is not OK.

The turbocharger impeller seals are leaking engine oil.

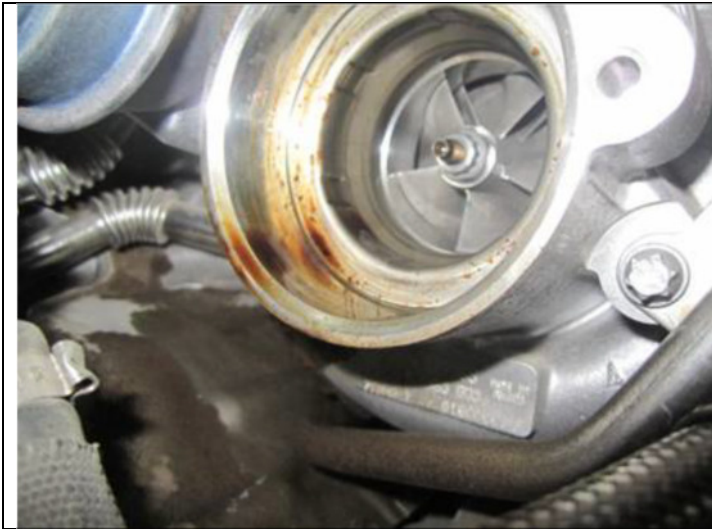
The turbocharger is OK.  
No engine oil can be seen around the turbocharger impeller.

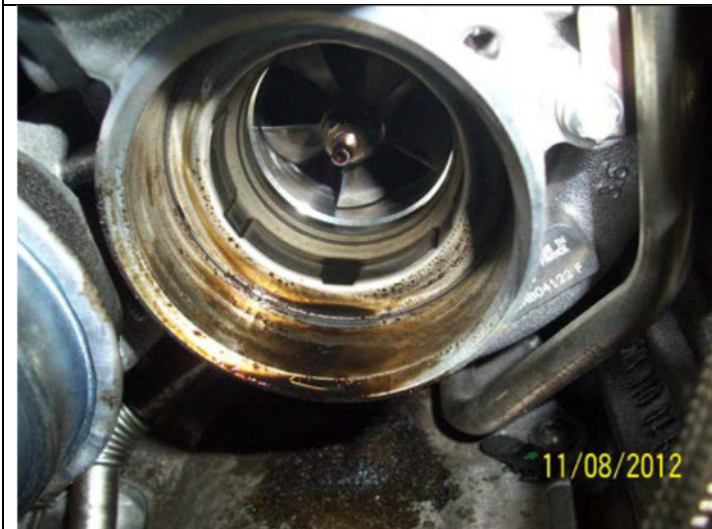
The turbocharger is OK.  
No engine oil can be seen around the turbocharger impeller.

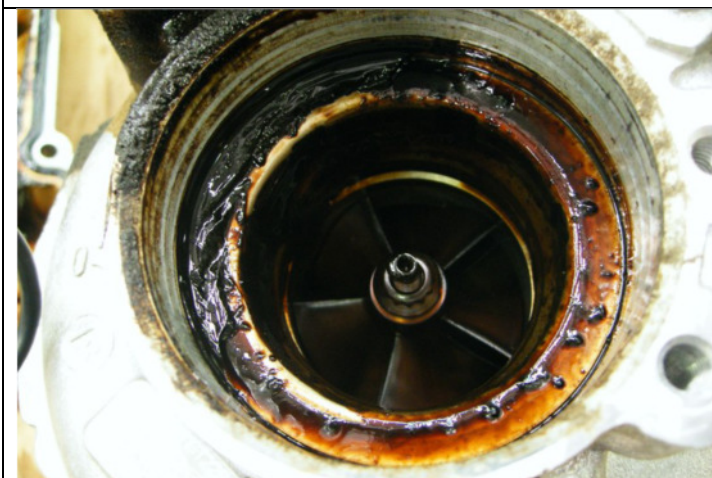
The turbocharger is not OK.  
The turbocharger impeller seals are leaking engine oil.

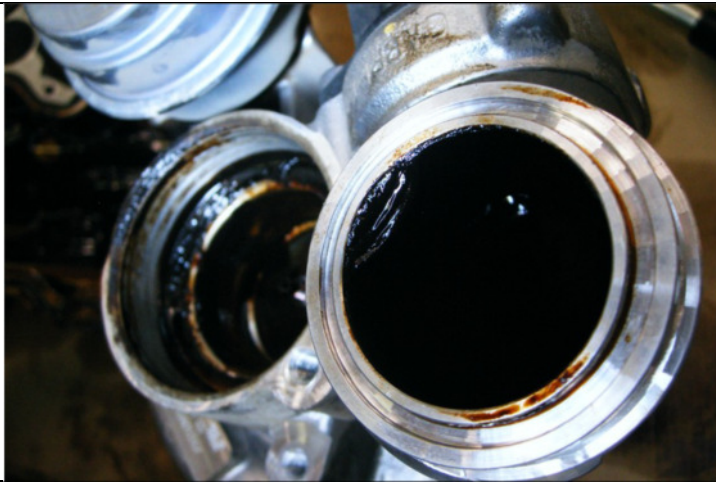
The turbocharger is not OK.

The turbocharger impeller seals are leaking engine oil.

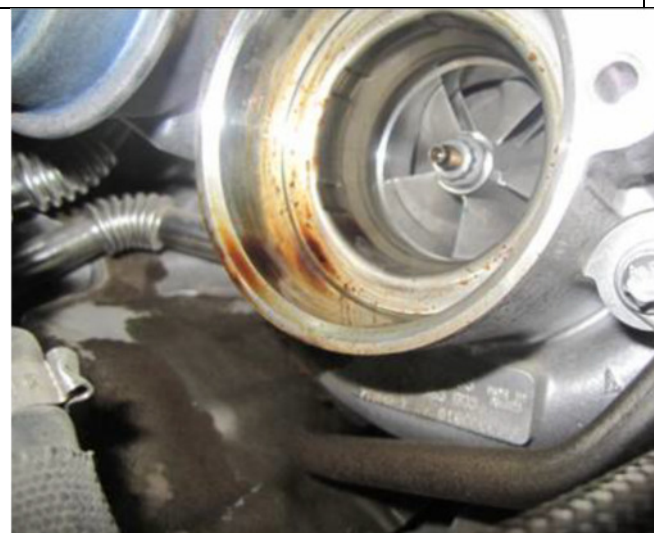
The turbocharger is OK.  
No engine oil can be seen around the turbocharger impeller.

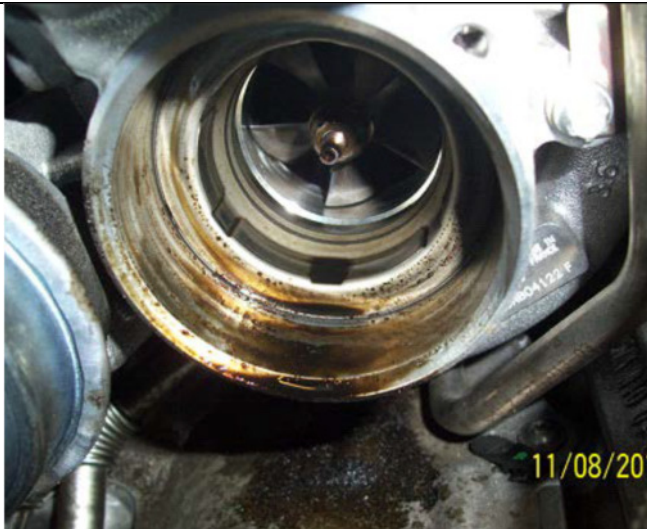
The turbocharger is OK.  
No engine oil can be seen around the turbocharger impeller.

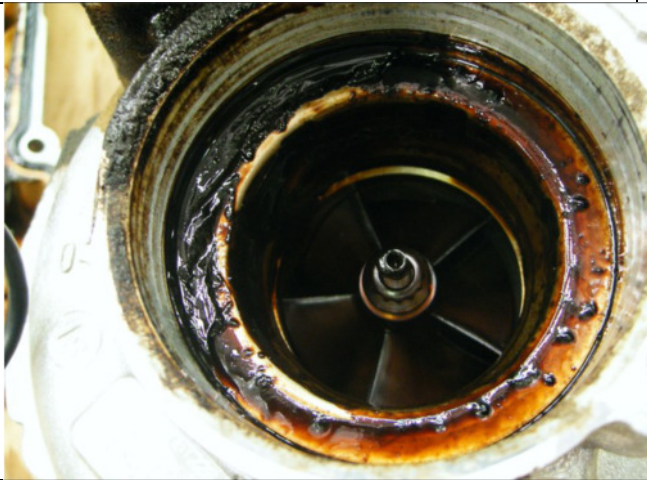
The turbocharger is not OK.  
The turbocharger impeller seals are leaking engine oil.

If the turbocharger inspection is "NOT OK", then replace the turbochargers in conjunction with the recommendations in step 11. Go to step 11.

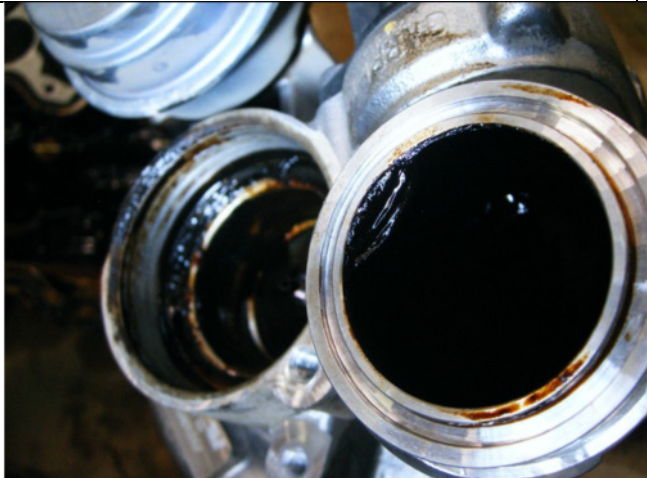
The turbocharger is not OK.  
The turbocharger impeller seals are leaking engine oil.

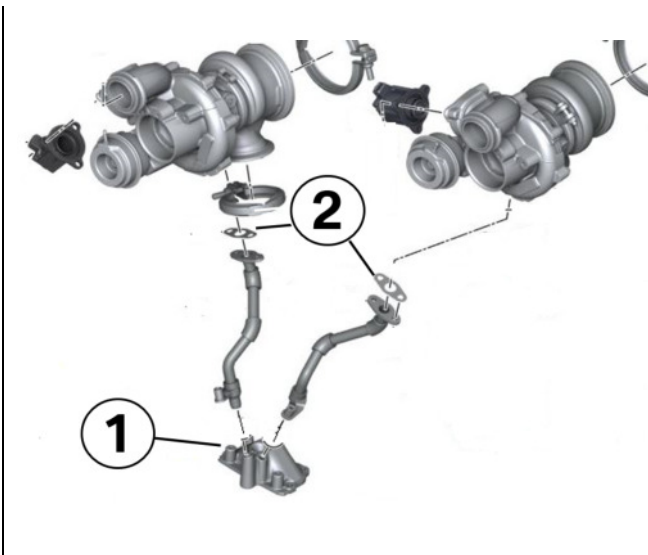
If engine oil is found under the turbos using a borescope then the oil return line cover (1) or the oil return line gaskets (2) are leaking engine oil.

(1) The oil return cover comes with all 3 O-rings. Use P/N 11 42 7 935 572.

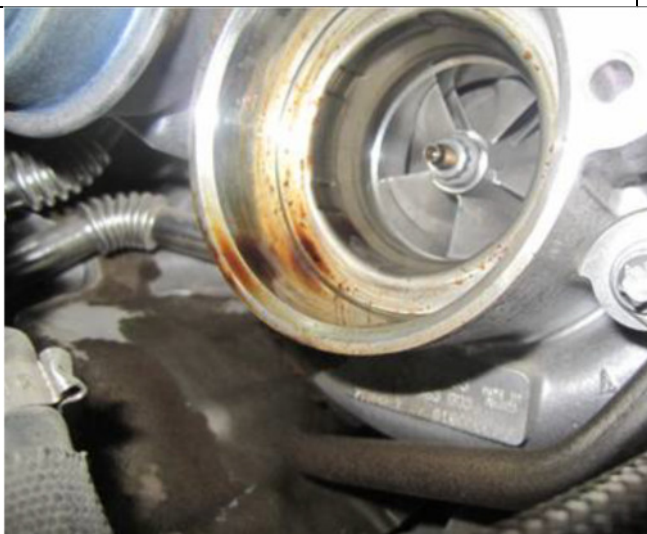
The turbocharger is OK.

No engine oil can be seen around the turbocharger impeller.

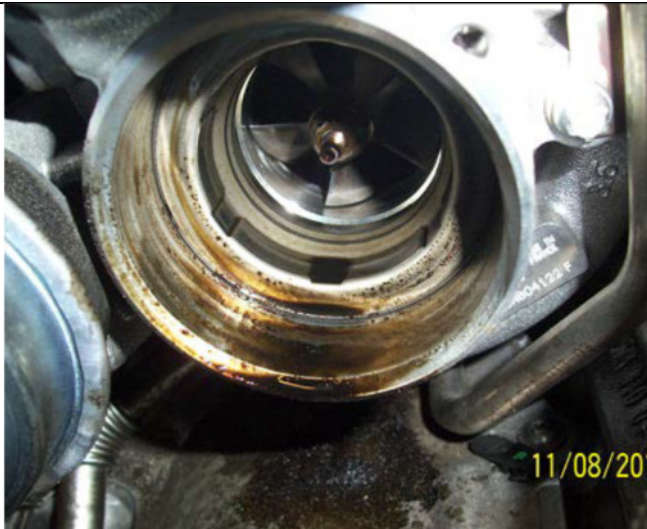
The turbocharger is OK.  
No engine oil can be seen around the turbocharger impeller.

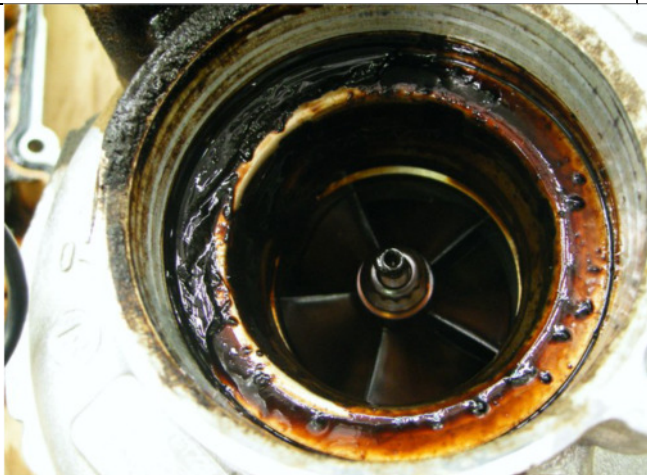
The turbocharger is not OK.  
The turbocharger impeller seals are leaking engine oil.

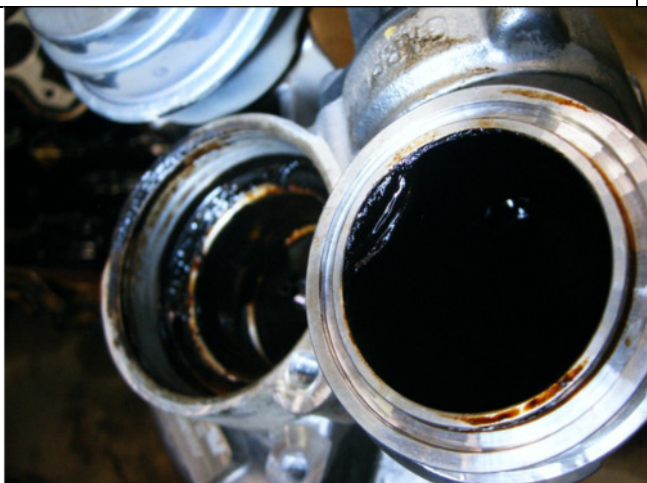
The turbocharger is not OK.  
The turbocharger impeller seals are leaking engine oil.
