# Technical Service Bulletin

## 91 MIB2 High: rearview camera/overhead view camera does not turn on

91 19 71 2055026/3 July 11, 2019. Supersedes Technical Service Bulletin Group 91 number 19-67 dated June 19, 2019 for reasons listed below.

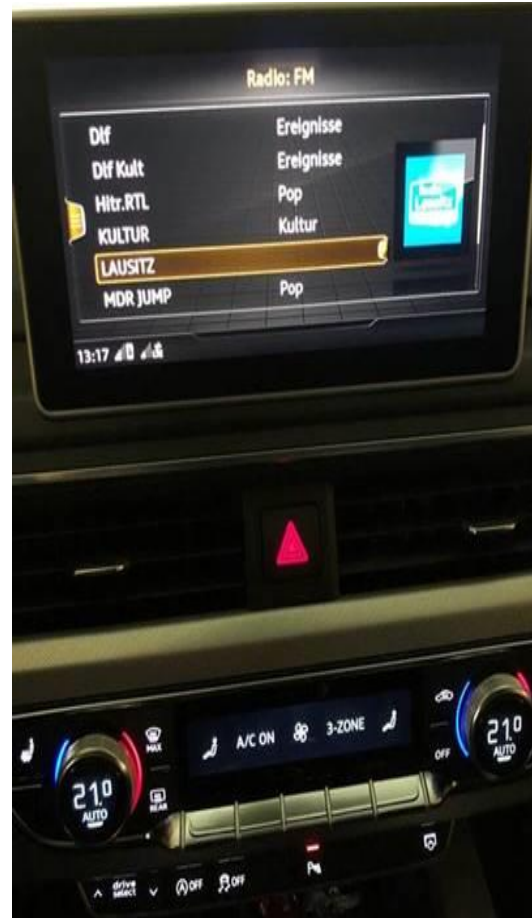
- The rearview/overhead view camera and the optical parking aid are sporadically not switched on when moving into reverse. The previously adjusted menu (radio, navigation, etc.) stays the same (Figure 1).
- The parking aid button in the center console lights up and an acoustic obstacle warning is given.

**Figure 1.** Previously adjusted menu stays the same (vehicles with camera software < 0318).

The MIB2 High software needs to be updated.

Update the MIB2 High infotainment system using either Method 1 or Method 2 according to TSB 2047576: *91 MIB2 High Software Update Instructions (PR Code 7UG)* and use SVM code indicated below:

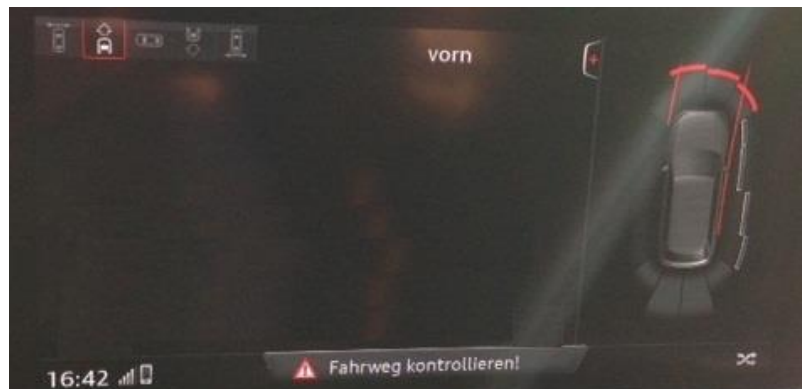
- The picture of the top view camera is black and no guide lines are shown (Figure 2).

**Figure 2.** Camera picture without guidelines (vehicles with camera software 0318).
