July 11, 2019

Version 3

Warranty Extension: Steering Feels Heavy, EPS Indicator Blinks with No DTCs or Comes On Steady with DTC 32-09, 32-08, or 61-04

Supersedes 19-021, dated May 31, 2019, to revise the information highlighted in **yellow**.

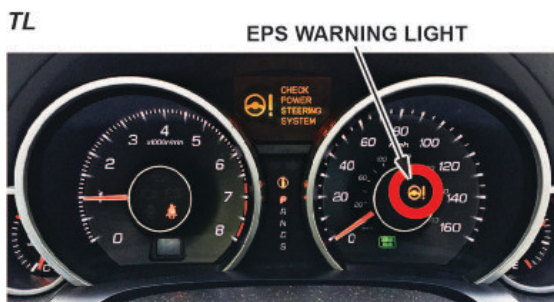
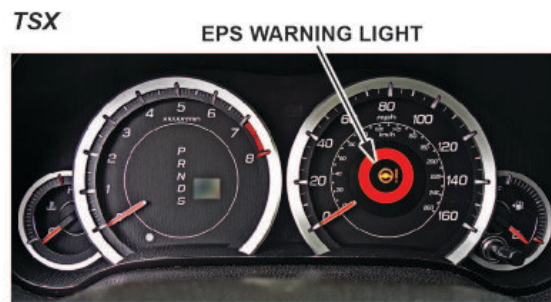
1. Connect the i-HDS, and check for the following DTCs:
 - 32-09 (motor current correlation)
 - 32-08 (EPS control unit internal circuit [current sensor])
 - 61-04 (motor harness malfunction)
 - If any of the listed DTCs are set, write down the DTC on the RO, and go to the applicable vehicle's REPAIR PROCEDURE.
 - If none of the listed DTCs are set, go to step 2.
2. Check if there are any other DTCs set.
 - If there are other EPS DTCs set, this bulletin does not apply. Continue with normal system troubleshooting.
 - If there are no other EPS DTCs set, go to step 3.
3. Check if the EPS indicator is blinking.

- If the EPS indicator is blinking, go to the applicable vehicle's REPAIR PROCEDURE.
- If the EPS indicator is not blinking, this bulletin does not apply. Continue with normal system troubleshooting.

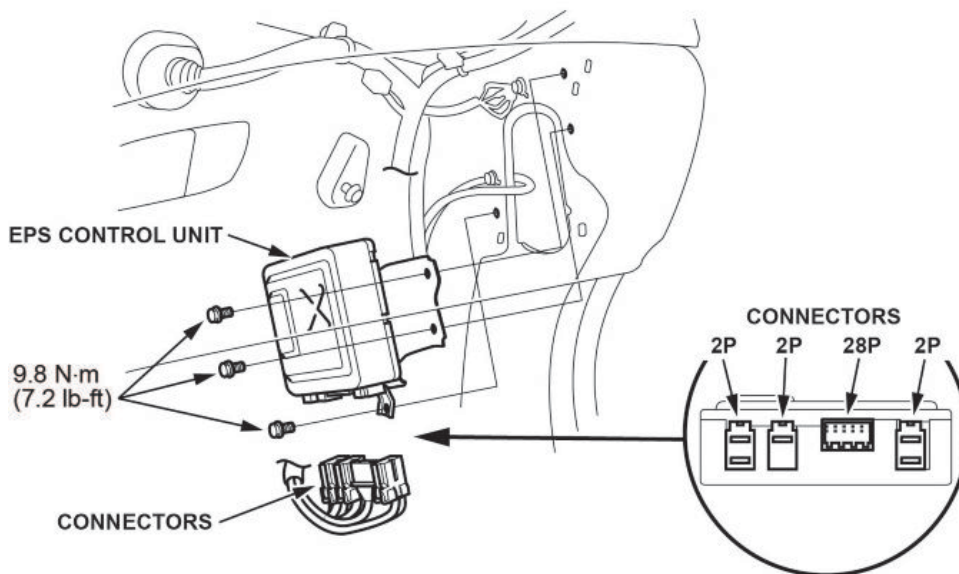
10. Disconnect the EPS control unit connectors.

11. Remove the three bolts from the EPS control unit, then remove the unit.

12. Install the new EPS control unit, torque the three bolts to **9.8 N·m (7.2 lb-ft)**, then connect the connectors.

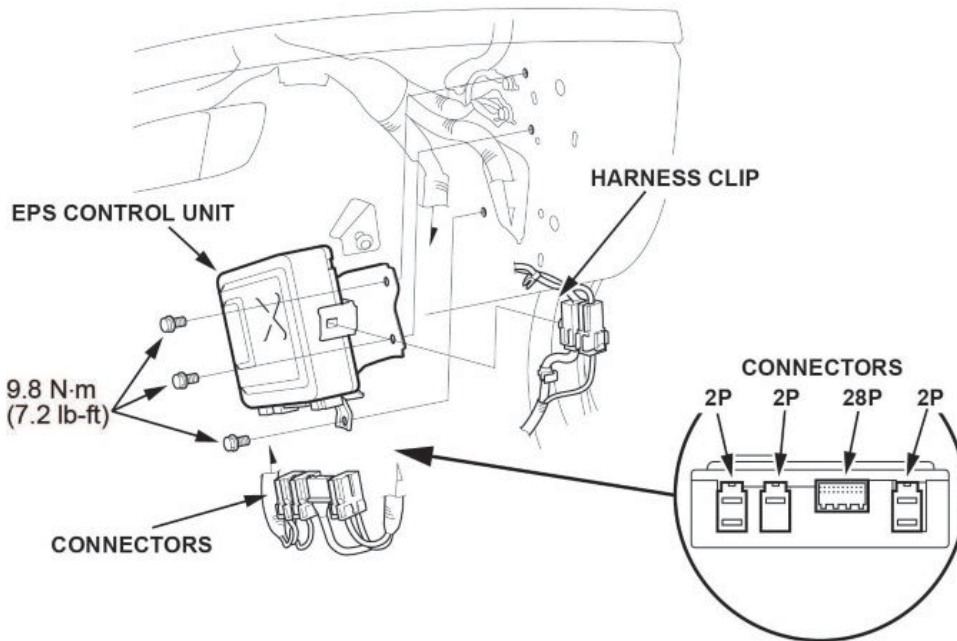
10. Loosen the mounting bolt from the lower side of the passenger's under-dash fuse/relay box.
11. Remove the mounting bolt from the upper side of passenger's under-dash fuse/relay box, and remove the passenger's under-dash fuse/relay box.
12. Disconnect the EPS control unit connectors.

13. Remove the three bolts from the EPS control unit, then remove the unit.
14. Install the new EPS control unit, torque the three bolts to **9.8 N·m (7.2 lb-ft)**, then connect the connectors.
15. Install the passenger's under-dash fuse/relay box, and connect the connectors.
16. Connect the negative cable to the 12 volt battery.
17. Enter the audio and/or navigation system anti-theft code.
