July 16, 2019

Version 5

## A/C Does Not Blow Cold Air and Condenser Leaks at Receiver Dryer Cap

Supersedes 18-080, dated May 3, 2019, to revise the information highlighted in **yellow**

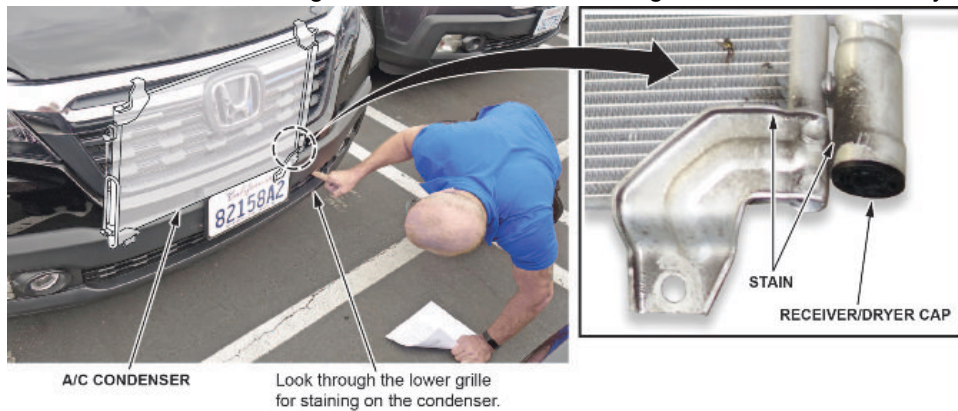
The A/C does not blow cold air, and the lower corner of the condenser around the receiver/dryer cap is stained.

There is poor O-ring compression against the receiver/dryer barrel wall.

Check if the A/C is blowing cold air and there is staining around the receiver dryer cap on the condenser.

- If the A/C is not blowing cold air and there is staining around the receiver dryer cap on the condenser, go to REPAIR PROCEDURE.
- If the A/C is not blowing cold air and there is no staining around the receiver dryer cap, continue with normal system troubleshooting.
