Service Bulletin

Bulletin No.: 00-06-01-012J

Subject: Use of Surface Conditioning Disks When Cleaning Gasket Sealing Surfaces and/or Reused Parts

Models: 2020 and Prior GM Passenger Cars and Trucks including Silverado 4500HD, 5500HD and 6500HD (Excluding Chevrolet Medium Duty Low Cab Forward Equipped with Diesel Engine).

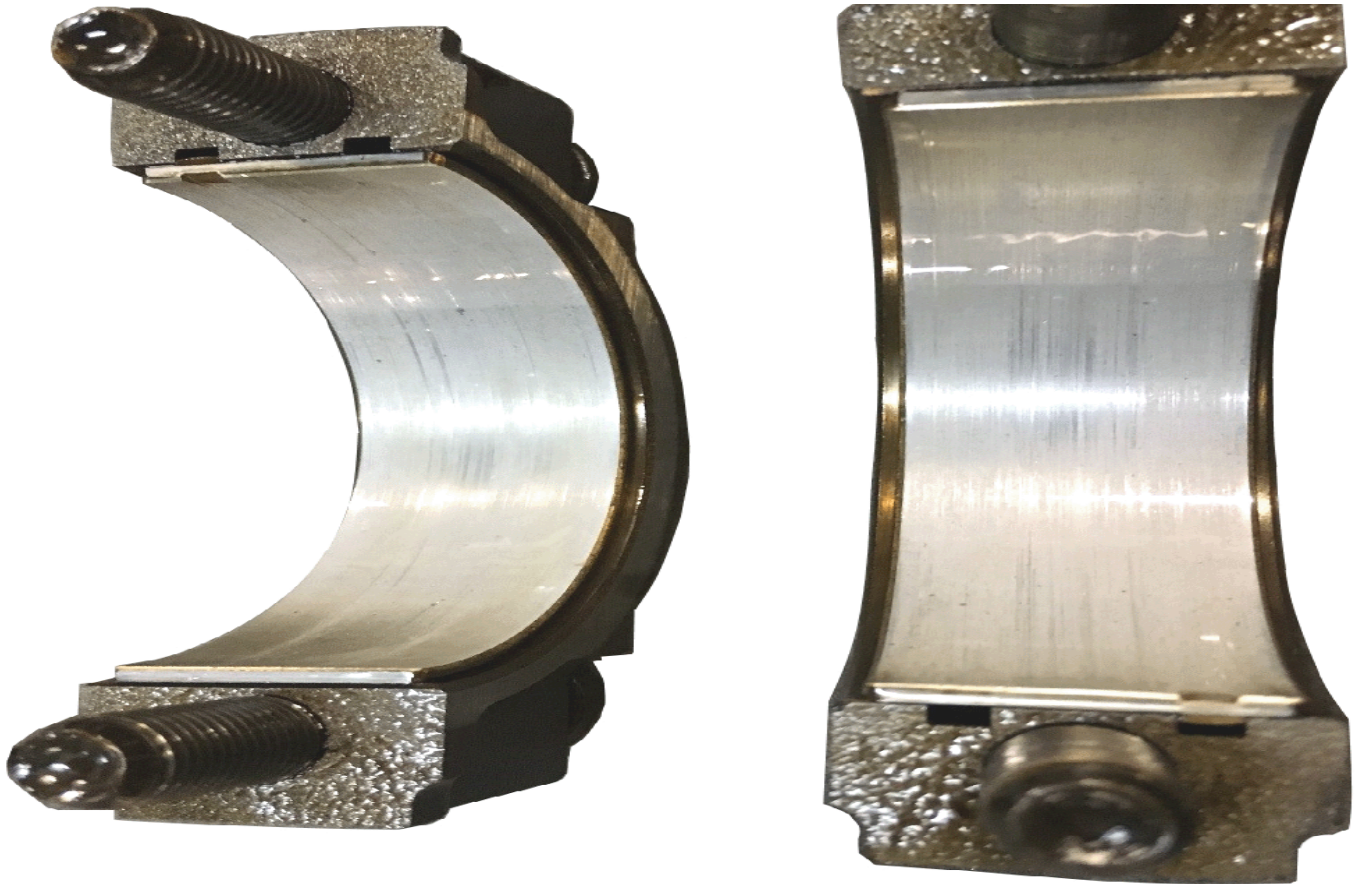
4788796

The presence of Aluminum Oxide in engine oil has been shown to cause premature engine bearing failure. In some cases, this failure occurs in as little as 2,200 km (1,367 mi) or less after the repair has been made.

The scratches on the bearings in the above picture were created when debris from an abrasive pad made its way into the bearing. This debris is a combination of the metal and particles from the abrasive pad that were removed when the engine was cleaned.

General Motors recommends the use of a razor blade or plastic gasket scraper to clean the gasket surface on components that are to be reused. When cleaning gasket surfaces, please note the following:

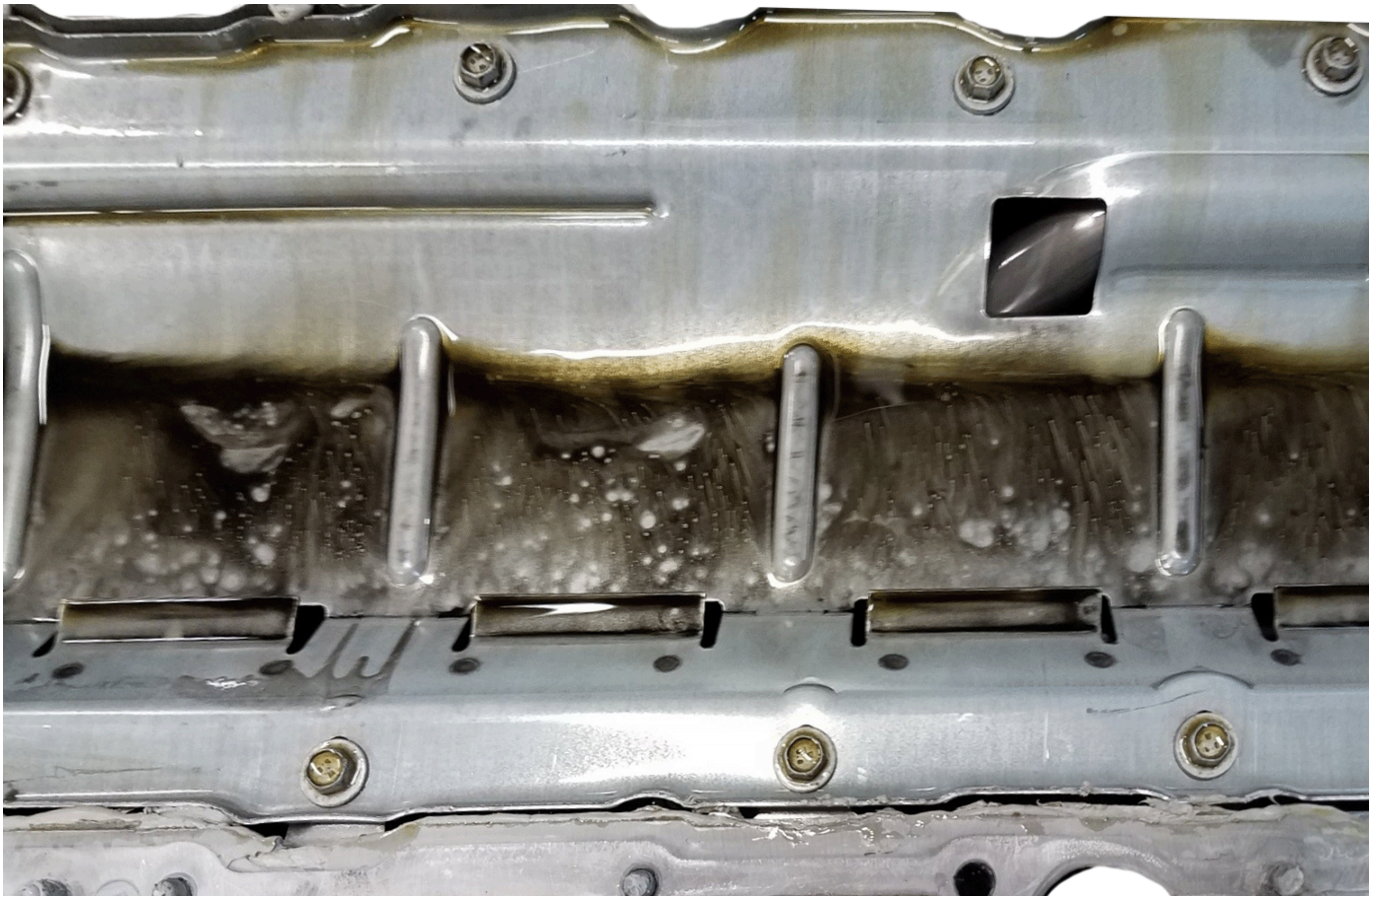
4789486

The crankshaft deflector in the picture above has debris that was left behind from the abrasive cleaning methods. Once the debris has gotten here, it can be distributed to any surface in the engine.

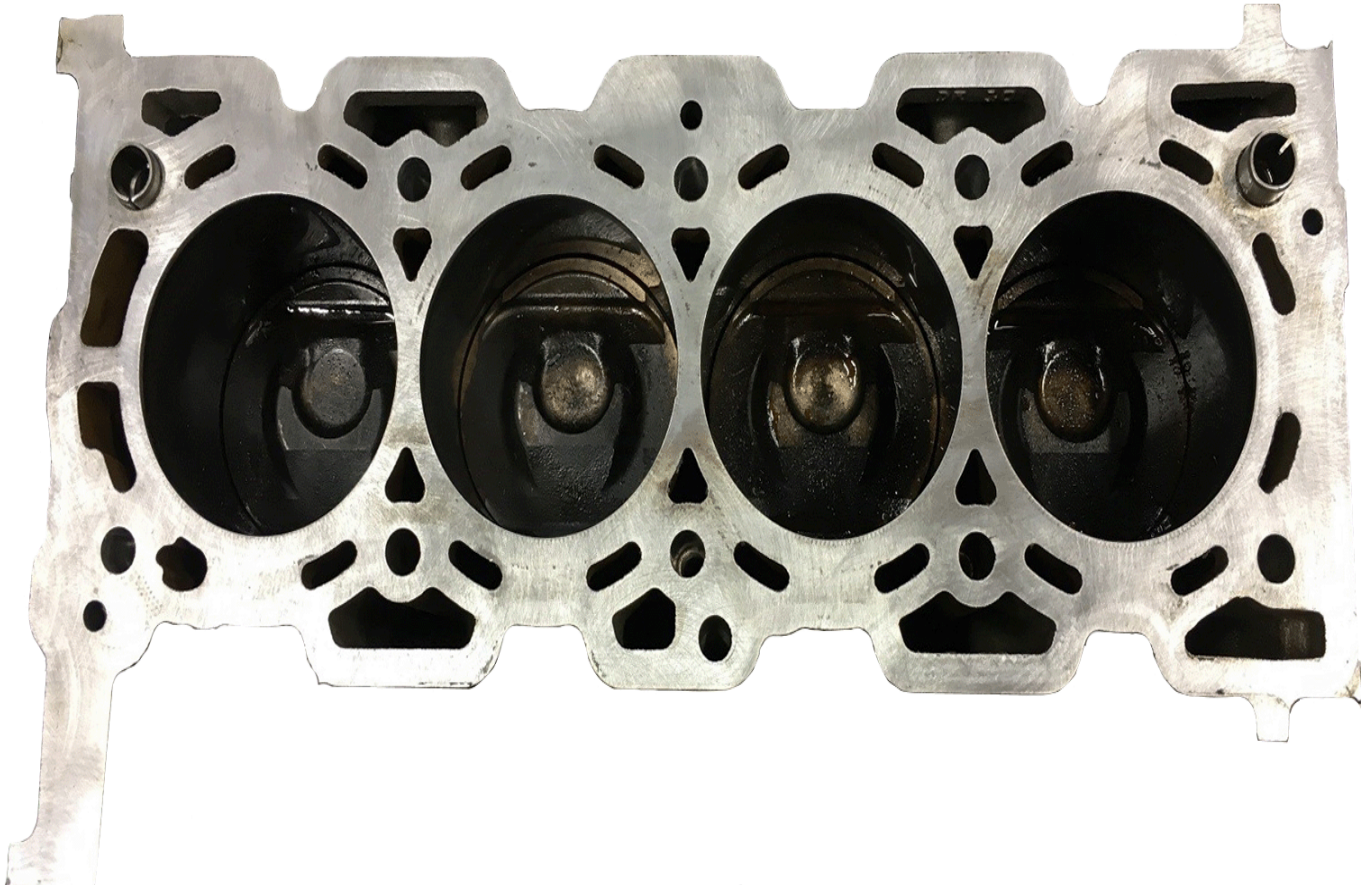
4788615

An overview of the deck face when it has been cleaned with an abrasive pad, left swirls on the surface and do not go in the same direction, which caused changes in the surface dimensions (flatness) of the block leaving it un-usable.

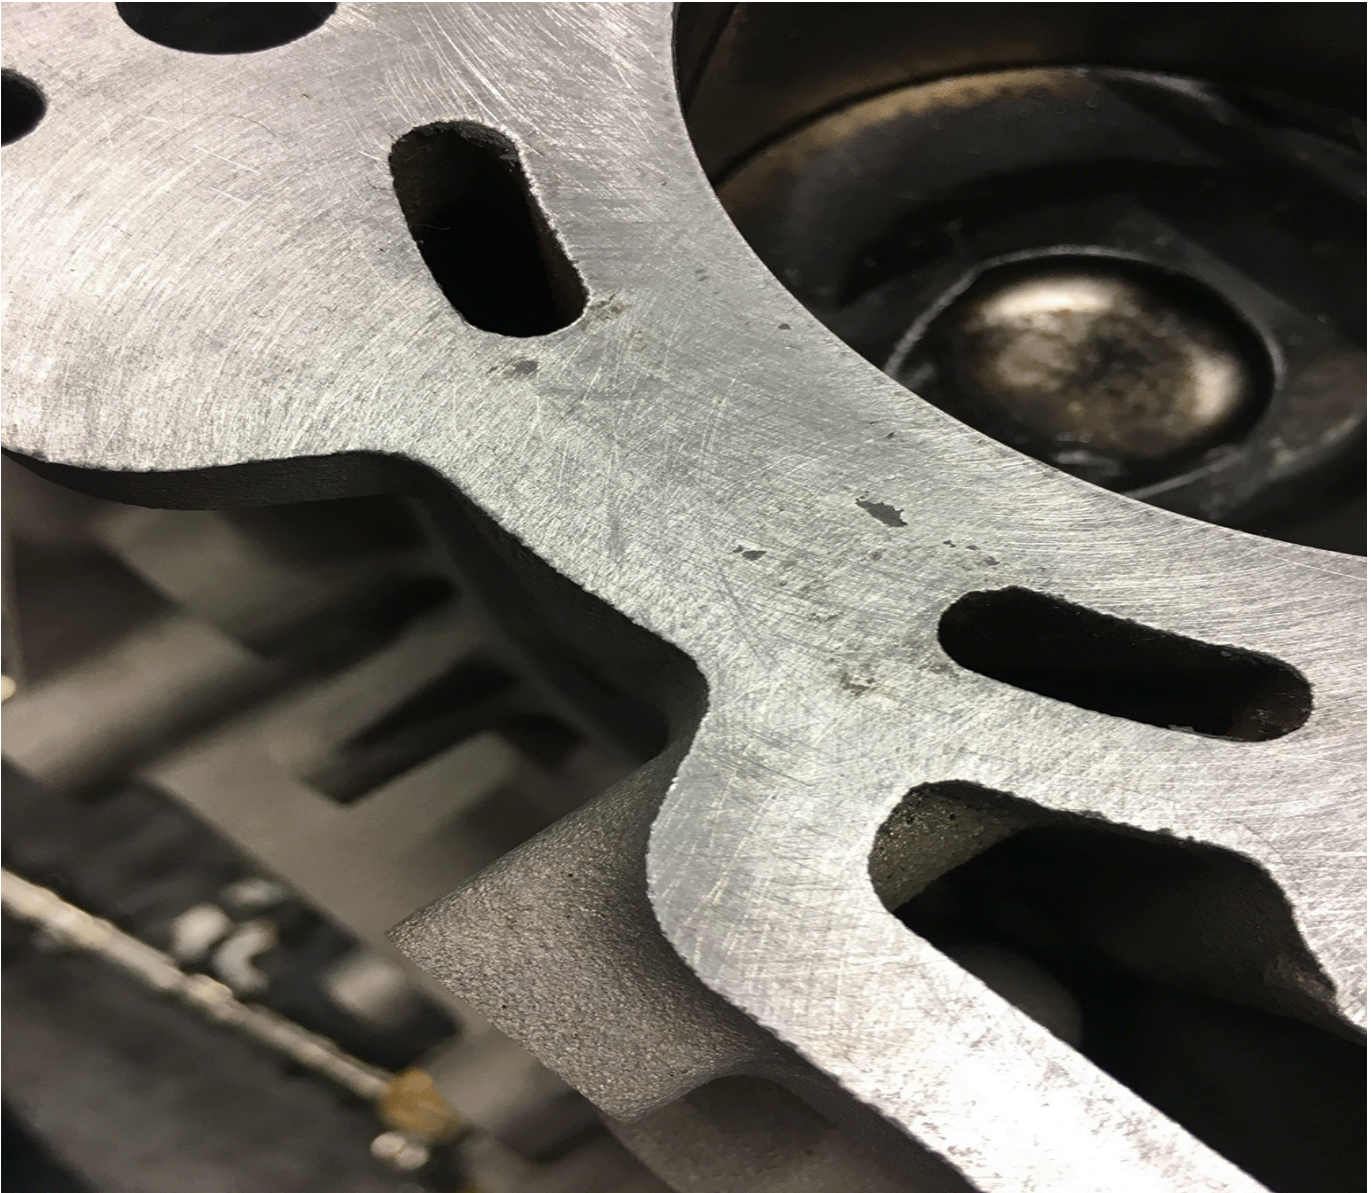
4789846

Scratches from the pad are deeper in some areas than others causing the gasket/seals not to properly seal against an uneven surface.

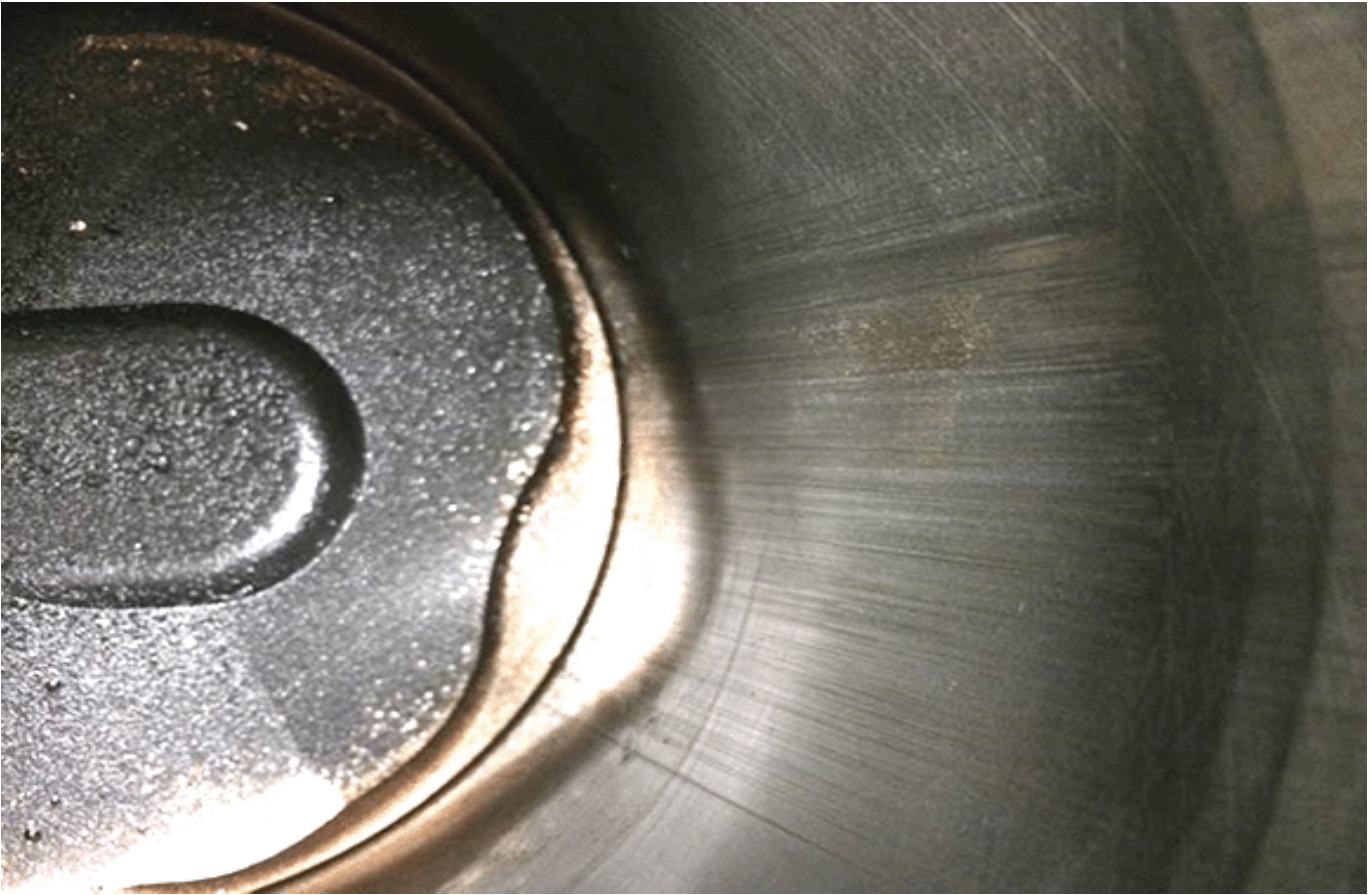
4788657

Note: Damage to the pistons and/or cylinder walls may result in an engine knocking, tapping and/or possible low compression.

The sides of this cylinder wall were scarred with scratches as a result of the debris created by the abrasive cleaning pads. This debris gets trapped between the piston head and the cylinder wall causing damage to the cylinder bore as the piston moves up and down.

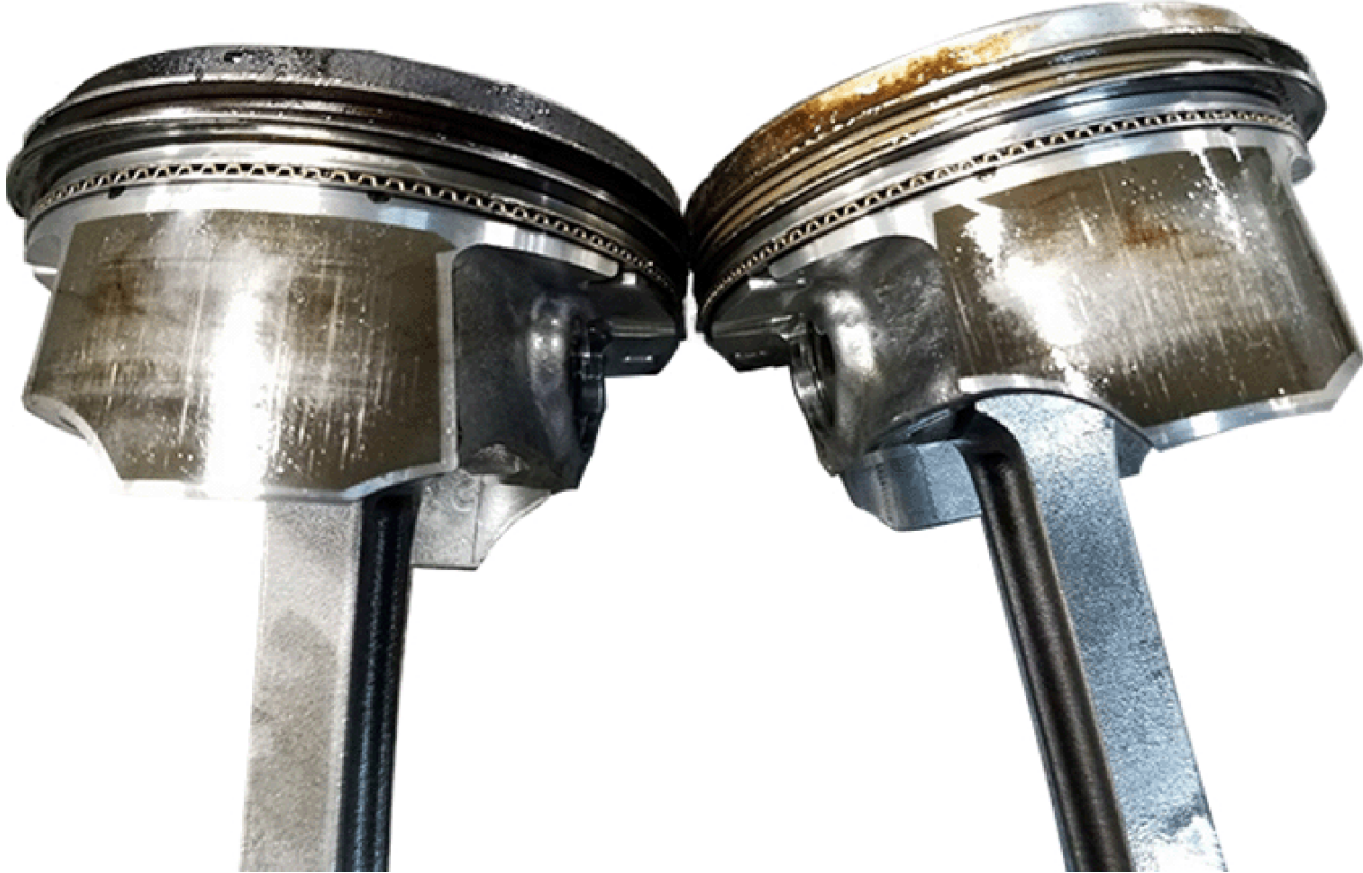
4800927

The piston skirt and piston ring damage caused by abrasive cleaning pads.

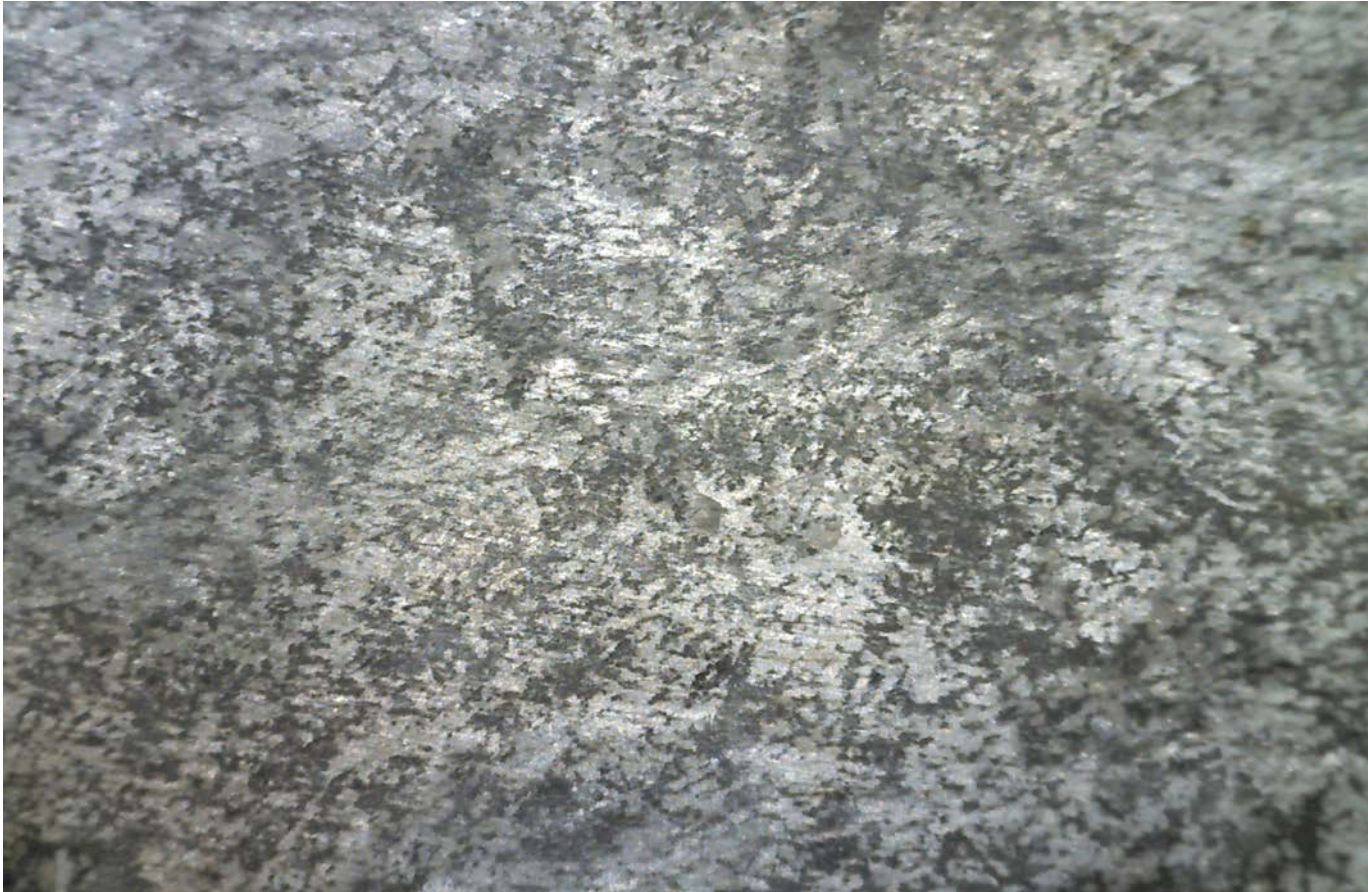
4791153

A close up of the sealing surface after cleaned with GM Low VOC Cleaner and plastic scraper.

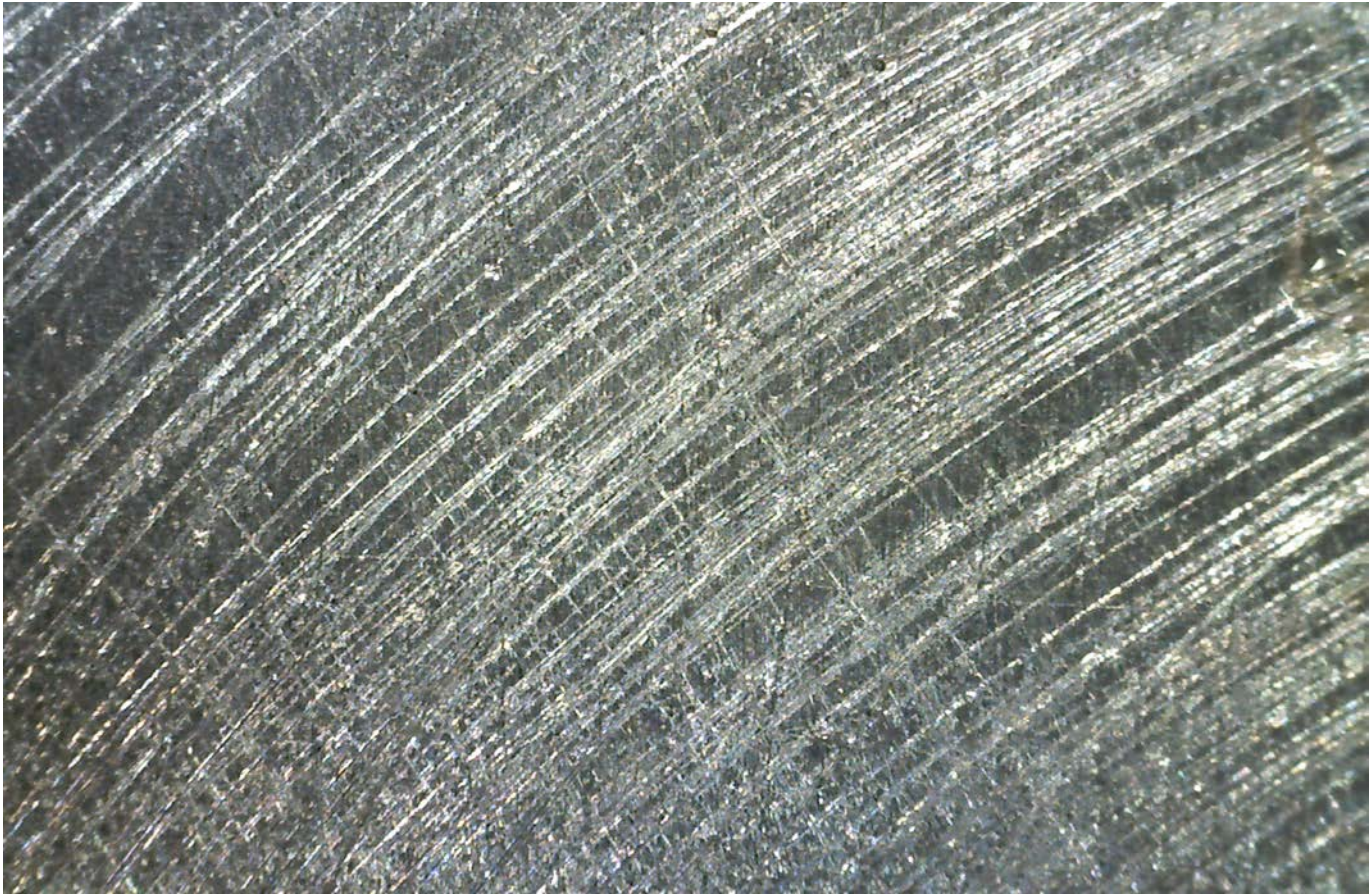
4791149

A close-up of the surface shows deep grooves caused by using an abrasive cleaning disc.

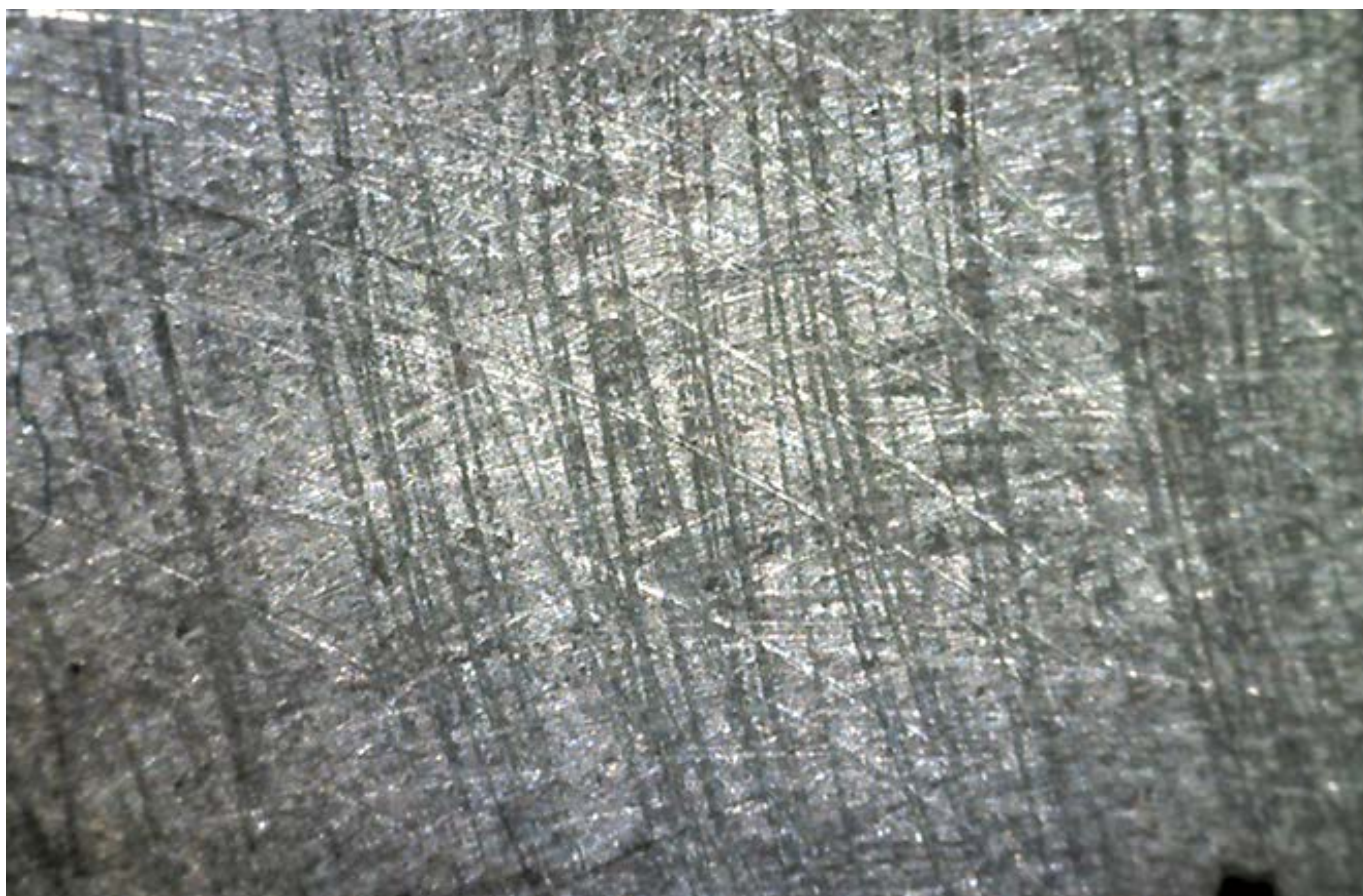
4791276

A close-up of the surface shows deep grooves caused by use of a wire wheel.
