# Technical Journal

**Damaged throttle body due to showroom device**

<b>REF NO:</b> TJ 34206.2.0	<b>ISSUING DEPARTMENT:</b> Technical Service	<b>CAR MARKET:</b> United States and Canada	
<b>PARTNER:</b> 3 US 7510 Volvo Car USA		<b>ISSUE DATE:</b> 2019-06-06	<b>STATUS DATE:</b> 2019-06-12
<b>FUNC GROUP:</b> 2510	<b>FUNC DESC:</b> Inlet and exhaust manifolds	Page 1 of 3

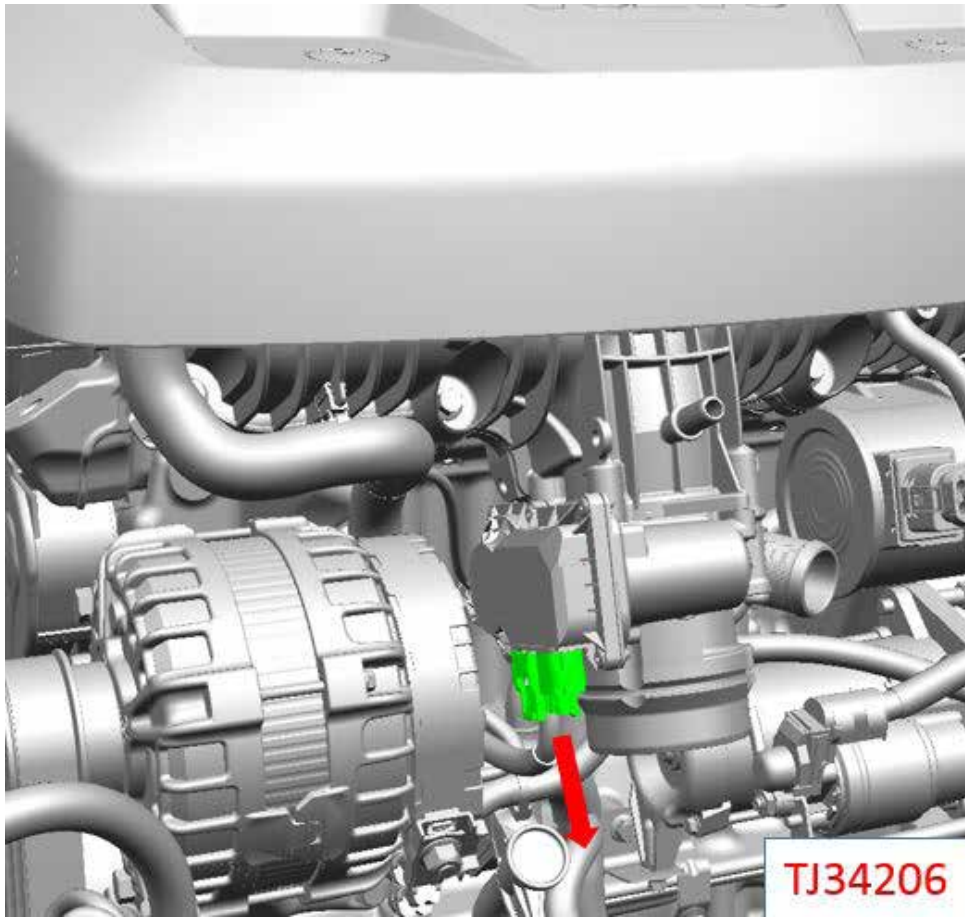
The throttle body may be damaged when using the showroom mode device with software 5.3 or earlier is used. This is due to the throttle body being constantly activated with this software.

\* If you use a BRIGO tool with software 5.3 or earlier and you cannot update the software to the latest release, remove the connector from the throttle housing (see picture 34206.jpg) to protect the throttle from constant activation.
