Technical Service Bulletin

Subject: CHECK ENGINE LIGHT ON WITH DTC P0300:00, P0301:00, P0302:00, P0303:00, AND/OR P0304:00	Bulletin No.: 01-012/19
	Last Issued: 07/02/2019

2012-2013 Mazda3 (with SKYACTIV)

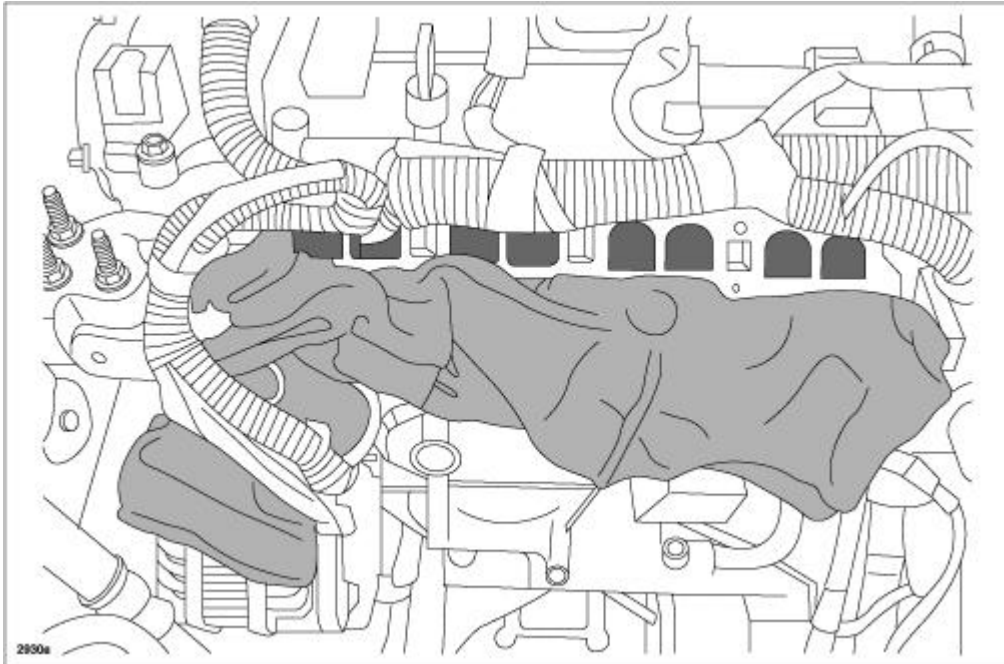
- b. Check for carbon deposit around the intake valves.

c. Spread shop towels under the intake ports to protect components from cleaner overflow.

CAUTION: Take care not to damage the alternator.
