Technical Service Bulletin

Subject: CUSHION TAPE AT FRONT END OF DASHBOARD COMING OFF	Bulletin No.: 09-026/19
	Last Issued: 07/12/2019

2014-2018 Mazda3 with VINS lower than JM1BN*****199539 (produced before Nov. 1, 2018)
2014-2017 Mazda6
2013-2016 CX-5

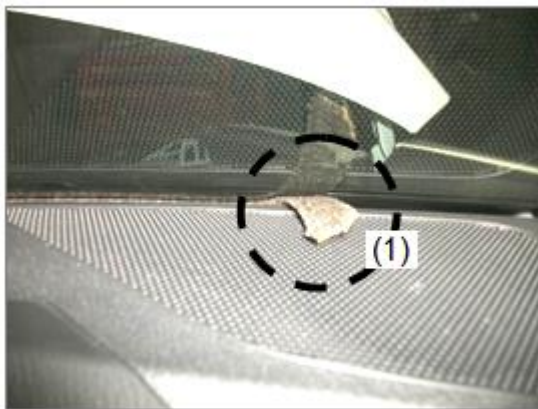
CX-5 (R.H.D.)

Some vehicles may exhibit the cushion tape (1) attached to the front end of dashboard coming off and showing at the base of the windshield.

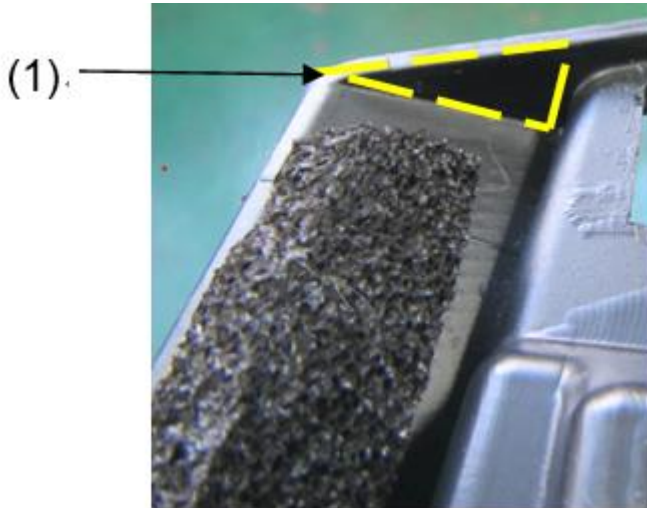
This is caused by the cushion tape peeling off from the end(s) due to interference with the windshield and vehicle vibration (CX-5/Mazda6) or from the gap between the dashboard and the cushion tape because there there is no rib (1) at the dashboard ends (Mazda3). To prevent the tape from peeling off, both ends of the cushion tape are now folded over to the back side of the dashboard (CX-5/Mazda6) or stapled (Mazda3).
