# Technical Service Bulletin

<b>Subject:</b>  <b>Fctry OR Factory MESSAGE DISPLAYED AFTER INSTRUMENT CLUSTER REPLACEMENT OR WHEN INSTALLING A ROOM FUSE IN A NEW VEHICLE</b>	<b>Bulletin No.:</b> 09-031/19
	<b>Last Issued:</b> 08/07/2019

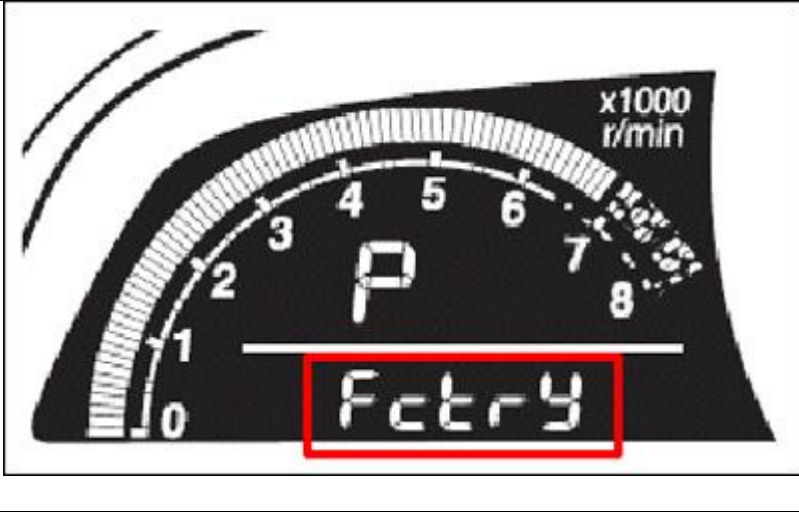
CX-3 shown:

After the installation of a new instrument cluster, the message "Fctry" or "Factory" is displayed instead of the odometer. This concern may also occur when a room fuse is installed in a new vehicle.

Some new instrument clusters are in the factory mode setting. Factory mode cancellation is required.
