40 Noises from the front end when steering

40 19 96 2053136/3 August 5, 2019. Supersedes Technical Service Bulletin Group 40 number 19-95 dated March 27, 2019 for reasons listed below.

Model(s)	Year	VIN Range	Vehicle-Specific Equipment	
А3	2015 - 2019	All	Not Applicable	
А3	2020	000001 - 001882	Not Applicable

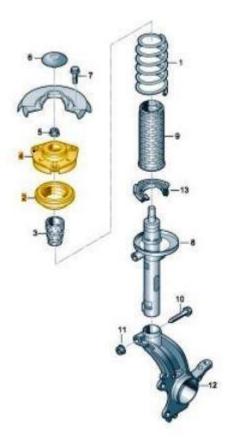
Noises from the left or right front end when steering.

The axial deep-groove ball bearing overlaps the suspension strut mounting. Over time the overlap can cause noises.

Figure 1. Suspension strut mounting and axial deep-groove ball bearing.

Tip: Axial deep-groove ball bearing and suspension strut mounting must always be replaced together. The two components must always be replaced on both sides (right and left).

1. Replace the axial deep-groove ball bearing (Figure 1, position 2) and the suspension strut mounting (Figure 1, position 4) according to the Elsa Repair Manual.

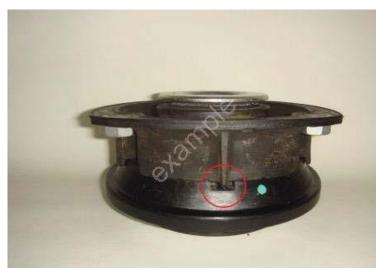
Figure 2. The correct installation position of suspension strut mounting and axial deep-groove ball bearing.

Ensure the correct installation position when assembling the suspension strut mounting and the axial deep-groove ball bearing. The bar of the axial deepgroove ball bearing must be central in the groove of suspension strut mounting (Figure 2).
