GLOBAL SAFETY FIELD INVESTIGATIONS
DCS5087
URGENT - DISTRIBUTE IMMEDIATELY

Subject: N192213530 - Service Update
Rear Fuel Tank Pump Transfer Failure

Models: 2019 Chevrolet Silverado MD

N192213530 Rear Fuel Tank Pump Transfer Failure

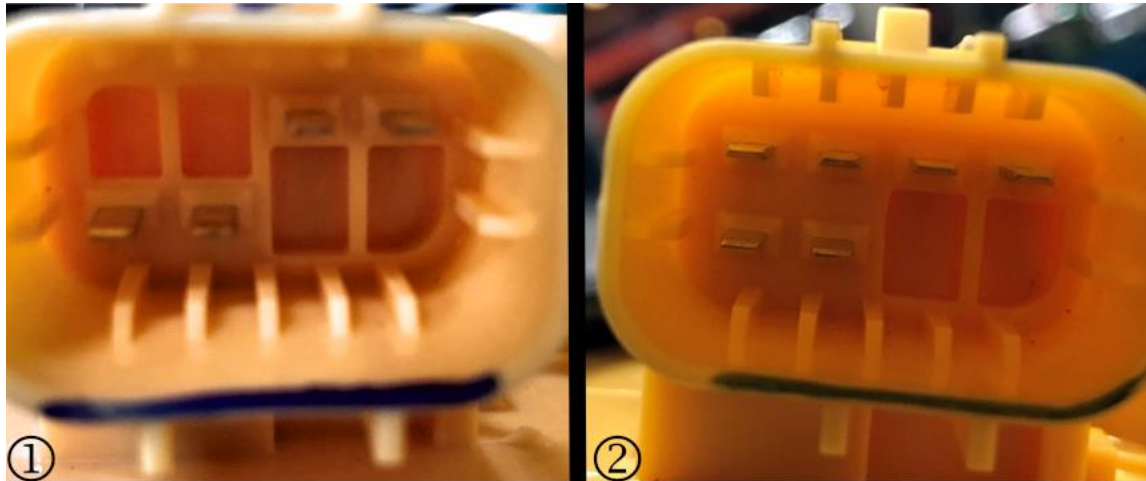
5354681

Condition	Certain 2019 model year Chevrolet Silverado MD vehicles may have a condition in which the rear fuel tank pump may fail to transfer fuel to the front fuel tank. If the fuel transfer fails, P-codes will set, and the fuel gage will default to "E", the low fuel warning will illuminate in the driver information center (DIC) and there will be 2 sets of 5 chimes upon initial warning. If the customer continues to operate the vehicle without refueling the front tank, the Check Engine Light will illuminate, and the vehicle may exhibit reduced power mode. The vehicle may also lose propulsion and may fail to re-start (dependent on fuel pressure).
Correction	Dealers are to inspect and, if necessary, replace the rear fuel pump.

2. Inspect the Auxiliary (rear) Fuel Tank Fuel Pump Module for the number of pins contained in the connector, as shown.
 - If the connector has four pins, as shown in (1), no further action is required. Reconnect the harness to the fuel pump module. If the fuel tank was dropped to allow inspection, reinstall it. Refer to *Auxiliary Fuel Tank Replacement* in SI.
 - If the connector has six pins, as shown in (2), replace the Fuel Tank Fuel Pump Module (Auxiliary Tank). Refer to *Fuel Tank Fuel Pump Module Replacement (Auxiliary Tank)* in SI.
