# HYUNDAI Technical Service Bulletin

19-BD-003H

**SUBJECT:** INFORMATION FOR HEADLAMP AND REAR COMBINATION LAMP CONDENSATION

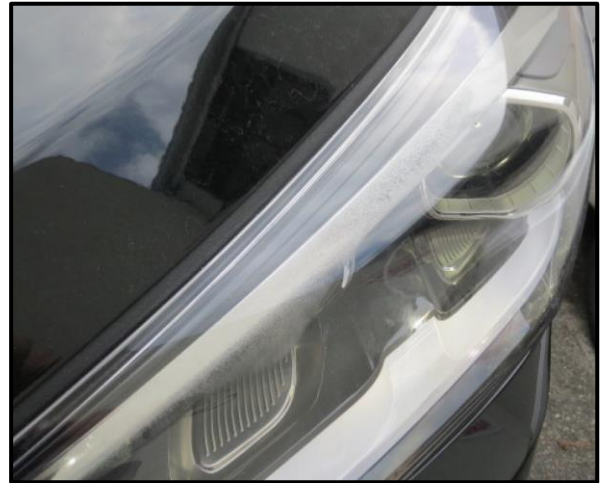
Condensation occurring inside the headlamp/rear combination lamp during or after a car wash cycle is considered a natural occurrence. This condition occurs when water vapor inside the headlamp/rear combination lamp is exposed to temperature variations.

*Normal condensation in the headlamp*

This condensation is NORMAL and can be corrected by turning on the headlamps for approximately 30 minutes with the engine running. Repair or replacement is NOT REQUIRED.

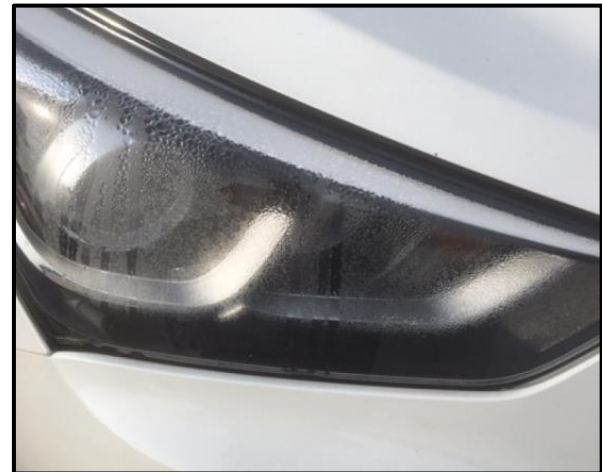
If water is collecting at the bottom of the headlamp assembly or the condensation remains after the headlamps have been on for 30 minutes or more, there may be a water leak in the assembly. The leak may be caused by a poor seal between the headlamp housing and lens, cracks in the headlamp assembly, or poor fitment.

*Water collecting inside the headlamp*

The condition should be diagnosed and repaired as necessary.

Replacement of the head lamp assembly for an actual water leak requires DPSM approval. Photos of the condition and proper documentation must be attached to a TechLine case.
