Title US07 / US10 D13 Turbocharger Gasket - Low Power, Poor Regen Performance

Engine family 13L Engine , MP8

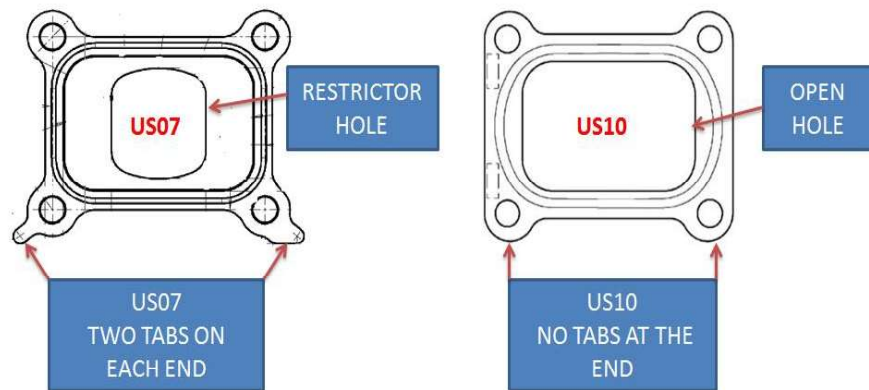
Cause The US07 turbocharger gasket installed in a US10 engine will cause low power and poor regen performance.

Solution The chart below shows the difference between the US07 and US10 turbocharger gaskets. Ensure the correct gasket is installed on each respective emissions level engine.
