Link Auxiliary Axle Hardware, Retorque
CXU, AN

PI0888, Link Auxiliary Axle Hardware, Retorque

(July 2019)

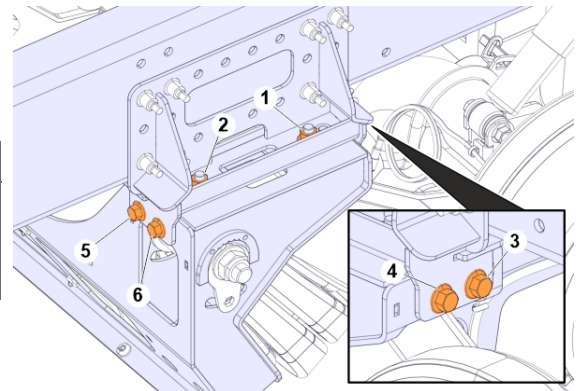
For certain MACK CXU and AN trucks built between 08/29/2016 and 01/25/2019, a new improved torque procedure has been introduced to maintain and distribute torque properly on the hardware attaching the Link auxiliary axle to the frame mounted brackets. Follow the repair instructions outlined in this document for re-torquing the indicated nuts or bolts.

6. Torque tighten the screws and nuts.

Tightening torque	
Fasteners	Tightening sequence: 1-6
	305 \pm $\frac{14}{34}$ Nm (225 \pm $\frac{10}{25}$ lb _r -ft)
