Title Diagnostic Trouble Codes (DTC) P20EE And P103C, Diagnostic Procedure; **REPLACE S GUIDED DIAGNOSTICS IN PREMIUM TECH TOOL (PTT) - US17+OBD16 And Newer Chassis ONLY**

Cause Procedures and checks to follow for P20EE and P103C on US17 and newer chassis.

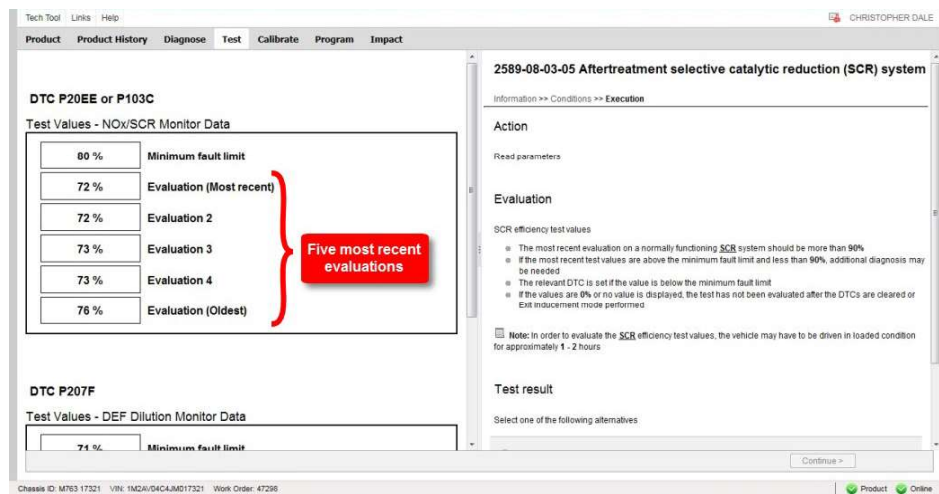
- The last five efficiency evaluations are displayed as shown in the screenshot above.
 - If all five tests are below the fault limit, SCR conversion has been poor for an extended amount of time.
 - If only one or two are below the fault limit, conversion is only intermittently poor.
 - Information on driving conditions when the poor conversion is occurring may provide insight into the cause of the codes.

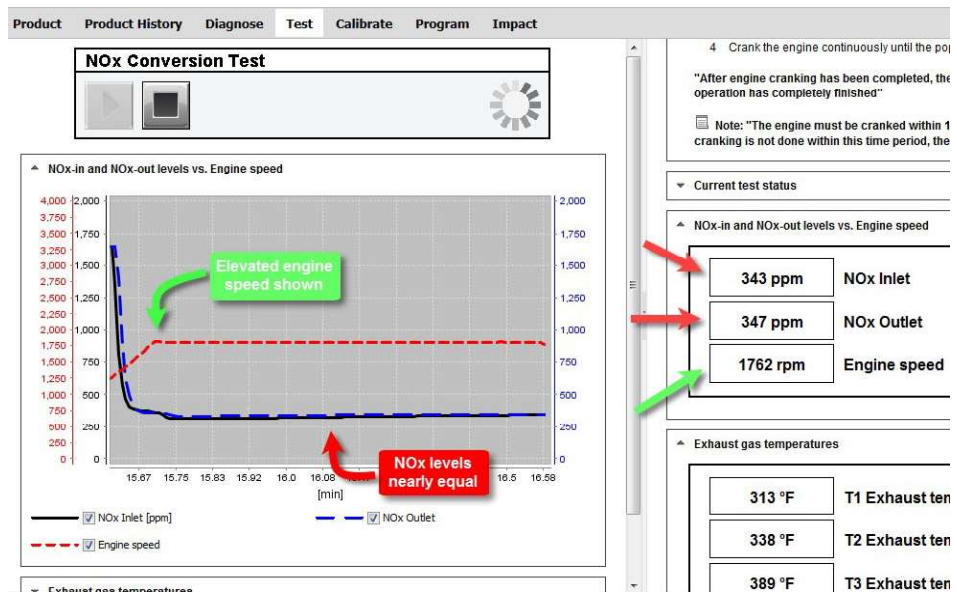
- While running NOx conversion test, if any new NOx sensor codes are logged (Egs: P220E-93, P220F-93), make sure to troubleshoot those codes.
- Inlet and Outlet NOx Sensor values should be close to each other at high engine speed (last portion of the test) as shown below.
- If during the test difference between NOx sensors are greater than 10%, it is recommended to replace the sensor reading the higher value and re-do the test.

The likelihood that both sensors require replacement at once is low. Replacement of both sensors at once should not be considered immediately unless affected by an upstream failure.

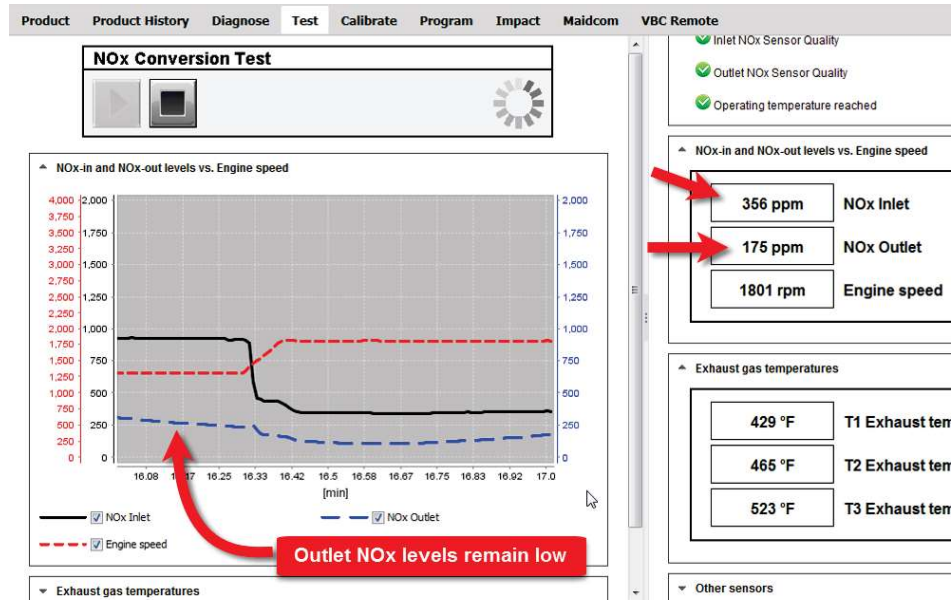
EMS Main Software Part Numbers 23470183 and 23470187, used for US17+OBD18 emissions, has a bug that allows DEF dosing to continue during the NOx conversion test. This causes continued low Outlet NOx sensor values as seen in the screen shot below and prevents

the desired behavior shown above.

In this instance, review earlier sections of the test to ensure that both sensors are responding to changes in the same manner. Examples of different stages to review are shown below.

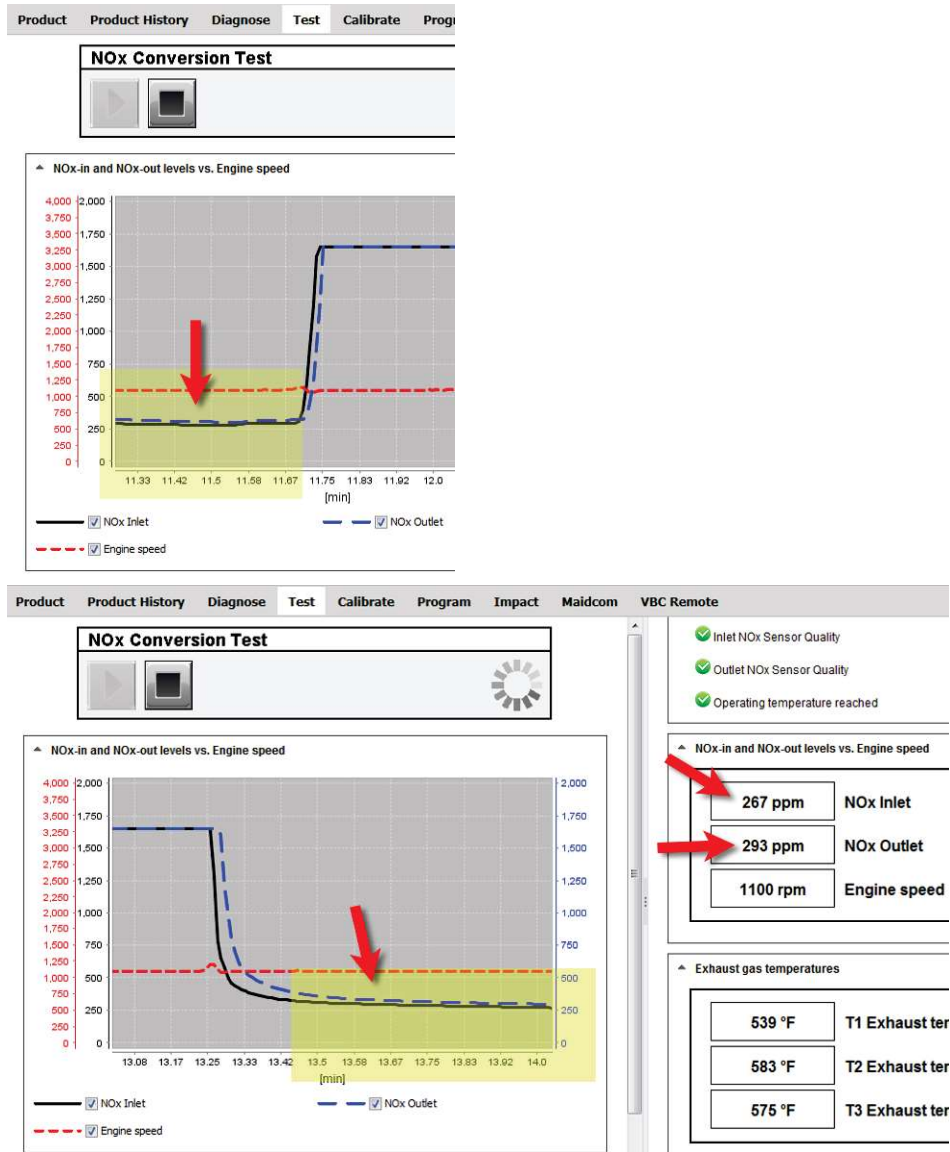
COMPARISON SHOULD BE DONE WHEN BOTH NO_x SENSORS ARE READING BELOW 600 PPM.
