Technical Service Bulletin

Topic	Clicking noises from front corner(s)
Market area	Bentley: worldwide (2WBE),Hongkong-Macau (5HK)
Brand	Bentley
Transaction No.	2052853/2
Level	EH
Status	Released for publishing
Release date	Jul 8, 2019

Bentayga

Clicking noise from front corner(s)

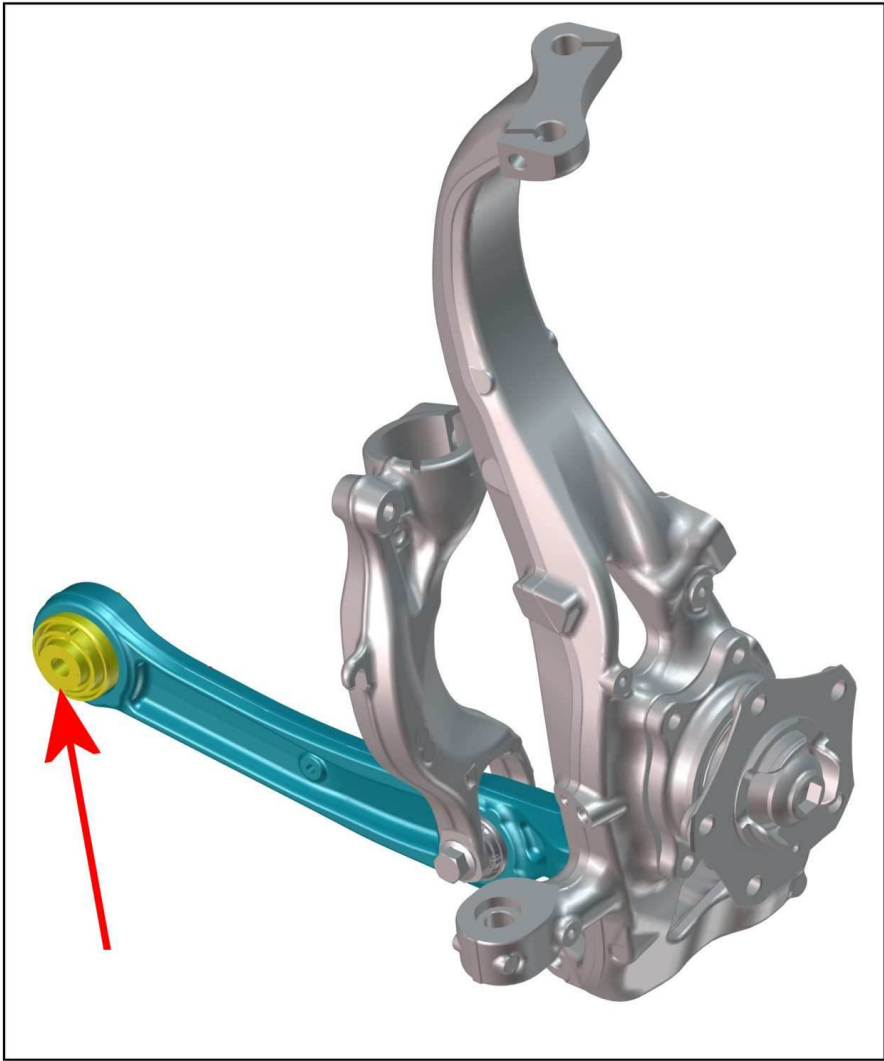
Figure 1

Symptom 1 - Single click from the front wheel corner(s) when the steering is moved from lock to lock whilst stationary

Ensure fault is as described and reference video <https://vimeo.com/298953282> If so then replace both front lower inner control arm bushes (Figure 1)

IMPORTANT: Please check the vehicle Repair History to confirm the inner bushes have not been previously replaced, if they have been replaced once before, **You must then replace the complete arm. Do Not carry out the bush replacement procedure more than once (per lever)**

IMPORTANT: Prior to starting this procedure ensure you have assembly lubricant part number G 052 566 A2 this must be used when fitting the new replacement bushes, the lubricant should only be used when the bushes are replaced as per the instructions within TPI 2052853/-

Each bush should have 5ml of lubricant applied prior to fitment within the bush, the grease should remain present throughout the fitting/pressing in procedure as the grease aids the fitting process and is also crucial once fitted to eliminate any further noise issues *Please Note that x1 – 100 ml tube will be sufficient for use on 20 bushes (10 vehicles) – Do not order x1 tube of lubricant per each individual vehicle complaint*

1) Remove the left and right hand side Lower suspension levers - Refer to Repair manual Rep.Gr.40

- Once removed refer to the attached document and follow the instructions to replace the left and right hand side lever inner bushes
