August 22, 2019

Version 6

A/C Does Not Blow Cold Air and Condenser Leaks at Receiver Dryer Cap

Supersedes 18-080, dated July 16, 2019, to revise the information highlighted in **yellow**

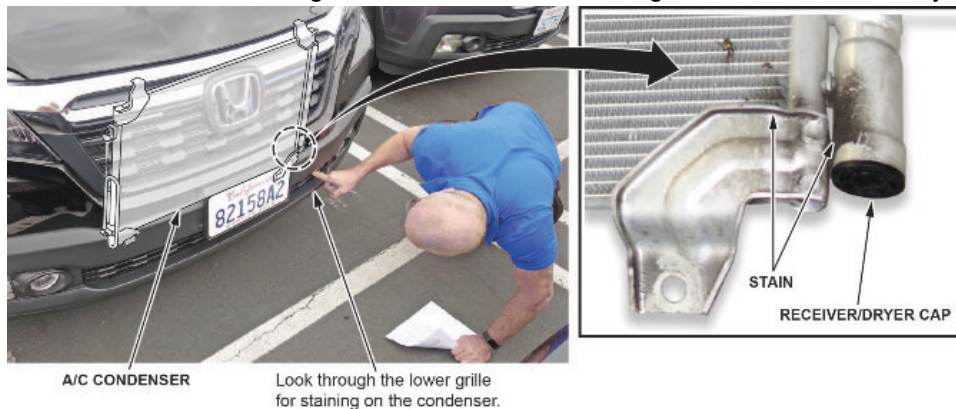
The A/C does not blow cold air, and the lower corner of the condenser around the receiver/dryer cap is stained.

There is poor O-ring compression against the receiver/dryer barrel wall.

Check if the A/C is blowing cold air and there is staining around the receiver dryer cap on the condenser.

- If the A/C is not blowing cold air and there is staining around the receiver dryer cap on the condenser, go to REPAIR PROCEDURE.
- If the A/C is not blowing cold air and there is no staining around the receiver dryer cap, continue with normal system troubleshooting.

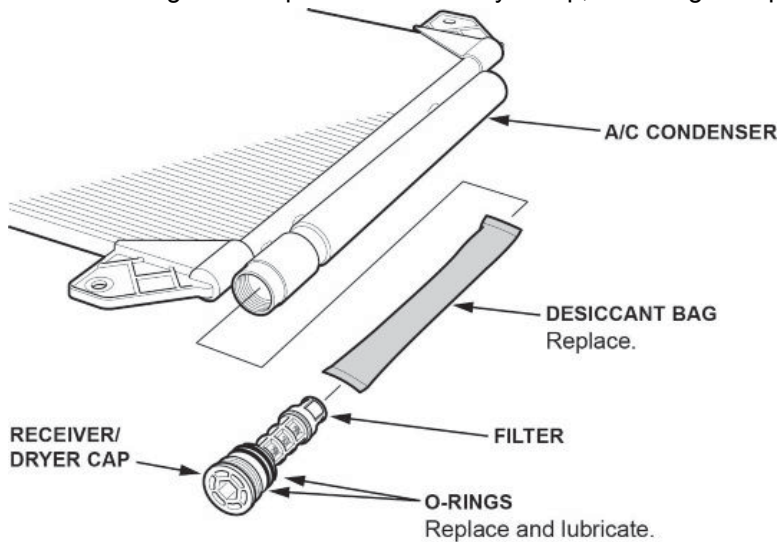
4. Remove the sub-assembly (cap, filter, and desiccant bag) from the condenser.

- Install the new desiccant bag as quickly as possible to prevent the system from absorbing moisture from the air.
- You will need to add **10 ml** of refrigerant oil (P/N 38899-RLV-A01) with the replacement of the desiccant bag.
- Do not over tighten the plastic receiver/dryer cap; it could get stripped.

5. Wipe the interior threads and sealing area of the receiver/dryer barrel with a lint-free cloth to remove all debris.
6. Apply a thin layer of refrigerant oil to the O-rings. Then install the new filter sub-assembly, and torque the cap to **12 N·m (9 lb-ft)**.
7. Install the A/C condenser. Refer to the service information.
8. Evacuate and recharge the A/C system. Refer to the service information.
9. Make sure the A/C system is operating properly.
10. *With Honda Sensing:* Do the millimeter wave radar aiming procedure. Refer to service information.
