# Technical Service Bulletin

## 91 SOS Emergency call function deactivated message in the cluster, DTC U153E00 stored in the telematics module

91 19 79 2055945/1 August 26, 2019.

Model(s)	Year	VIN Range	Vehicle-Specific Equipment
A4, A5, A6, A7, Q5, Q7, and Q8	2019 - 2020	All	With ConBox Low

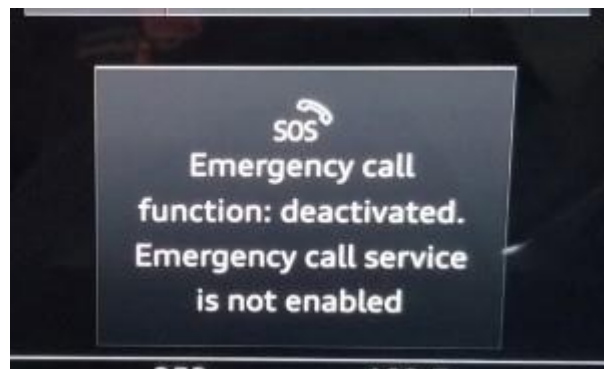
The warning message “SOS Emergency call function deactivated” is seen in the instrument cluster (Figure 1 or 2).

Figure 1. SOS warning in the instrument cluster.

This DTC will set the warning message upon the vehicle losing signal to the MNO (AT&T). However, depending on how long the signal is lost, the vehicle may require a full sleep cycle in order for the DTC to go sporadic and thus the warning message turned off in the cluster.

1. Follow the recommended troubleshooting steps provided by GFF.
2. Please note the time and date when the DTC was set and document it in the repair order in the event the car returns for a repeat repair.
3. If the SOS button LED is green, then tell the customer that this warning is normal and is shown whenever the vehicle is driven in an area with little-to-no LTE service with AT&T.
4. No further analysis is required.

1. Follow the recommended troubleshooting steps provided by GFF.
2. Ignore the recommendation to replace the hardware if recommended by GFF.
3. If the SOS button LED is red or off, then gain access to the J949 - Emergency Call module (see Elsa).

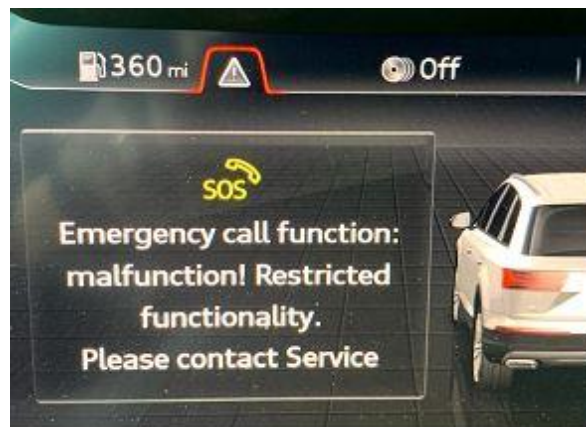
Figure 2. SOS warning in the instrument cluster.
