Technical Service Bulletin

96 Traffic sign detection: wrong way warning message in the instrument cluster

96 19 42 2055256/1 August 14, 2019.

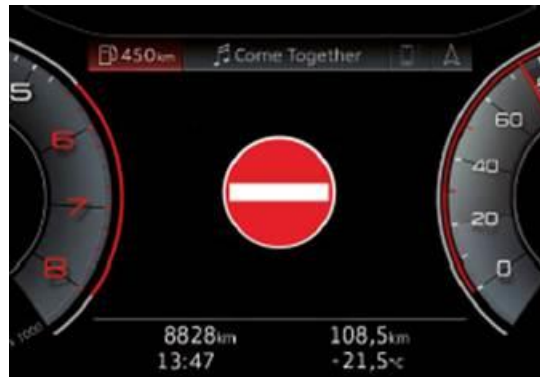
- The wrong way traffic sign appears in the instrument cluster (Figure 1).

Figure 1. Wrong way traffic sign in the instrument cluster.

An incorrect dataset has been written to a small number of vehicles. The wrong way warning sign is only intended to be active in vehicles with 3rd generation traffic sign detection (A6, A7, A8, Q8, and Audi e-tron quattro).

An updated dataset for the control module for driver assist systems, J1121 (address word 00A5) solves the problem.

1. Follow all instructions in TSB 2011732: *00 Software Version Management (SVM), operating instructions.*
2. Update the control module for driver assist systems, J1121 (address word 00A5) using the SVM action code as listed in the table below, if necessary:
