P20EE (diagnostic troubleshooting code) SOLUTION - NOX CONVERSION EFFICIENCY

Prevost vehicles

B13R (9700 us/can)

SP18-35D

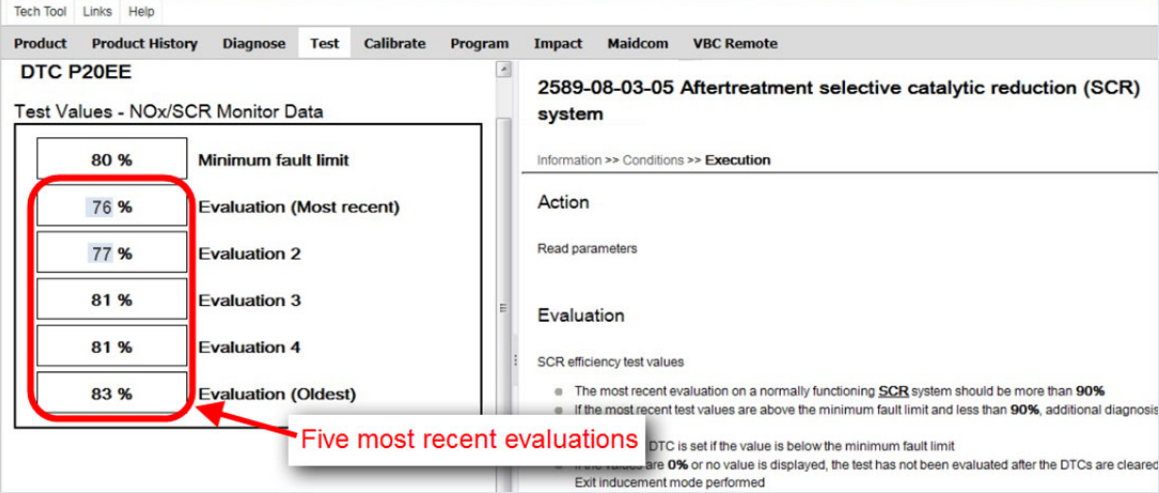
| # | checklist | INITIALS & DATE |
|---|--|---|
| 2 | <p>Take a screen capture of the five most recent SCR efficiency evaluations (Test screen 2589-08-03-05), attach to the repair order.</p> <p><i>Example of SCR efficiency evaluations</i></p> <p style="text-align: center;">➡ Are the five most recent SCR efficiency evaluations hovering around or lower than 80%?</p> <p style="text-align: center;">YES <input type="checkbox"/> NO <input type="checkbox"/></p> | |

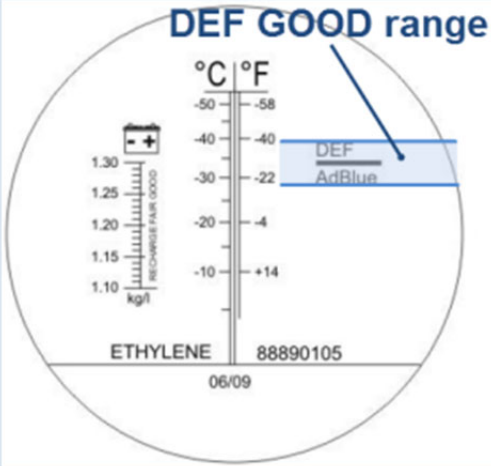
| 5 | <p>Test the concentration of DEF and record the result below. Tool: refractometer # 88890105.</p> <div style="text-align: center;"> </div> <p style="font-size: small;">Apply a drop of DEF on the viewer of the refractometer. If the level is above the word "DEF" or below the word "AdBlue" the DEF is contaminated. If no level is shown, it may indicate chemical residue, such as pure water or diesel fuel.</p> <p>➡ Is the DEF of proper concentration? YES <input type="checkbox"/> NO <input type="checkbox"/></p> | |

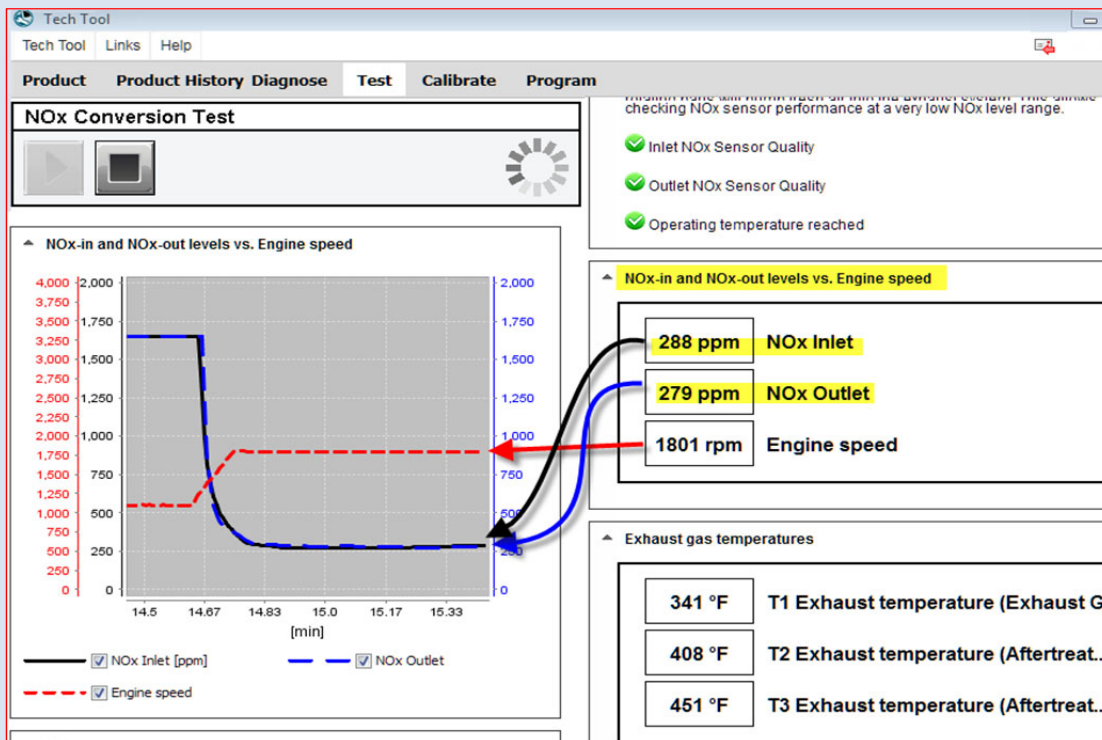
Use this test to compare the inlet and outlet NOx sensor ppm levels. Usually we monitor the last part of the test, just before shutdown, when the engine runs at high rpm (1800 rpm). Both levels should be close to each other at that point. See the example below (image). **Take screen captures.**

If both NOx sensor ppm levels are **close to each other** during the last part, as shown in the example above (image), then both NOx sensors are good.

If ppm levels difference **exceeds 10%**, then the sensor reading higher should be considered as defective.

Replace the defective sensor¹ if applicable and then perform a new NOx sensor test once again to make sure that the replacement sensor is good.

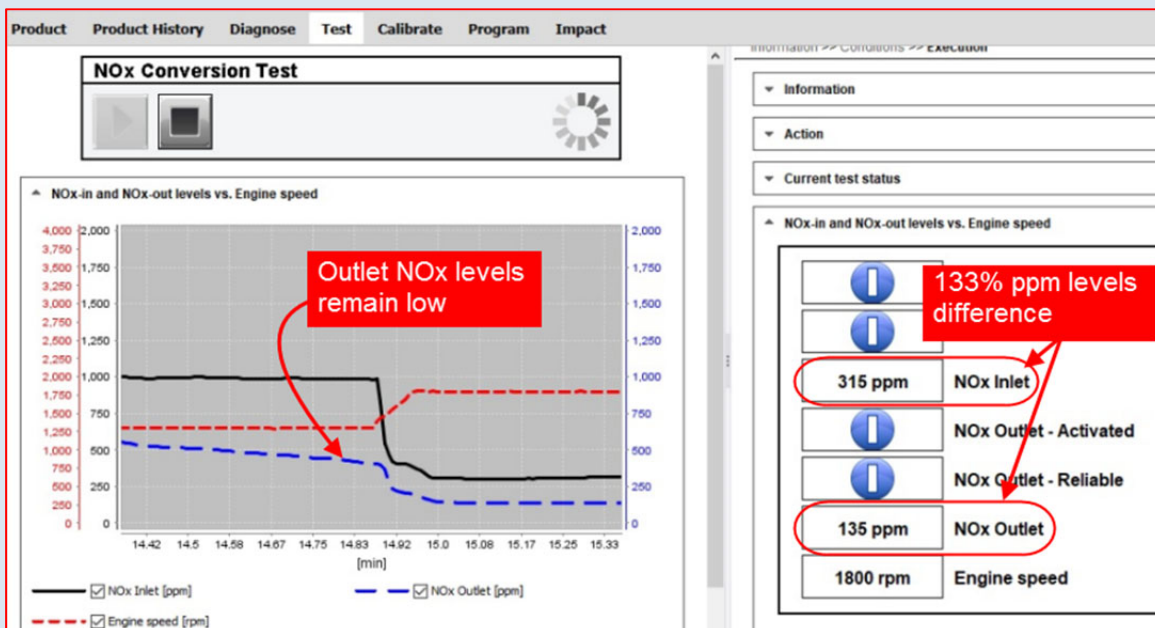
NOx Conversion Test With engine ECU software number 23470183

Engine ECU software number 23470183 allows DEF dosing to continue during the last part of the NOx conversion test (just before shutdown). This causes continued low outlet NOx sensor ppm levels, as seen in the example below. **Take screen captures.**

DIFFERENT BEHAVIOR. In this example, the NOx sensors ppm levels are not close to each other because DEF is still injected during the last part of the test. **In this instance, review earlier sections of the test** to ensure that both sensors are responding to changes in the same manner. Examples of different stages to review are shown below.

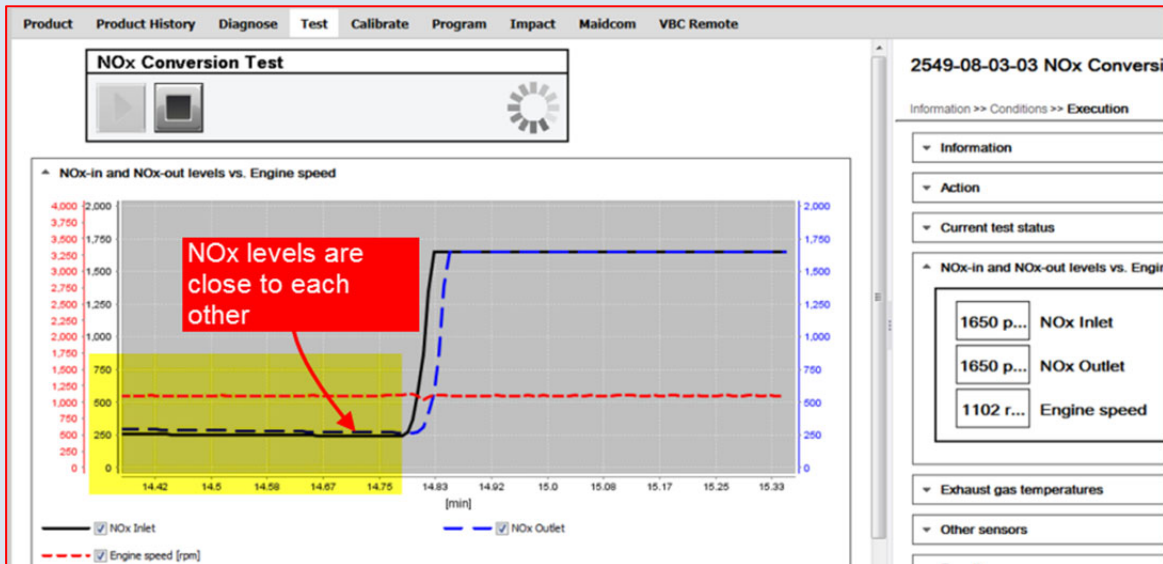
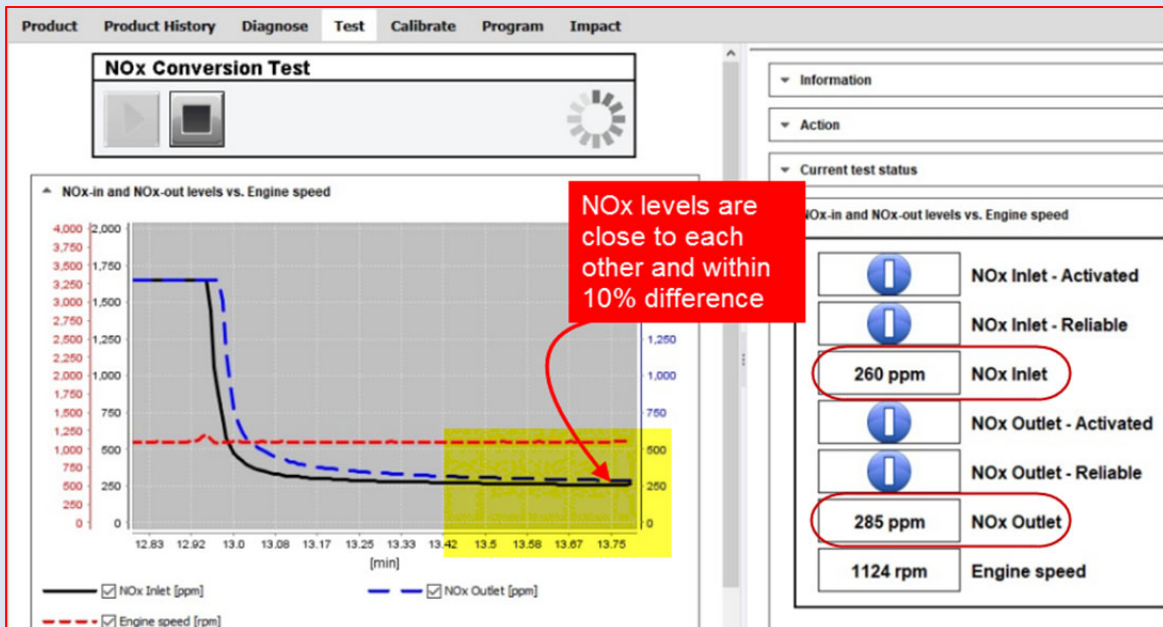
COMPARISON SHOULD BE DONE WHEN BOTH NOX SENSORS ARE READING BELOW 600 ppm

The NOx sensors levels are close to each but earlier during the test (images above & below).

If both NOx sensor ppm levels are **close to each other** at a point during the test as shown in the examples (image) above, then both NOx sensors are good.
If ppm levels difference is **greater than 10%**, then the sensor reading higher should be considered as defective.
