Latest Vehicle Concern Fixes

Heavier Then Expected Steering

2016 Onwards Range Rover & Range **Rover Sport**

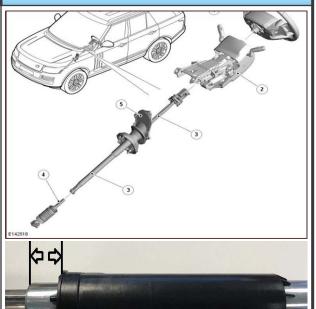
• Customer states the steering is heavier than expected.

• The sleeve on I-shaft may have moved down on the I-shaft.

- LTB01224 is on sign-off to replace the bulk head seal and I-shaft when parts are available.
- ETA on new I-shaft is the 20th of June
