SERVICE BULLETIN

Classification: EC17-033b	Reference: NTB17-113b	Date: August 28, 2019
------------------------------	--------------------------	--------------------------

2017-2018 ROGUE SPORT; WHEN COLD LONG CRANK TIME, ENGINE TURNS OFF, HESITATION, ROUGH IDLE, OR MISFIRE

APPLIED VEHICLES: 2017-2018 Rogue Sport (J11)

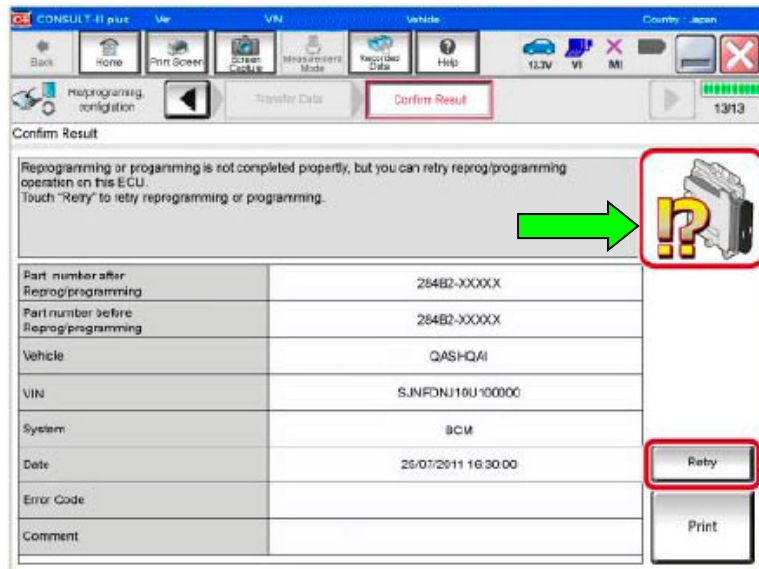
Figure 6

If reprogramming does not complete and the “!?” icon displays as shown in Figure 6:

- Check battery voltage (12.0–15.5 V).
- Ignition is ON, engine OFF.
- External Bluetooth® devices are OFF.
- All electrical loads are OFF.
- **Select retry and follow the on screen instructions.**
- “Retry” may not go through on first attempt and can be selected more than once.

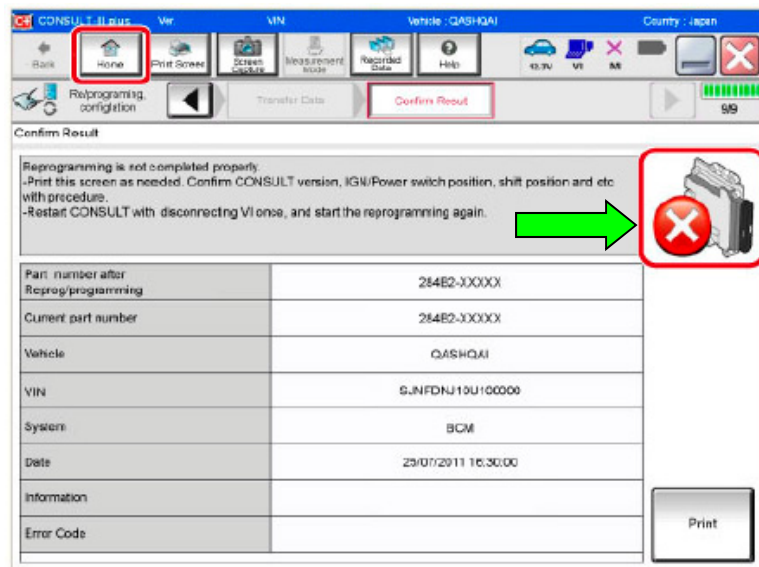
Figure 7

If reprogramming does not complete and the “X” icon displays as shown in Figure 7:

- Check battery voltage (12.0 – 15.5 V).
- CONSULT A/C adapter is plugged in.
- Ignition is ON, engine OFF.
- Transmission is in Park.
- All C-III plus / VI cables are securely connected.
- All C-III plus updates are installed.
- **Select Home, and restart the reprogram procedure from the beginning.**
