Bulletin No.: PIT4601A
Published date: 08/14/2019

PIT4601A Wind Whistle Noise From Front Of the Vehicle at Speeds Above 55 mph

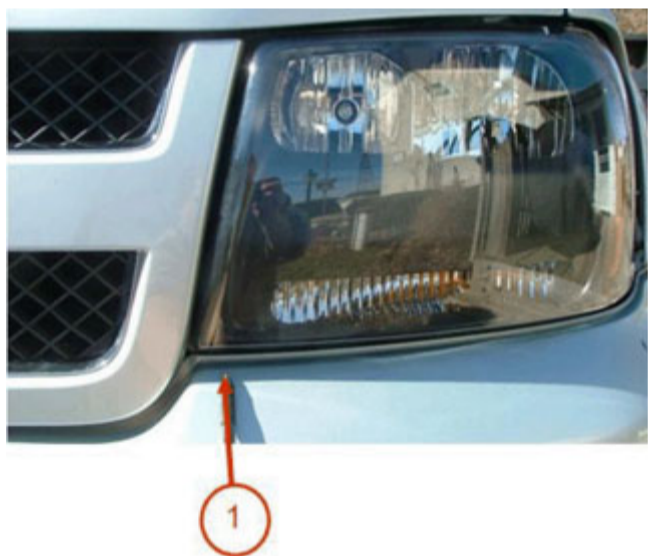
Some customers may comment of a wind noise from the front of the A-pillar, either of the outside rear view mirror(s), or the front of the vehicle. Typically the noise occurs at speeds above 55mph. The source of this noise may be from the headlamp area called out as number

(1) in the image above.

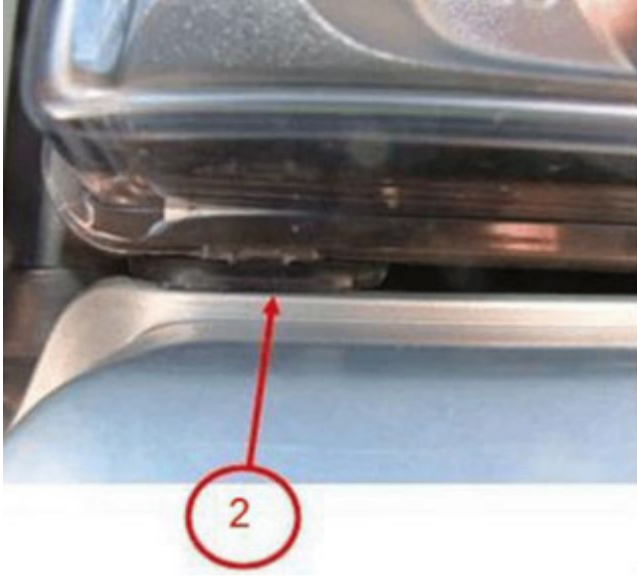
Closer inspection of this area may reveal an improperly positioned front fascia in relation to the head light capsule. Refer to (2) in the image above.
