Preliminary Information

PIP5651D Possible Charge Air Cooler Outlet Hose Disconnected From Throttle Body And One or More of The Following DTCs P0172, P0299, P0101, P0506, P1101

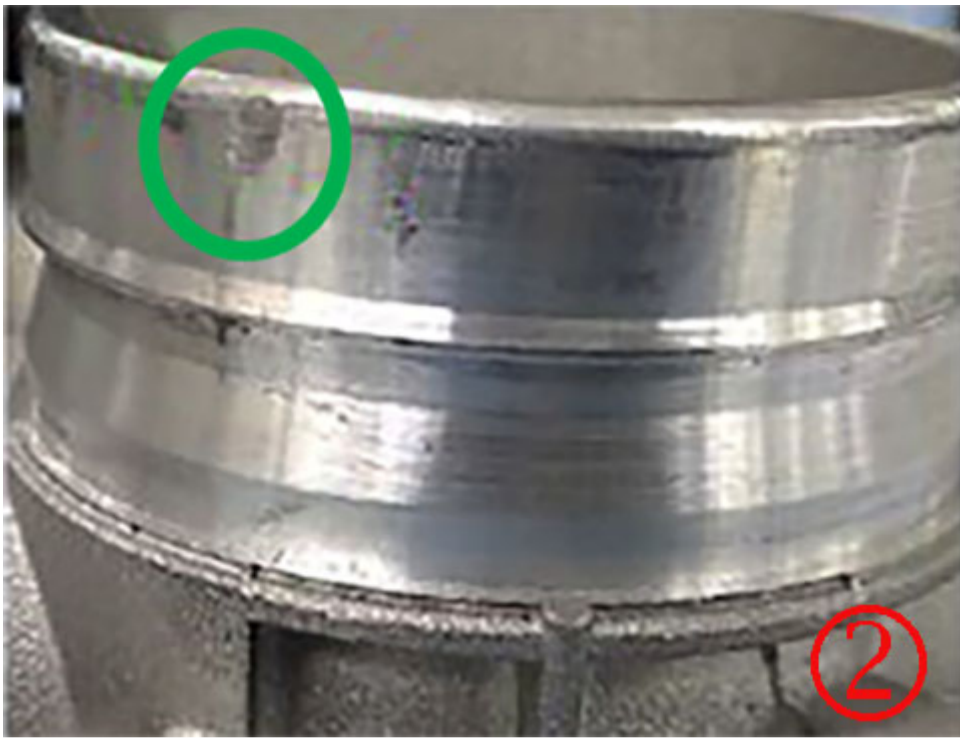
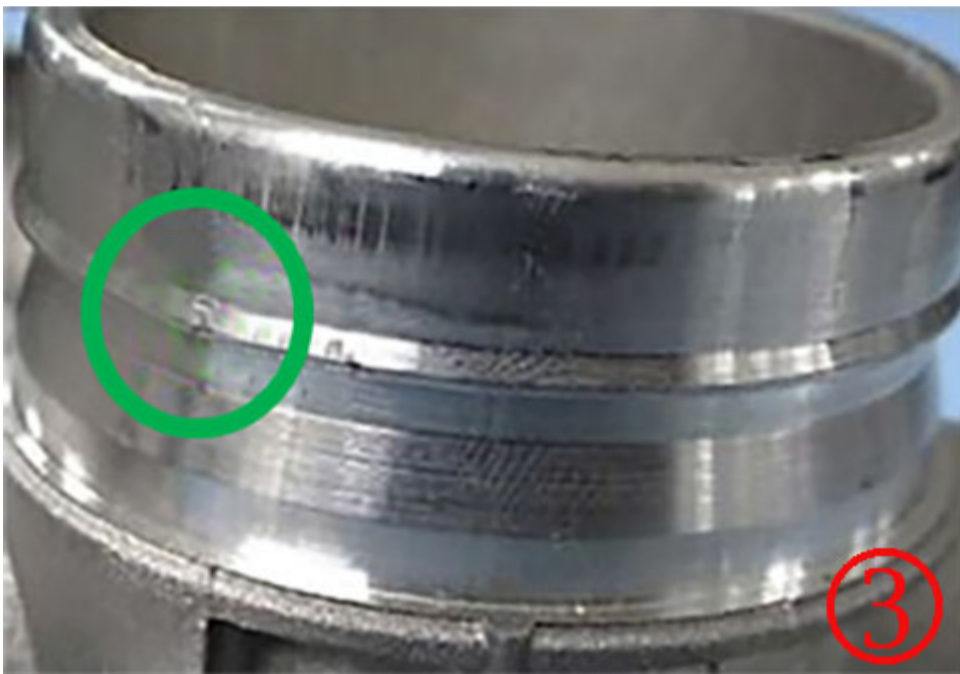
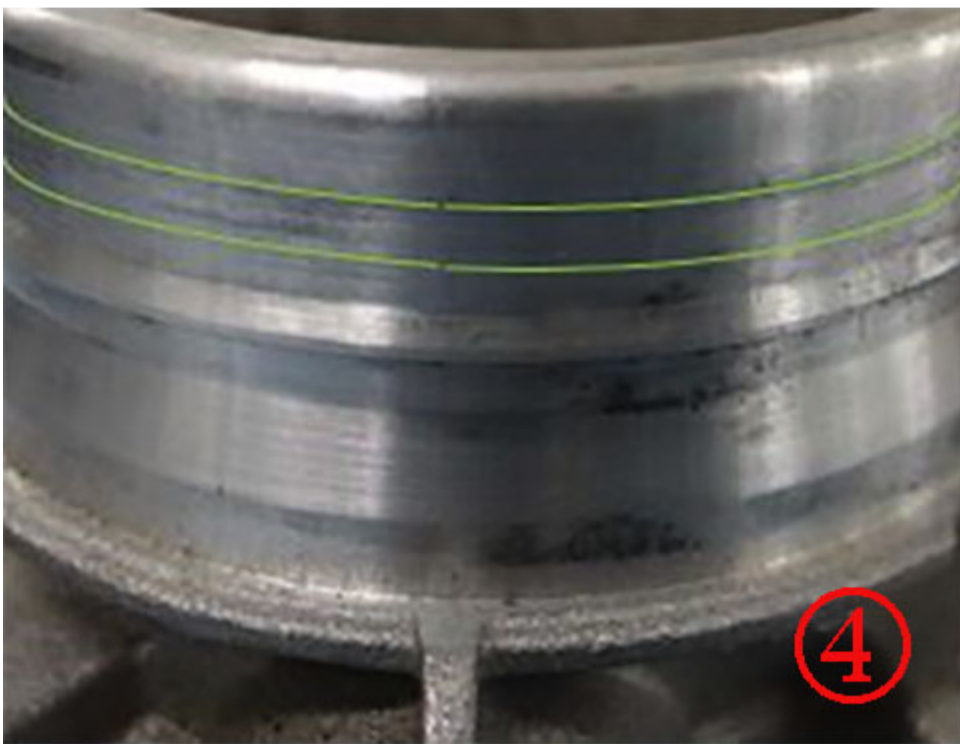
Photos 1-4 below show normal witness marks on the throttle body and normally will not require replacement.
