Technical Service Bulletin

SUBJECT:			No:	TSB-19-52A-003
CORRECTION TO FRONT PILLAR TRIM			DATE:	August 2019
ASSEMBLY INSTALLATION PROCEDURE - SMR				2015-19 Outlander Sport/RVR
CIRCULATE TO:	[] GENERAL MANAGER	[] PARTS MANAGER		[X] TECHNICIAN
[X] SERVICE ADVISOR	[X] SERVICE MANAGER	[X] WARRANTY PROCESSOR		[] SALES MANAGER

This TSB updates the Interior and Supplemental Restraint System (SRS) section of the affected Service Manuals, to correct the front pillar trim assembly installation procedure.

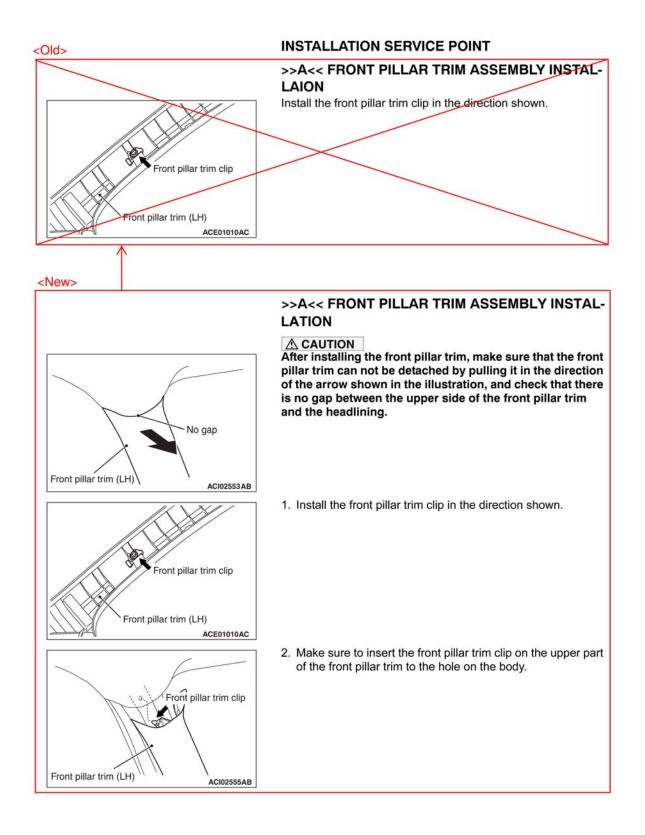
Please make the indicated changes to the 2015 Outlander Sport/RVR Service Manual, Group 52-Interior and Supplemental Restraint System (SRS) -> Group 52A-Interior -> Trims -> Interior Trim Removal and Installation.

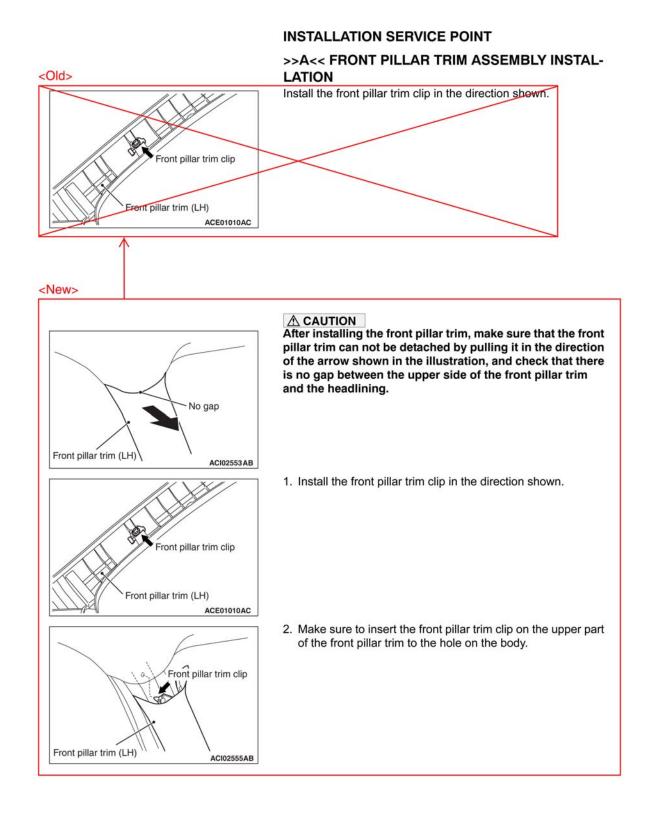
Please make the indicated changes to the 2016 Outlander Sport/RVR Service Manual, Group 52-Interior and Supplemental Restraint System (SRS) -> Group 52A-Interior -> Trims -> Interior Trim Removal and Installation.

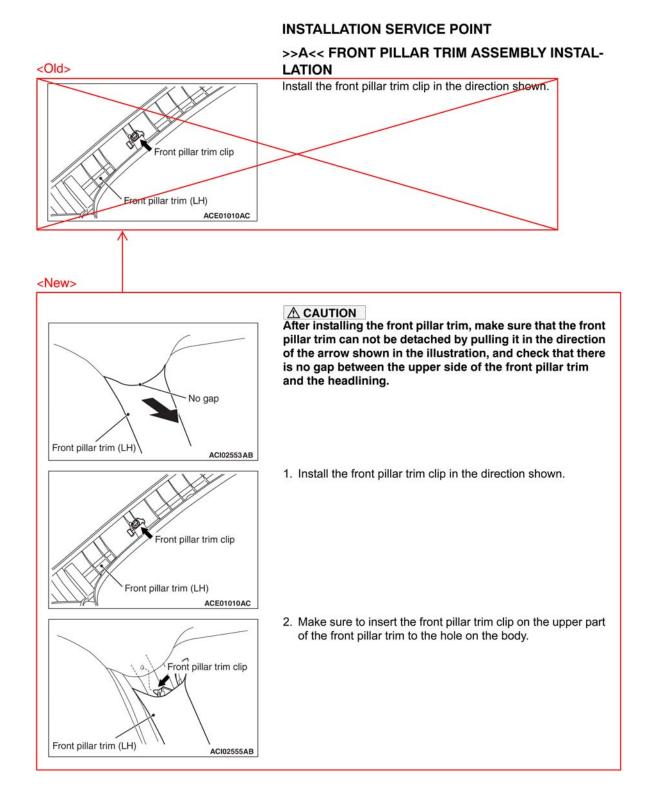
Please make the indicated changes to the 2017 Outlander Sport/RVR Service Manual, Group 52-Interior and Supplemental Restraint System (SRS) -> Group 52A-Interior -> Trims -> Interior Trim Removal and Installation.

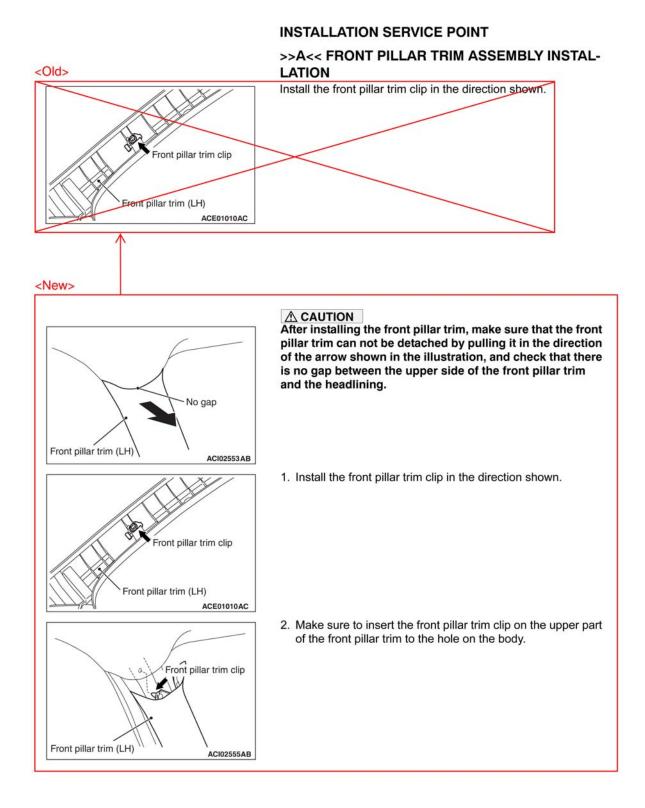
Please make the indicated changes to the 2018 - 2019 Outlander Sport/RVR Service Manuals, Group 52-Interior and Supplemental Restraint System (SRS) -> Group 52A-Interior -> Trims -> Interior Trim Removal and Installation.
