JTBO0591NAS3

TECHNICAL BULLETIN

Front Seat Bolster Wear - Oyster Leather Only

MODEL:	MODEL YEAR:	VIN:
F-PACE (X761)	2017 Onwards	045068 Onwards
XF (X260)	2016 Onwards	Y00461 Onwards

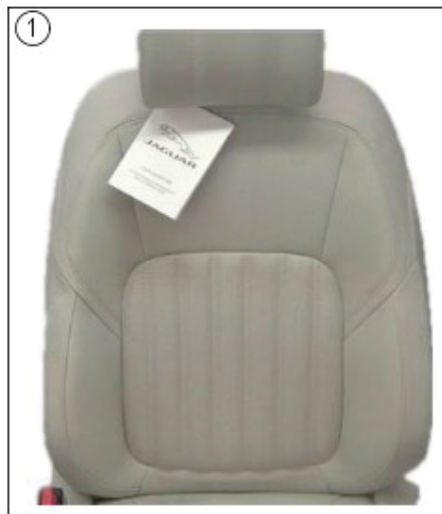
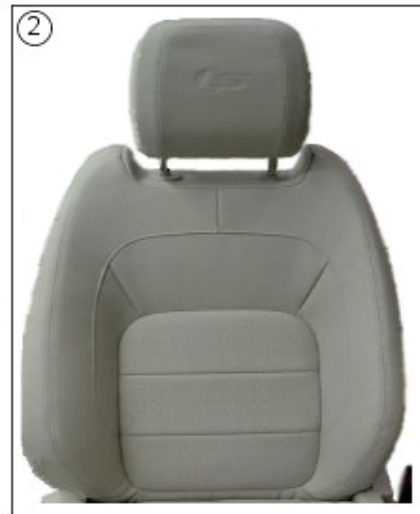
E230171

- Oyster Windsor (1); Oyster Houndstooth (2).
- If premature cosmetic wear is visible on any of the front row seat cushion and/or backrest covers, the front row seat cushion and backrest covers **must** be renewed on **both** front row seats.

Inspect the front row seat cushion and backrest covers for premature cosmetic wear.

- ■ If there is any premature cosmetic wear visible on any of the front row seat cushion covers and/or front row seat backrest covers, continue to the service instruction below.
- ■ If there is not any premature cosmetic wear visible on any of the front row seat cushion covers and/or front row seat backrest covers, do not continue with this technical bulletin; the customer concern does not relate to its content.
