Service Bulletin

Bulletin No.: 17-NA-143

Subject: Clicking Noise from Front On Acceleration and Deceleration at Low Speeds

Brand:	Model:	Model Year:		VIN:		Engine:	Transmission:
		from	to	from	to		
Buick	Enclave	2018	2019				
Cadillac	XT5	2017					
	XTS						
Chevrolet	Traverse	2018					
GMC	Acadia (VIN N)	2017					
Holden	Acadia	2019	2019

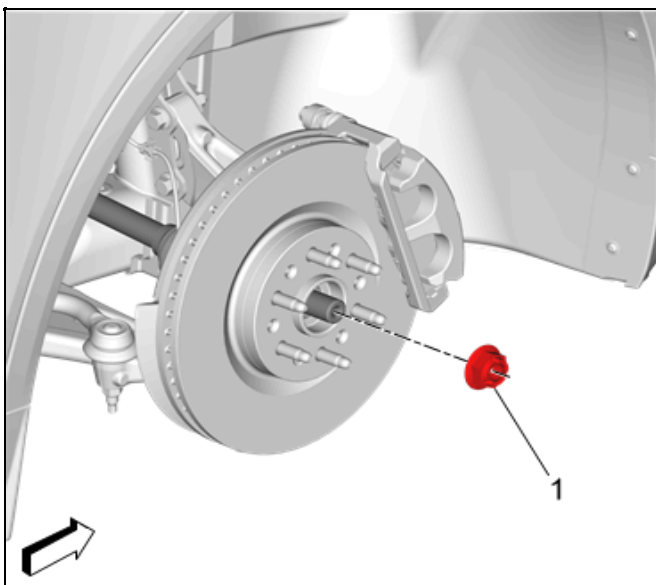
4296858

Caution: DO NOT use air tools to remove the wheel drive shaft nut. Damage to the wheel drive shaft threads could occur. Use hand tools only.

2. Remove the wheel drive shaft nut (1) and **DISCARD** the nut.
3. Separate the steering linkage outer tie rod from the steering knuckle.

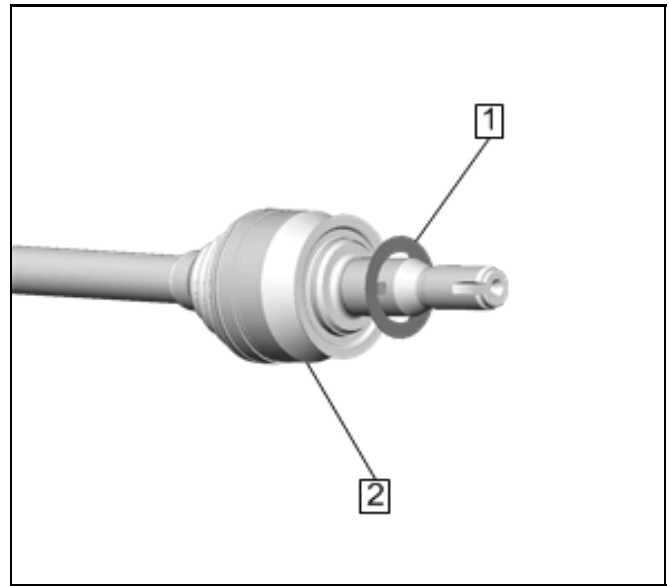
4174916

Involved Region or Country	North America, Australia, Russia, Middle East, Israel, Palestine, Japan, South Korea, Columbia, Chile, Peru, North Africa and New Zealand.
Condition	Some customers may comment on a clicking noise from front wheels on Acceleration and Deceleration at low speeds.
Cause	This condition may be caused by a loss of torque on the drive axle nut.
Correction	If the above condition has been confirmed, the axle nut and anti-click washer must be replaced.

8. Remove the washer (1) from the wheel drive shaft (2) and **DISCARD** the washer.
9. Position the new washer onto the wheel drive shaft.
10. Using care, install the drive shaft into the hub.
