**Subject: Engineering Information – Charge Port Receptacle Melting On the Vehicle**

Brand:	Model:	Model Year:		VIN:		Engine:	Transmission:
		from	to	from	to		
Chevrolet	Bolt EV	2017	2020	-	-	-	-

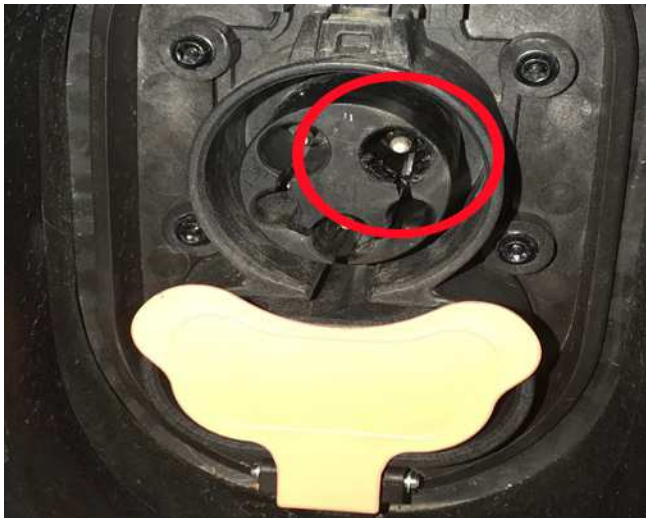
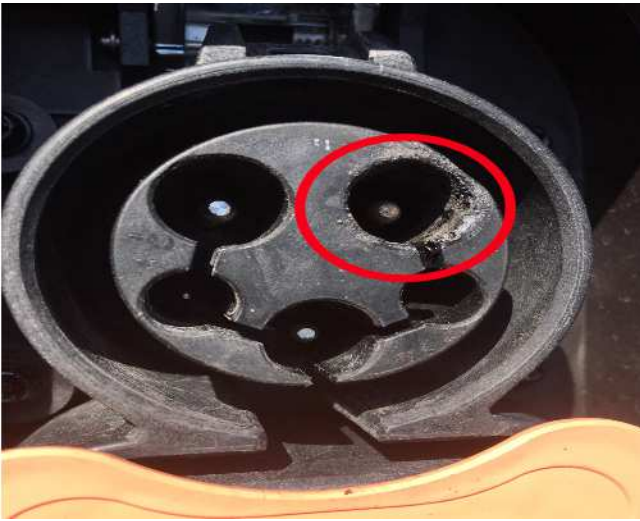
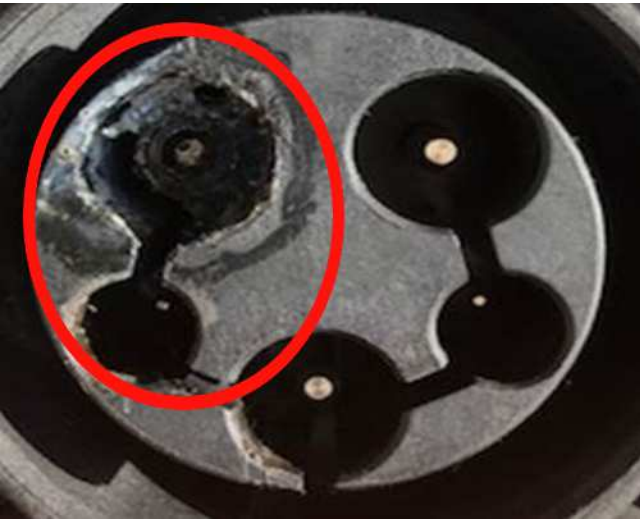
<b>Involved Region or Country</b>	North America
<b>Condition</b>	<b>Important:</b> If the customer did not bring their vehicle in for this concern, DO NOT proceed with this EI. Some customers may comment that the charge port receptacle is melting on the vehicle.
<b>Cause</b>	GM Engineering is attempting to determine the root cause of the above condition. Engineering has a need to gather information on vehicles PRIOR to repair that may exhibit this condition. As a result, this information will be used to "root cause" the customer's concern and develop/validate a field fix.

3. Pictures of charge port receptacle melted are shown above.

If you encounter a vehicle with the above concern, perform the following listed below and contact the engineer with your findings.

1. Identify the location and brand of the charge station that the event occurred.
2. Inspect for signs of damage and/or contamination of the charge station plug.
