Complaint - Seam in Shoulder Area of Front Backrest Cover Becomes Detached: Replacing front backrest cover (81/19)

Model Line: **Cayenne (9YA)**

Model Year: **As of 2018**

Subject: **Front backrest cover (left/right)**

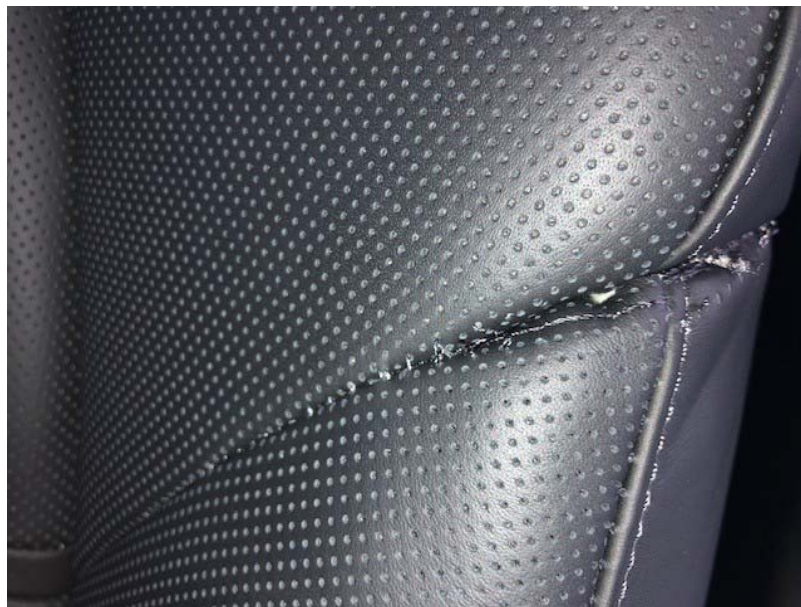
Information: A seam can become detached in the shoulder area of the front backrest covers, see example Figure 1.

Figure 1 Shoulder Seat Seam

- There is an **airbag seam** near the seam in the shoulder area.
- **Reworking** of the seam in the shoulder area is **not permitted**. There is no guarantee that the airbag seam will release correctly afterwards in the event of an accident.

In the event of a complaint, the relevant front backrest cover must be replaced, see ⇒ *Workshop Manual '741919 Removing and installing cover for front backrest'*.
