TECHNICAL BULLETIN

211-00

Steering heavier than expected

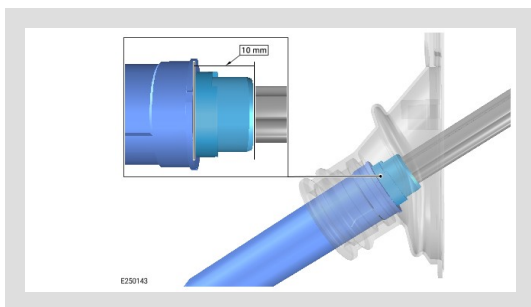
4.

Measure the area shown.

- If the area shown is **greater** than **10 mm**, continue to '**Steering column shaft and boot - Renew**'.
- If the area shown is **less** than or equal to **10 mm**, do not continue with this bulletin. Continue diagnosis using TOPlx (see TOPlx Workshop Manual section 211-04: Steering Column - Diagnosis and Testing - Steering Column).

Renew the steering column shaft and steering column shaft boot (see TOPlx Workshop Manual section 211-04: Steering column - Steering column shaft).
