TECHNICAL BULLETIN

501-17

Roof Opening Panel Seal Adrift

MODEL:	MODEL YEAR:	VIN:	ASSEMBLY PLANT:	APPLICABILITY:
Discovery (LR)	2017-2019	000225-090175	Solihull	Vehicles With: Roof Opening Panel

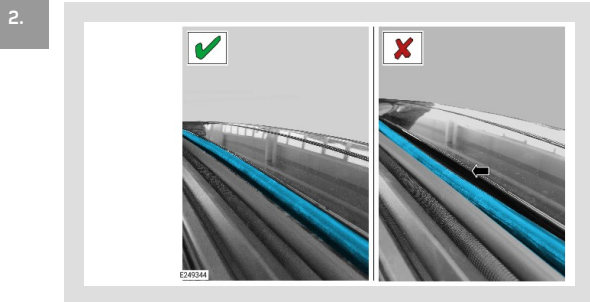
Visually inspect the roof opening panel main seal.

- If any part of the roof opening panel main seal **is not** installed correctly, **continue to step 3.**
- If the roof opening panel main seal **is** installed correctly, **this is not the cause of the customer's concern. Continue diagnosis using the TOPlx Workshop Manual section 501-17: Roof Opening Panel - Diagnosis and Testing - Symptom Chart - Wind noise.**
