SIB 62 01 19

2019-08-07

INSTRUMENT CLUSTER AND ONBOARD COMPUTER INTERMITTENTLY INOPERATIVE

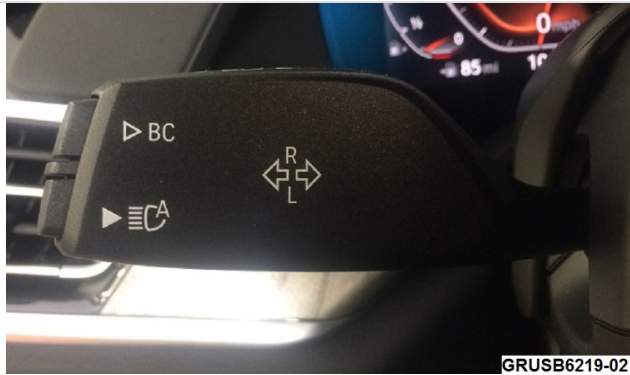
Instrument Cluster (KOMBS18) functions are intermittently inoperative, including:

- On-board Computer (BC) button on turn signal stalk (BC button shown at left)
- Radio displays
- Menu button
- Turn signal displays
- Arrows on multifunction steering wheel
- MFL thumbwheel control (shown at left)

Program/encode the vehicle to Integration level (I-level) S18A-19-07-530 or higher.

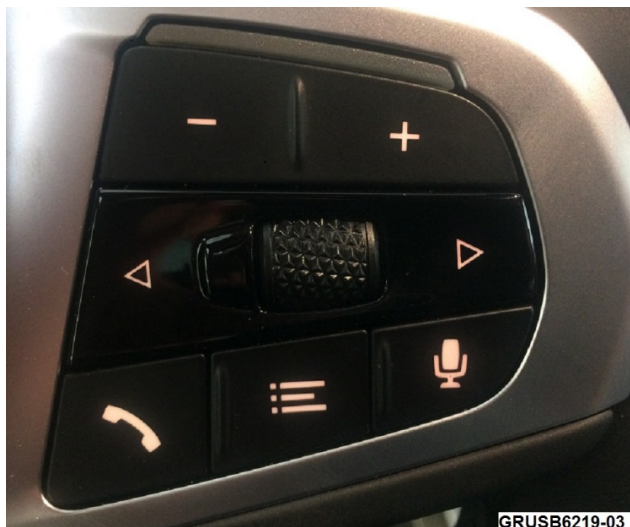
Additionally, the audio source, radio station, or music track cannot be changed using the MFL.
