SIB 18 01 18

2019-08-07

DIAGNOSING NOISE FROM THE REAR EXHAUST FLAP (B58)

F22 (2 Series Coupe)	F23 (2 Series Convertible)	F30 (3 Series Sedan)	F32 (4 Series Coupe)
F33 (4 Series Convertible)	F34 (3 Series Gran Turismo)	F36 (4 Series Gran Coupe)

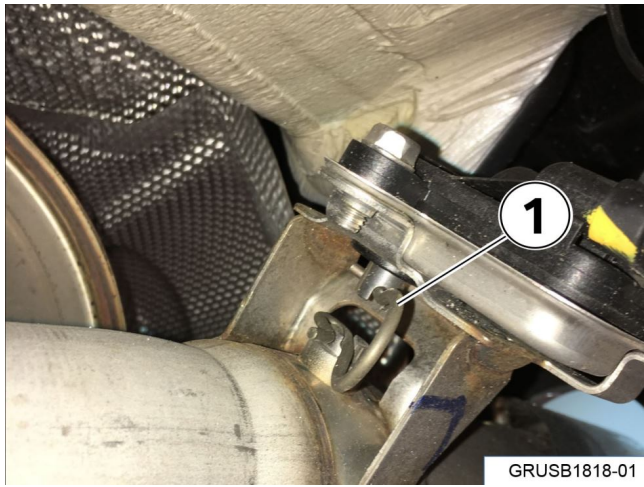
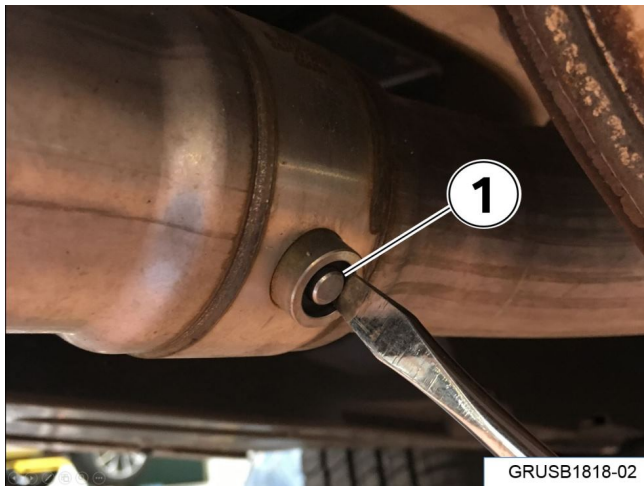
1. DME software application error (I-level is lower than F020-17-11-540) may cause the flap to stay in an undefined position which will cause it to rattle due to not being supported against a stop.
2. Loose or failed attachment bow (aka "fixing bow"; the clip that connects the exhaust flap actuator to the exhaust flap)
3. Excessive play in the pivot bushing of the exhaust flap.

<ol style="list-style-type: none"> 2. If the attachment bow (1) is loose or damaged or missing – Replace the attachment bow.
--	---
