Technical product information

Topic	Anti theft alarm activates for no reason			
Market area	Bentley: worldwide (2WBE),Hongkong-Macau (5HK)			
Brand	Bentley			
Transaction No.	2055907/1			
Level	EH			
Status	Approval			
Release date

Bentayga

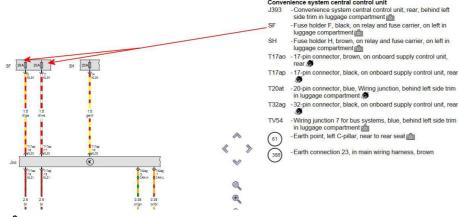
Figure 2

DTC - B133029 Sensor for anti theft alarm implausible signal evident within the Onboard supply control unit 2 (J393) (Address 46)

- The event memory "B133029 Sensor for anti-theft alarm system implausible signal" is sporadically entered:
- The event memory "B133029 Sensor for anti-theft alarm system implausible signal" is statically entered:
- The complaint can be remedied by a reset of the comfort control unit J393 (diagnostic address 46) refer to the Measure instructions within this TPI

- 2) Pullfuses 9 and 11 from fuse holder SF
- After the fuses have all been pulled for a short moment, they can be plugged in again. Subsequently, the function of the anti-theft alarm system is again functional to specification
- Erase the DTC from Address 46
