Service Alert

Subject: CLOCK CANNOT BE RESET AFTER BATTERY DISCONNECT	Service Alert No.: SA-021/19
	Last Issued: 09/04/2019

2007-2012 CX-7
2007-2015 CX-9

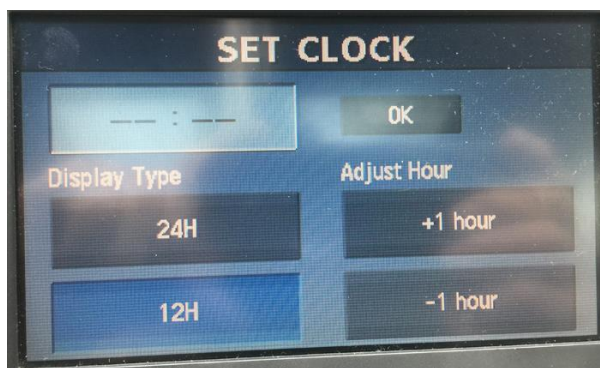
Some vehicles may experience a clock failure after a battery disconnect. The clock shows dotted lines and cannot be reset.

Mazda is aware of this issue and is working on a permanent solution. Perform Interim Repair Procedure. This service alert will be revised when a final countermeasure repair is available.

1. Verify customer concern.
2. Disconnect and reconnect the vehicle battery at the 1:00 hour. Note:
 - If the customer cannot wait for the 1:00 hour to perform this procedure, put the customer in a loaner vehicle.
 - This procedure must be repeated every time the battery is disconnected.
3. Verify repair.
