## SERVICE BULLETIN

**APPLICABILITY:** 2010-**19MY** Legacy and Outback  
 2014-**19MY** Forester  
**2012-19MY** Impreza  
**2013-19MY** Crosstrek (Exc. 19MY PHEV)  
 2015-**19MY** WRX  
**2019-20MY** Ascent

**NUMBER:** **16-103-16R**

**SUBJECT:** Transmission Fluid Seepage

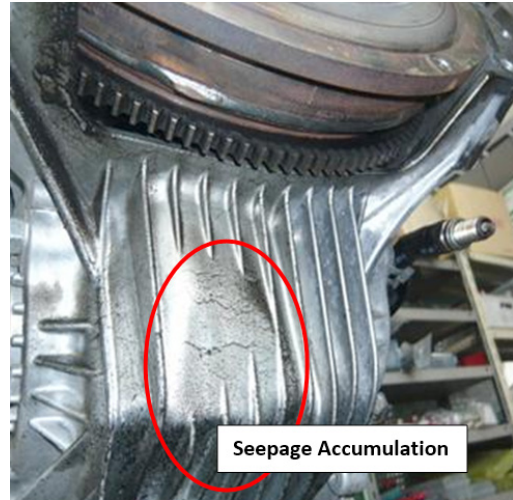
As a first step, during inspection of the customer's concern, confirm the fluid found to be seeping is CVT fluid (CVTF) and not engine oil. The photos below are examples of where CVTF seepage may be evident.

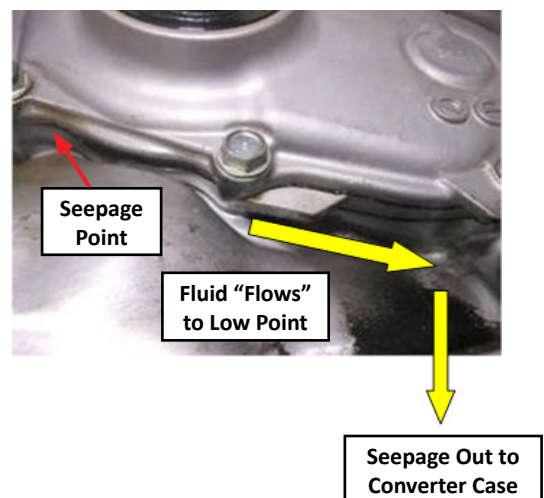
- Once the inspection has confirmed the seepage is CVTF, remove the CVT assembly following the procedure outlined in the applicable Service Manual.
- **CAREFULLY** remove the torque converter from the CVT and inspect the area of the oil pump chain cover as indicated in the photo below for any accumulation of CVTF and road dirt which may also have collected in the area.

**NOTE:** A small amount of fresh CVT fluid may appear near the 6:00 position of the seal area during removal of the torque converter (GREEN circle).

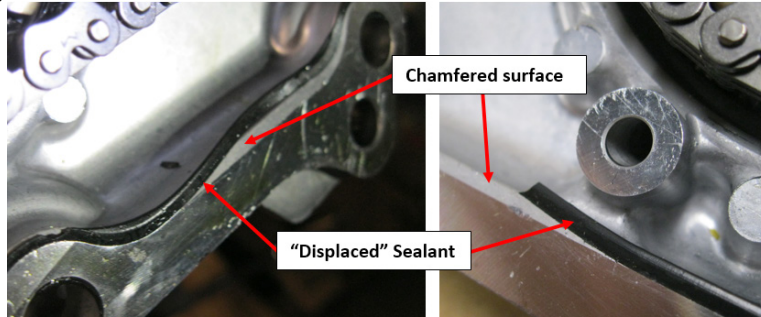
- Take note of how the sealant on the removed cover forms an additional “seal” when it becomes displaced into the chamfer around the inside edge of the case’s machined surface at assembly.

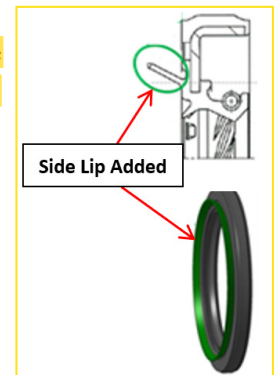
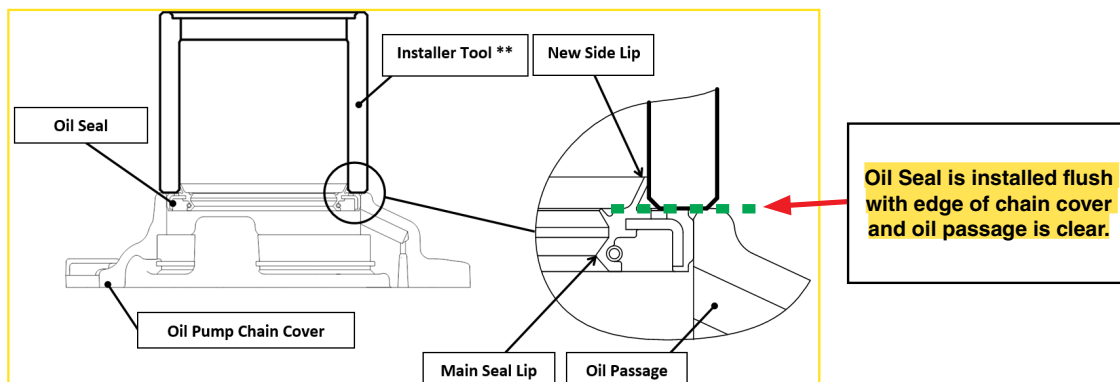
- The re-designed input shaft oil seal has a new side lip added to supplement the existing main seal lip. The purpose of the additional side lip is to direct the flow of dust and water around the seal and away from the sealing surfaces.
- Apply CVT fluid to the main seal lip **only** before installation.
- When installing this new seal, it is **STRONGLY** recommended to use the proper installer tool **\*\*OPTIONAL Special Tool 927890000** as shown in the illustration below. Otherwise, If the seal were to be installed too deep into the bore of the chain cover (beyond flush with the chain cover edge as shown below), the oil passage may become restricted or blocked.

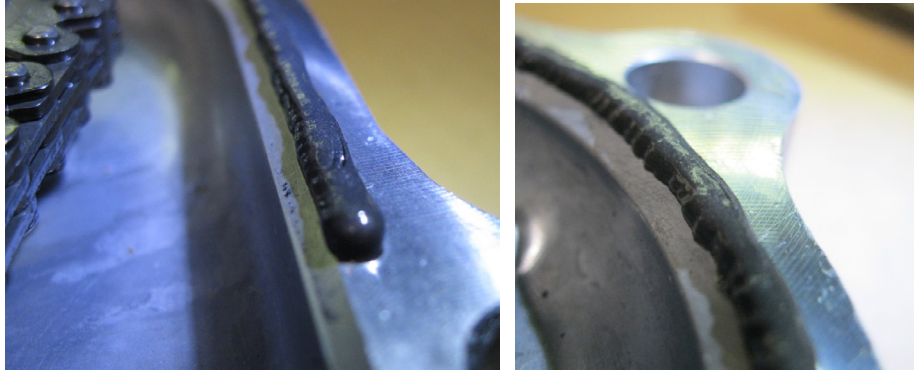
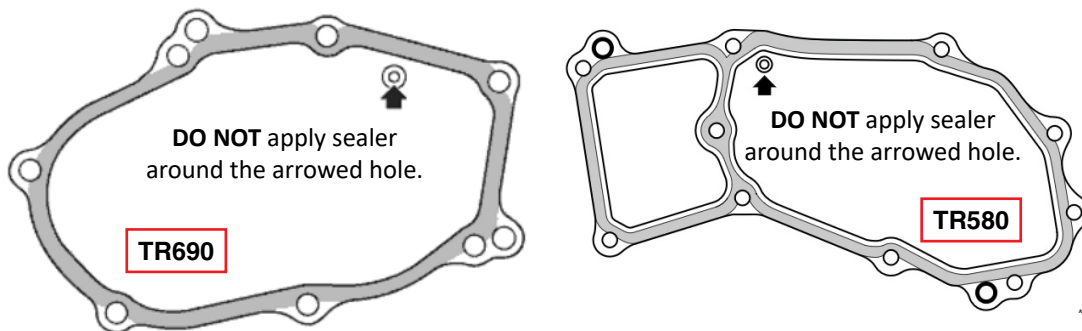
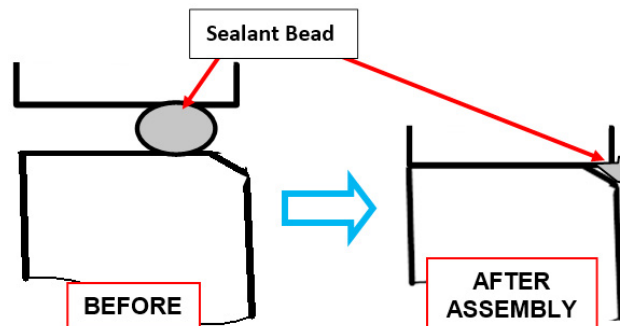
**NOTE:** As shown above, a properly applied, small bead of sealant will fill in the chamfered portion after the cover is installed. Do not use an excessive amount of sealant.

- Once both surfaces and the area surrounding the cover are completely clean, dry and the new input seal is properly installed, CAREFULLY apply the new sealant bead to the cover along the edge of the chamfer as shown below.
