THIS IS A TECH TIP, NOT A TECHNICAL BULLETIN.

60-18-02TT Manual Sun Shade Will Not Stay Closed or Opens Slightly While Driving

Release date: 09/20/2019

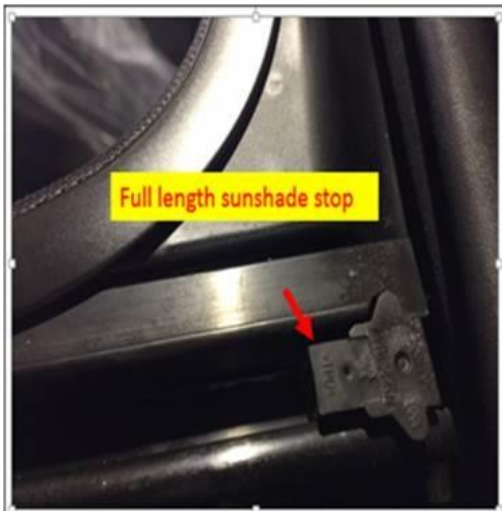
Figure 1

The Detents for retaining the Sunshade can become weak leading to the Sunshade opening slightly while driving.

- Carefully remove approximately 2mm of material from the rear section of the Rubber Bump Stop (Figure 1).
- Apply a 1 inch to 2 inch (25mm-50mm) strip of Felt Tape to the Track by the End Stop (Figure 2). Felt Tape part number 533 863 288 A from the VAS Noise Elimination Kit can be used.
