Technical Service Bulletin

91 SOS Warning displayed in the instrument cluster, no communication to the telematics control module

91 19 90 2056076/2 September 18, 2019. Supersedes Technical Service Bulletin Group 91 number 19-85 dated September 5, 2019 for reasons listed below.

Model(s)	Year	VIN Range	Vehicle-Specific Equipment
A4, A5, A6, A7, A8, Q5, Q7, Q8, and Audi e-tron quattro	2019 - 2020	All	With ConBox

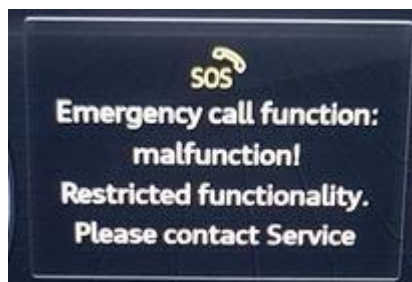
- An SOS Warning is displayed in the instrument cluster (Figure 1).

Figure 1. Emergency call malfunction warning.

- No diagnostics communication can be established with the control module for emergency call module and communication unit (telematics control module or ConBox), J949 (address word 0075).

A software bug can cause the control module to freeze during cold start.

1. Remove the telematics control module, J949 (address word 0075) according to the repair manual in Elsa.
2. Open the battery compartment of the telematics control module, J949 (address word 0075) and disconnect the backup battery.

3. Leave the battery disconnected for approximately 60 seconds.
4. Reinstall the backup battery back into the telematics control module, J949 (address word 0075).
5. Reinstall the telematics control module, J949 (address word 0075) back into the vehicle.
6. **If ODIS still cannot connect** to the telematics control module, J949 (address word 0075), follow the ODIS test plan.

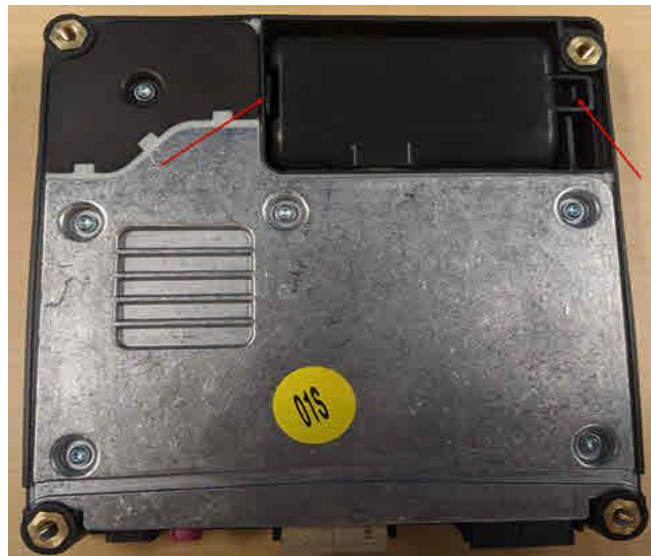
Figure 1. Backup battery compartment location.

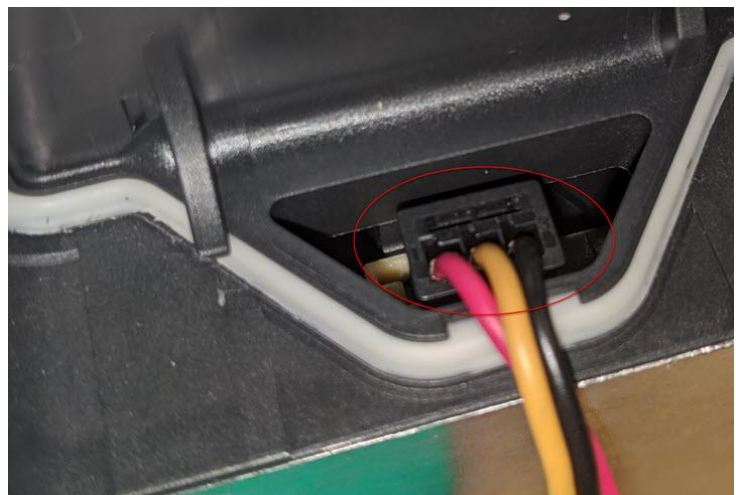
Figure 2. Backup Battery connector (no release mechanism).
